Date 10. Aug. 1982	
VERITAS Report No. IOD 32/82/106	Subject Group
Department 032	
Project No. 322852	
Title of Report FRIGG FIELD FLARE PLATFORM REVISED DESIGN, FABRICATION AND INSTALLATION RESUME	
Approved by

This report is a revision of the original design, fabrication and installation resumé of the Frigg Field Flare Platform. The new revision includes all changes, repairs and modifications compared with the original structural design.

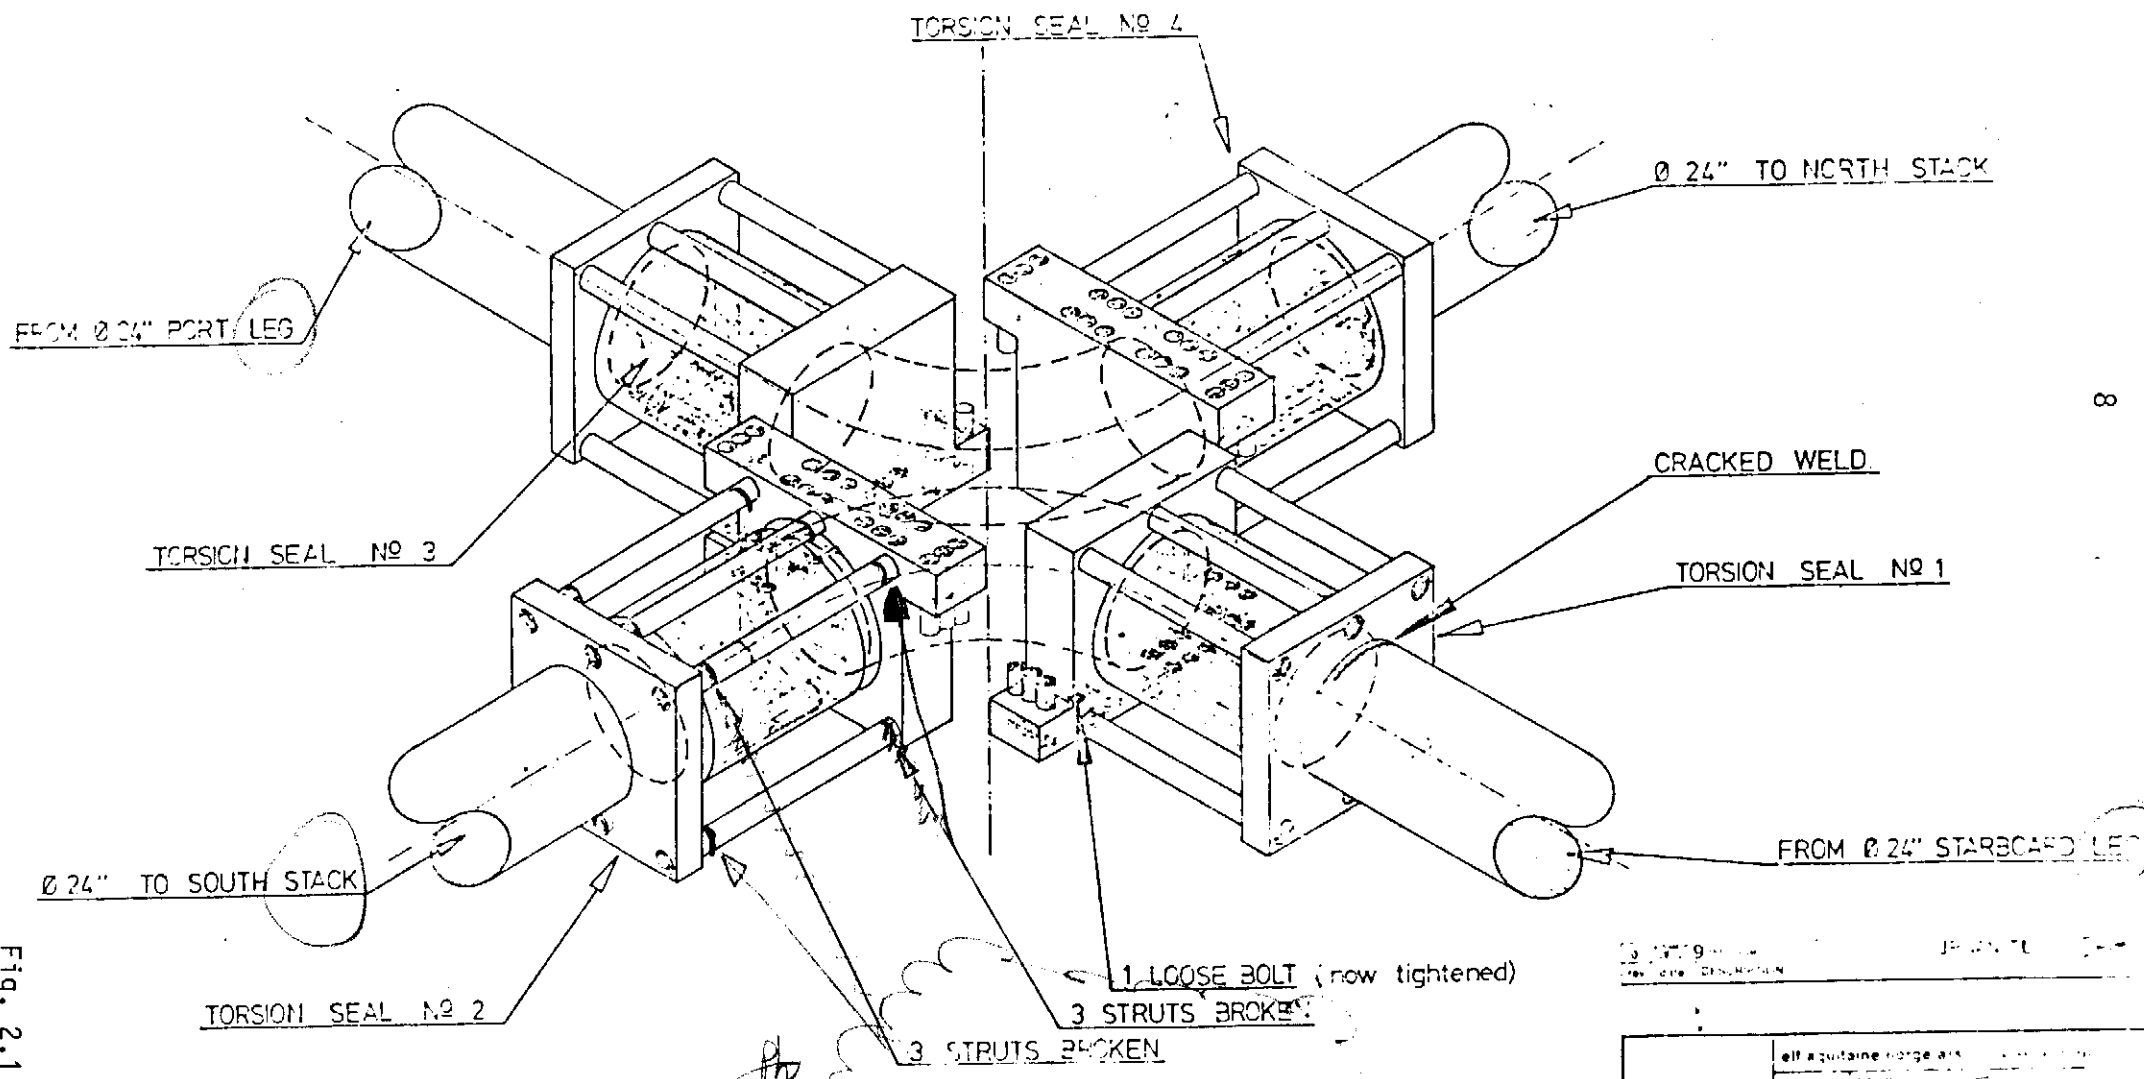
Fig. 2.1

- Crack in flange material of torsion seal support no. 1 from about 11 o'clock to 2 o'clock, see fig. 2.1.
- The ribs on torsion seal supports were not gradually rounded near the pipe/flange weld as indicated on drawings.
- The axial weld on pipe corresponded to the most stressed rib on the torsion seal support.

- All 6 struts were broken. The upper 3 struts were broken at the bearing side and the lower 3 at the flange side, see fig. 2.1.
- The seal had been displaced in lateral and vertical direction.

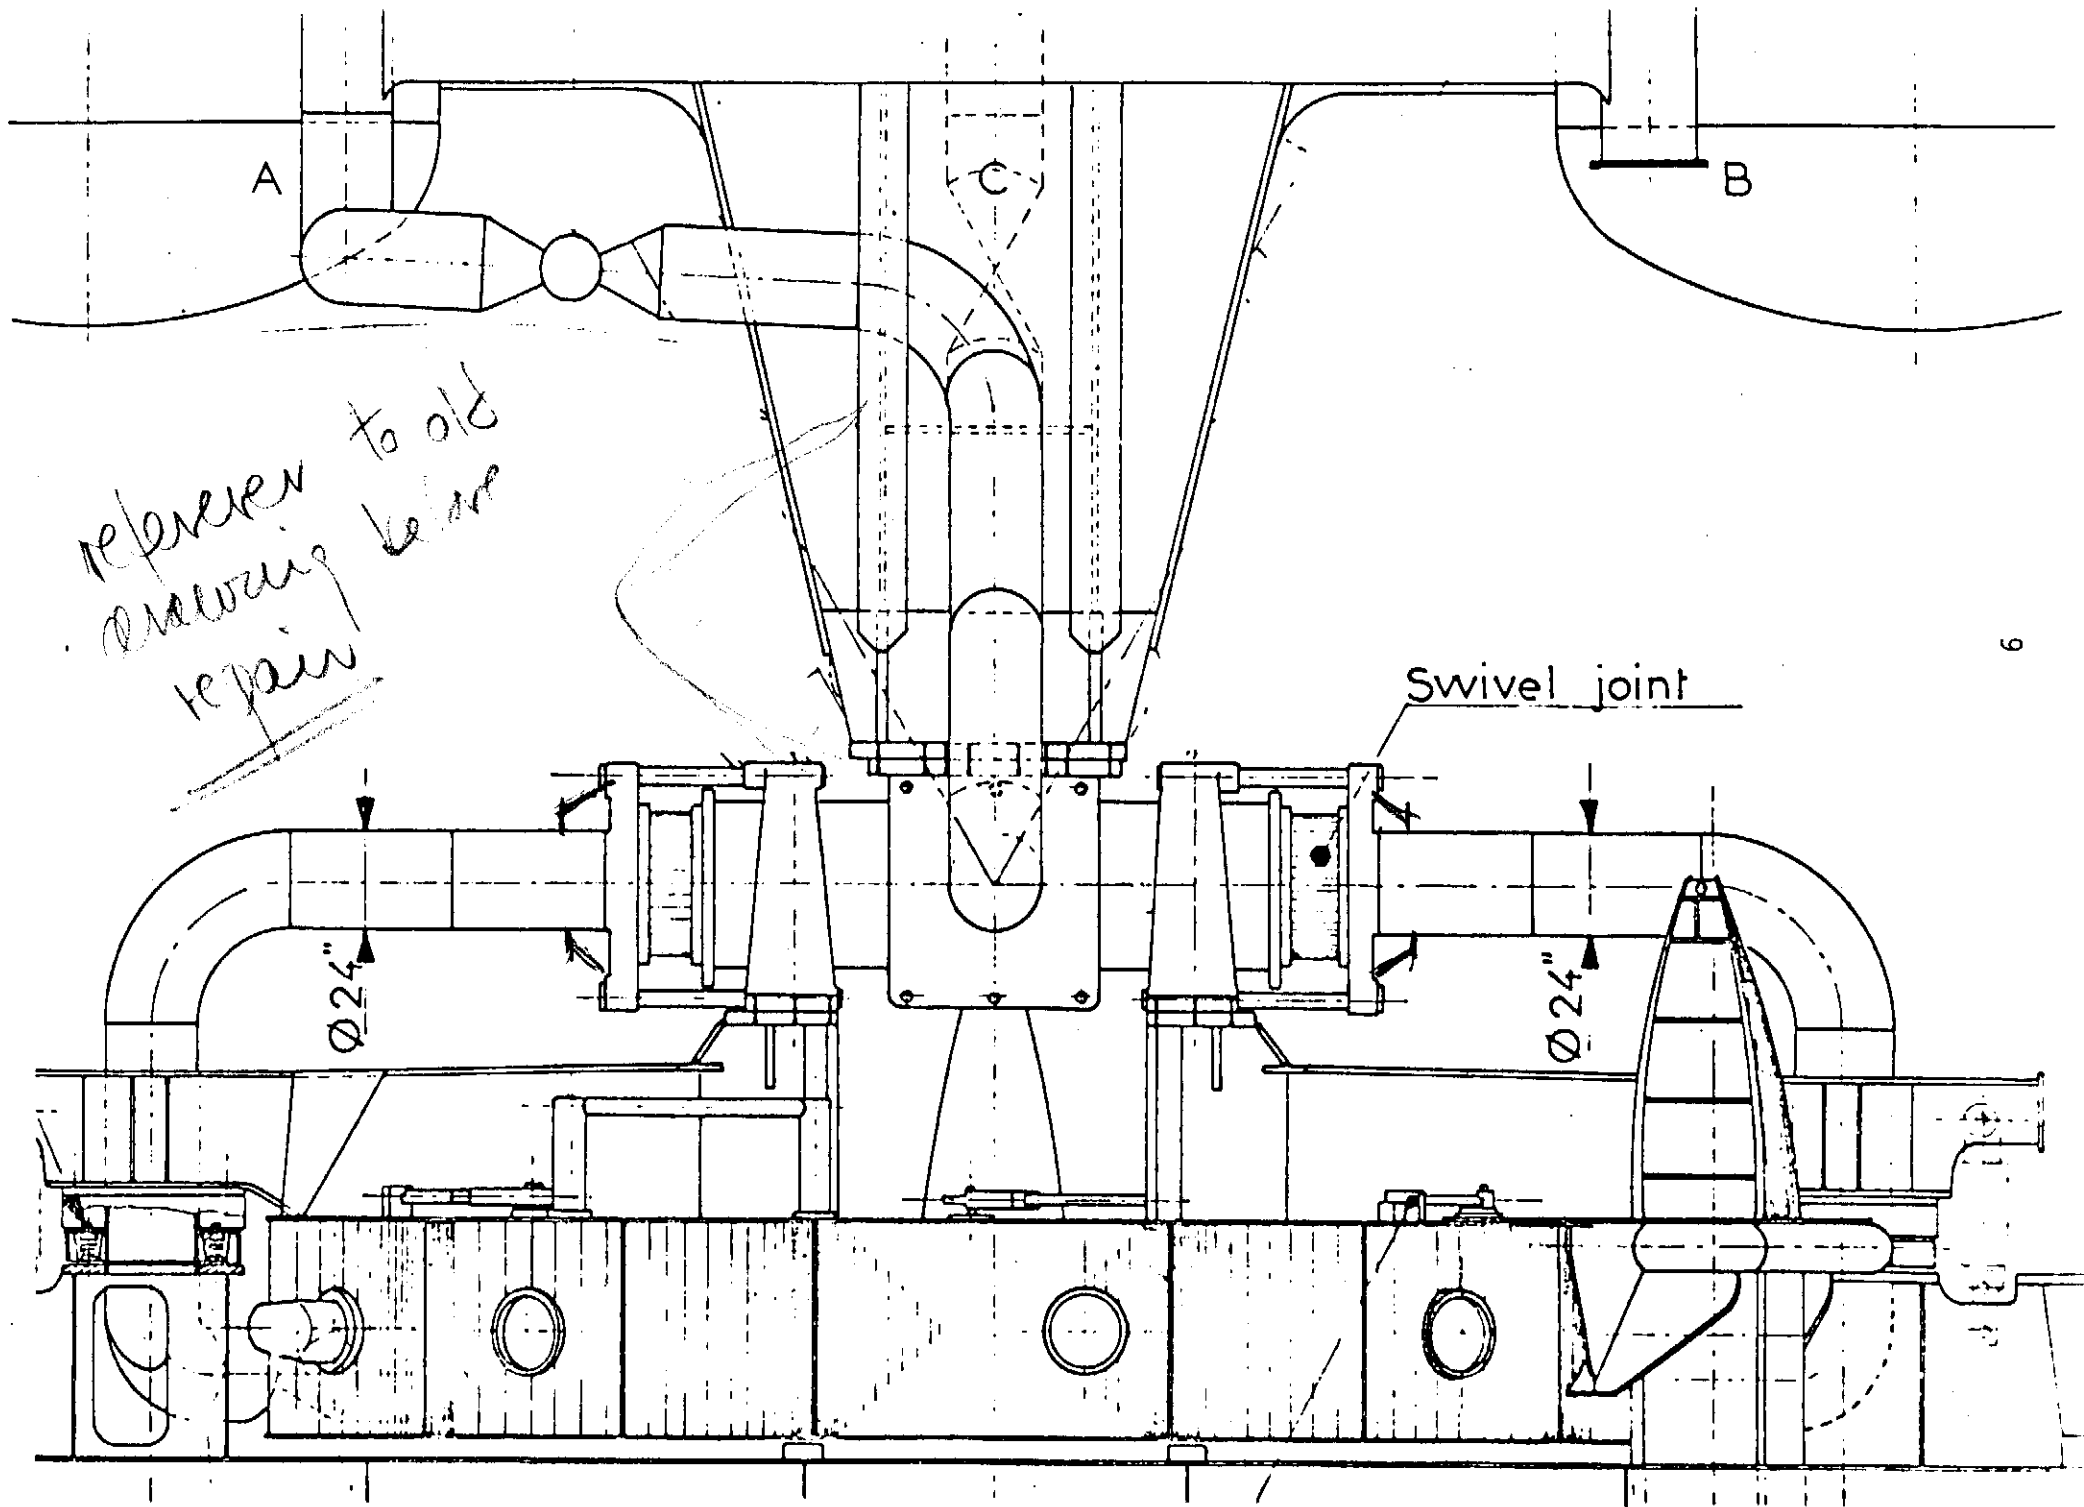
FIG. 2.2

- For dismounting, the pipe had been cut and a horizontal displacement of 10-15 cm arised, see fig. 2.2. Thus indicating that the pipe may have been forced in place during mounting.
- The pipe was deformed at the weld between bend and horizontal pipe, see fig. 2.2.
- The pipe was resting against the yoke, see fig. 2.2.
- Some of the stiffening around the hole in the yoke was cut away to make the pipe fit in the hole.

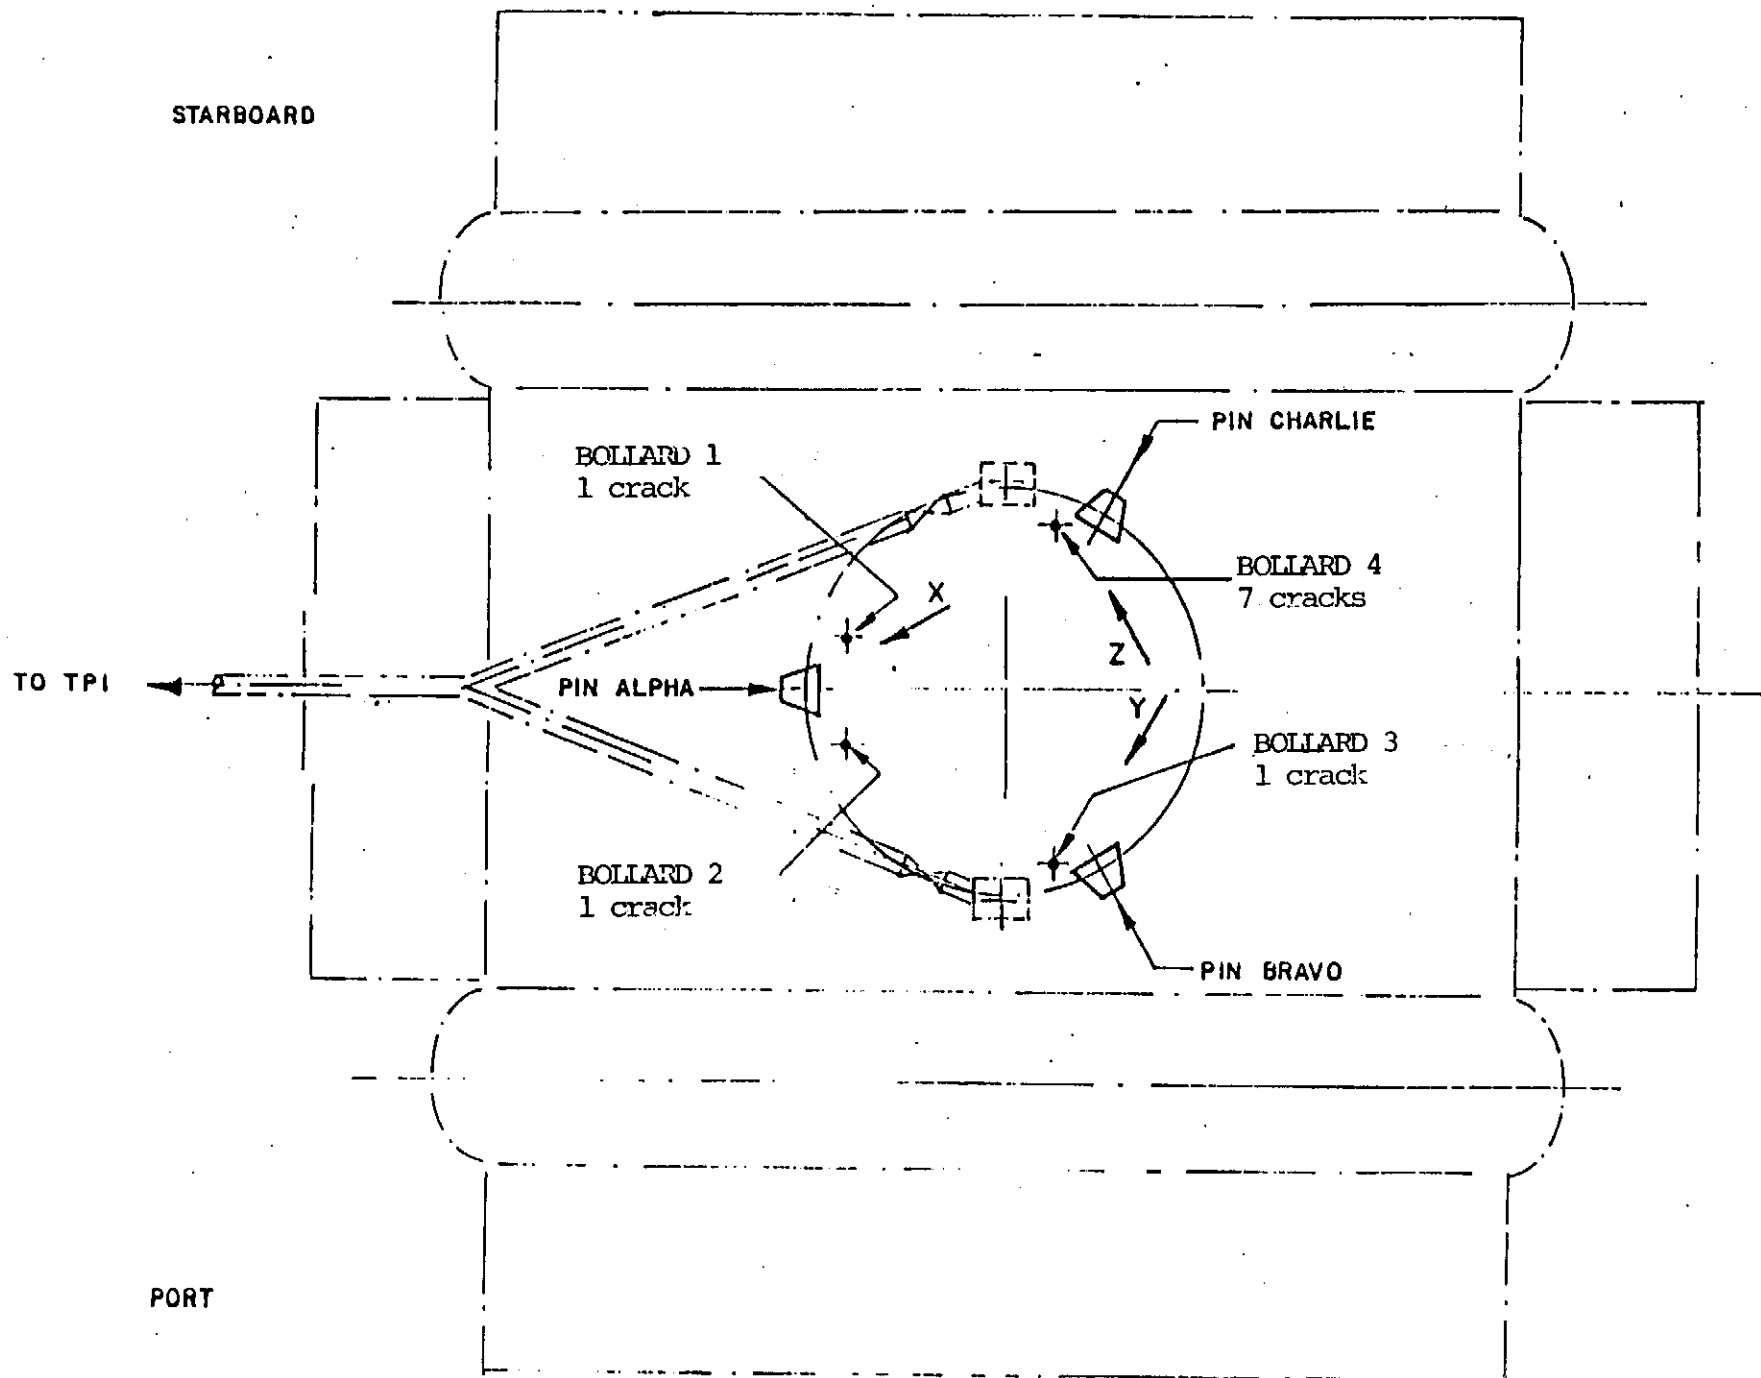
FIG. 2.3

During inspection of base, som large cracks were revealed at 4 bollards welded to the base plate, see fig. 2.3. For details, ref.reports (7), (8). (9) and (10).

stress level in the affected plates was very low and that it was sufficient to remove the bollards and to stop the cracks.

The bollards were removed and stopper holes were drilled at the cracks. Underwater work was performed in accordance with the procedures (11) and (12). A part of the base plate at bollard 4 was cut out for examination, see paragraph 2.7.4.

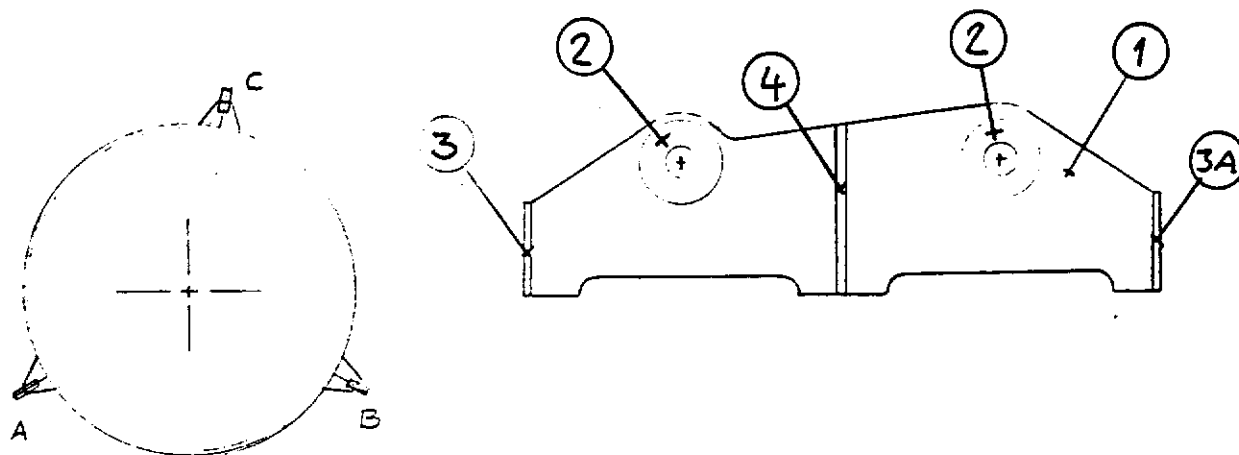
Fig. 4.2

On both stacks two parts
of the pipes were cut off
due to crack appearance.
New pipes were made and
welded on.
See fig. 4.2

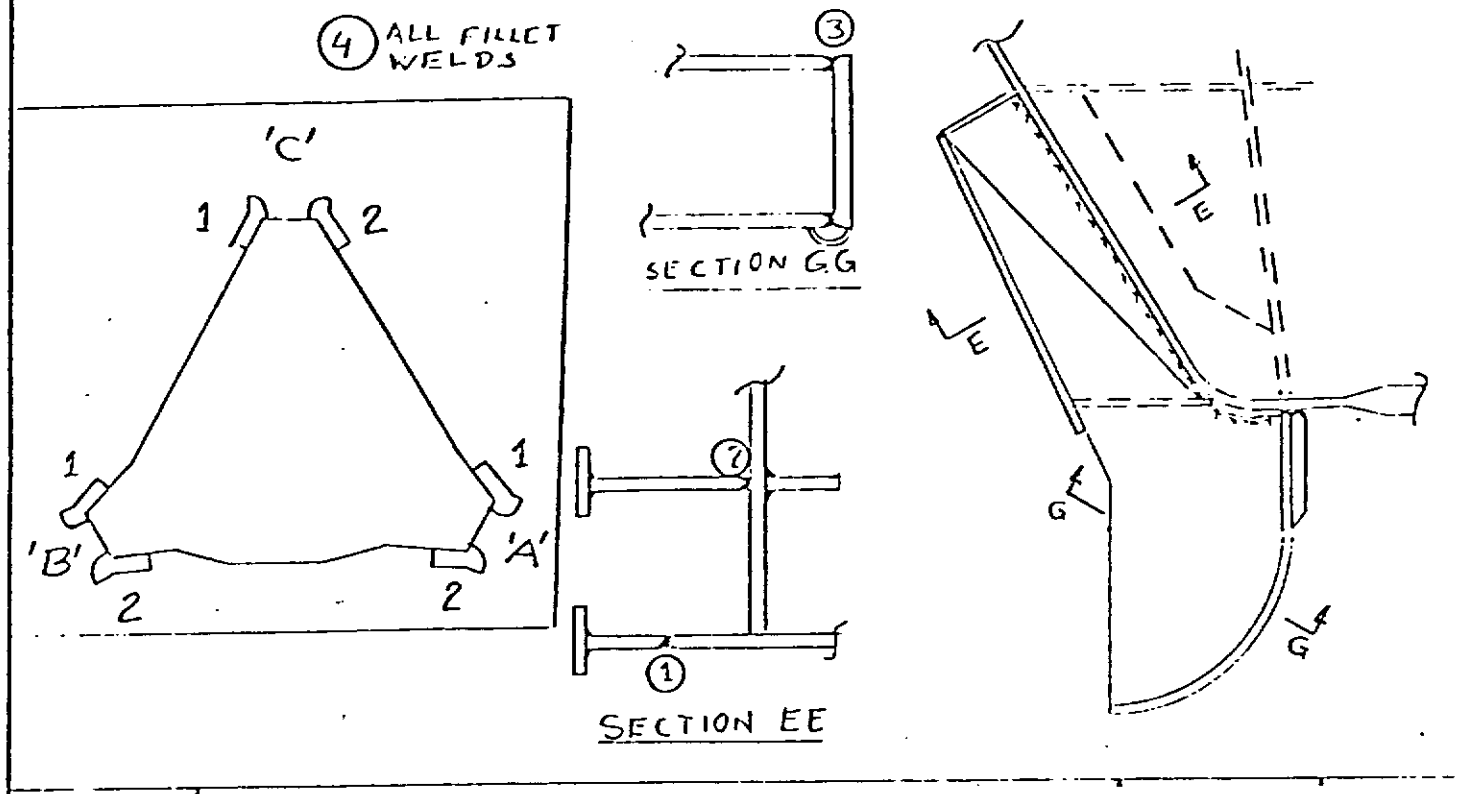
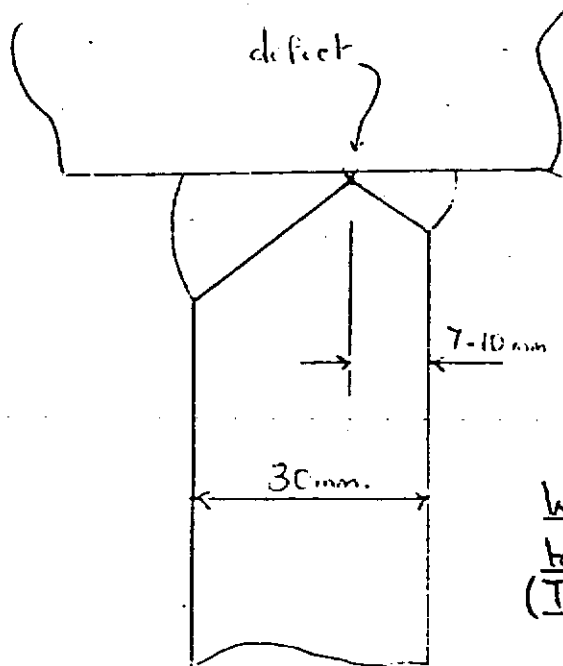
FIG. 4.4 WELDS ON BRACKET A1

U.S. examination of welds on wedging revealed lack of penetration on welds A1, B1 and B2 according to enclosed test report, ref. figs. 4.4, 4.5, 4.6. The U.S. examination was conducted less than 12 hours after final welding. The EAN site management decided to carry out repairs on weld B2, and leave the other welds in present condition. The repair of B2 was done and U.S. examination less than one hour after completion of welding showed no defects present. The flooding of the flare was carried out while the surface temperature of the repaired weld was about 50°C. The NDT-inspection carried out was not accepted by the DnV surveyor. The brackets are welded to primary structure and any cracks or cracklike defects in this will affect the fatigue life. Thus, it seems appropriate that these welds are subjected to regular and close inspection in the future.

defect - Lack of fusion, for full length of weld (over 1500 mm) also cracking 150 mm long

Weld re-tested after repair and found to be acceptable
(Tested immediately after welding)

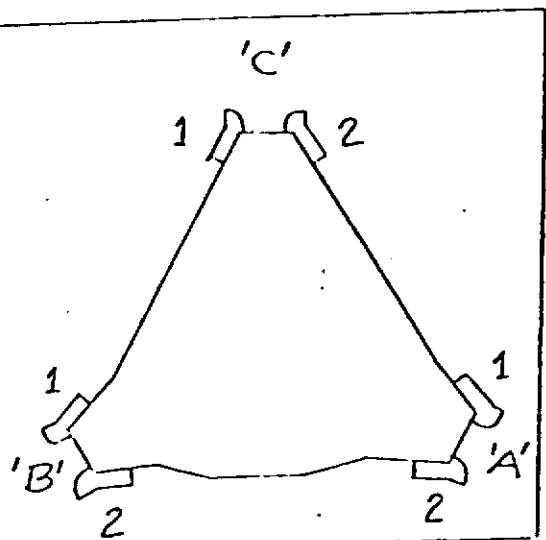
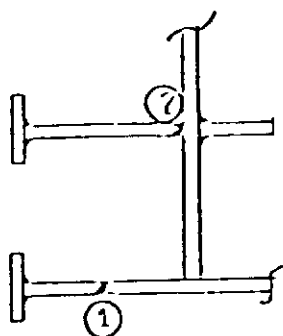
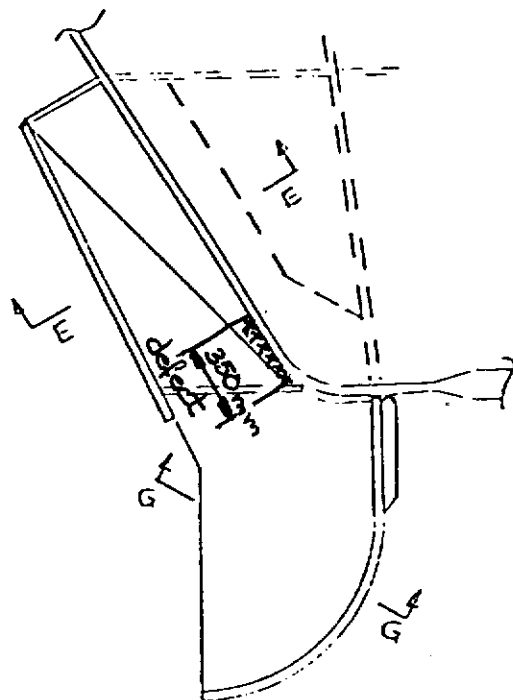
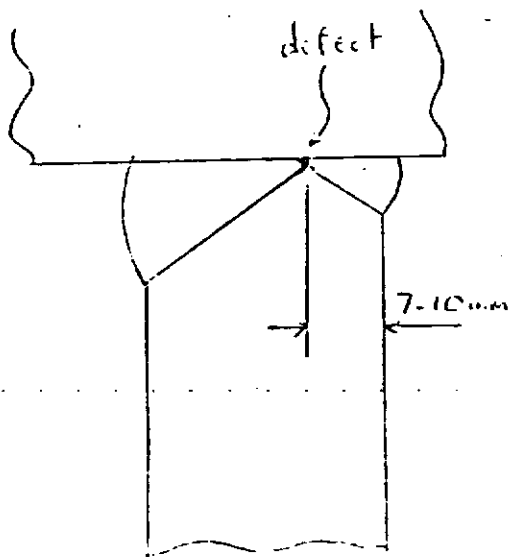
SKETCH '2'

defect - lack of penetration

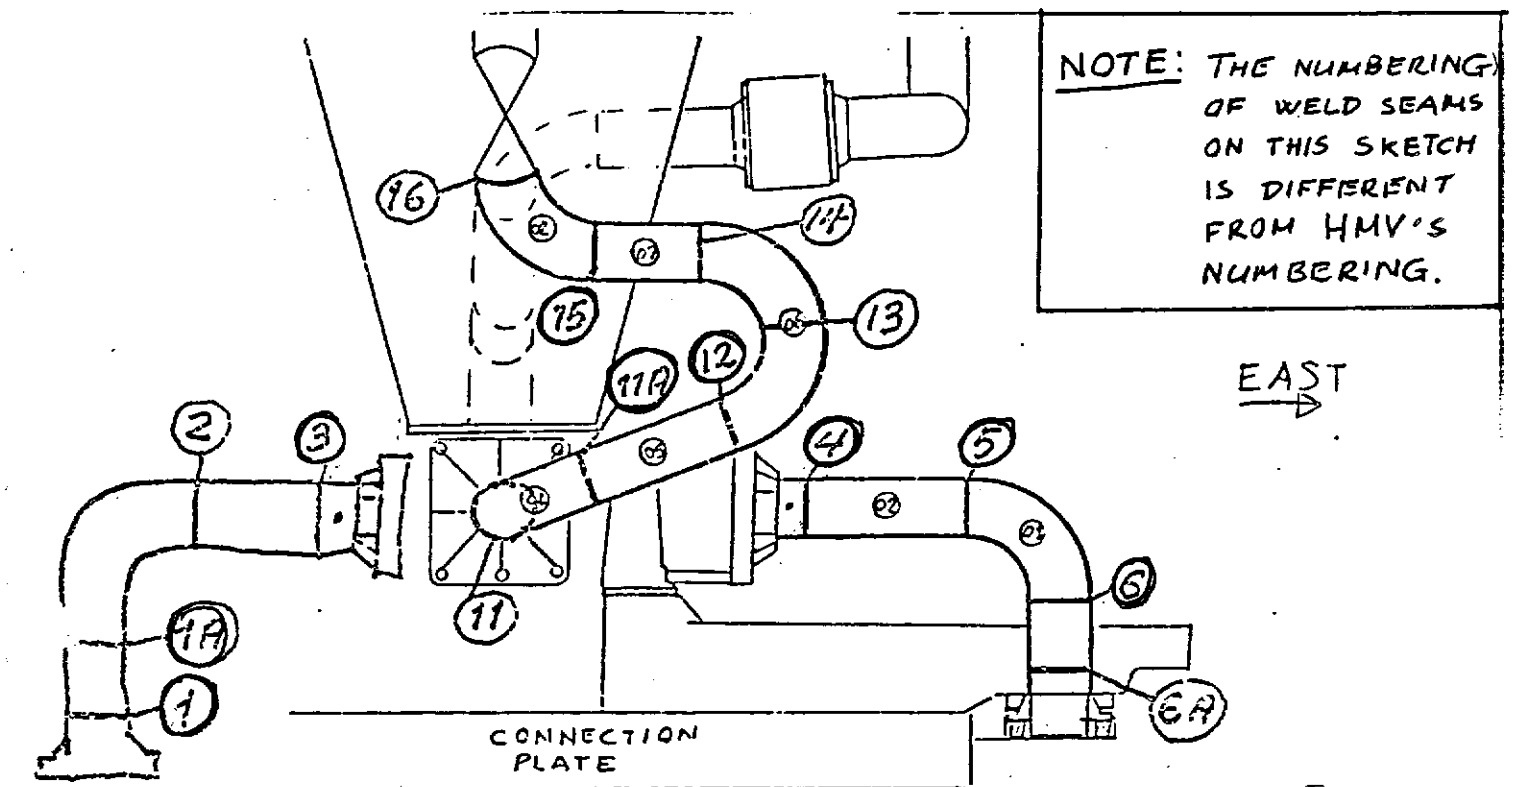
REPAIRS OF 24" GASLINE

During assembling at HMV, it was discovered that the materials were delivered with 1/2-x groove instead of specified V-groove. It was also discovered misalignment in the piping, mainly due to ovality in the tubes and elbows. Maximum misalignment were measured to 10 mm over 150 mm length. Inside misalignments were ground to smooth transition with inclination 1:4. Outside misalignments in way of longitudinal weld seam were compensated for by buttering in order to maintain specified wall thickness. The welds that were repaired are specified in the attached copies from HMV, fig. 4.7 and 4.8.

WELD NO	OUTSIDE OF WELD	INSIDE OF WELD
1	OK!	OK TO BE GRINDED
1A	OK!	OK TO BE GRINDED AND BACKWELDED
2	OK!	OK!
3	BUTTERING	OK TO BE GRINDED BEFORE BUTTERING AND BACKWELDING
4	BUTTERING	OK
5	BUTTERING	OK
6	TO BE GRINDED	OK TO BE INSPECTED AFTER FINISHING OF GRINDING
6A	OK!	OK
11	OK!	OK
11A	OK!	OK After Grinding done
12	BUTTERING AND GRINDING SMOOTH	OK After Grinding "
13	OK!	OK
14	OK!	OK
15	BUTTERING AND GRINDING SMOOTH	OK
16	OK!	OK

All requirements on welds 1-16 carried out and found acceptable
28/7-80 J. [Signature]
