FRIGG FIELD - DRILLING PLATFORM NO. 2
STRUCTURAL PARTS
DESIGN, FABRICATION AND INSTALLATION
(DFI) RESUMÉ

NORWEGIAN PETROLEUM DIRECTORATE

DET NORSKE
VERITAS

Date November 1, 1977	
Department 57	Project No. 601636
Approved by <i>S. H. Olsen</i>	
Client/Sponsor ref.	
Reporters sign. <i>Oddvar Alfstad</i>

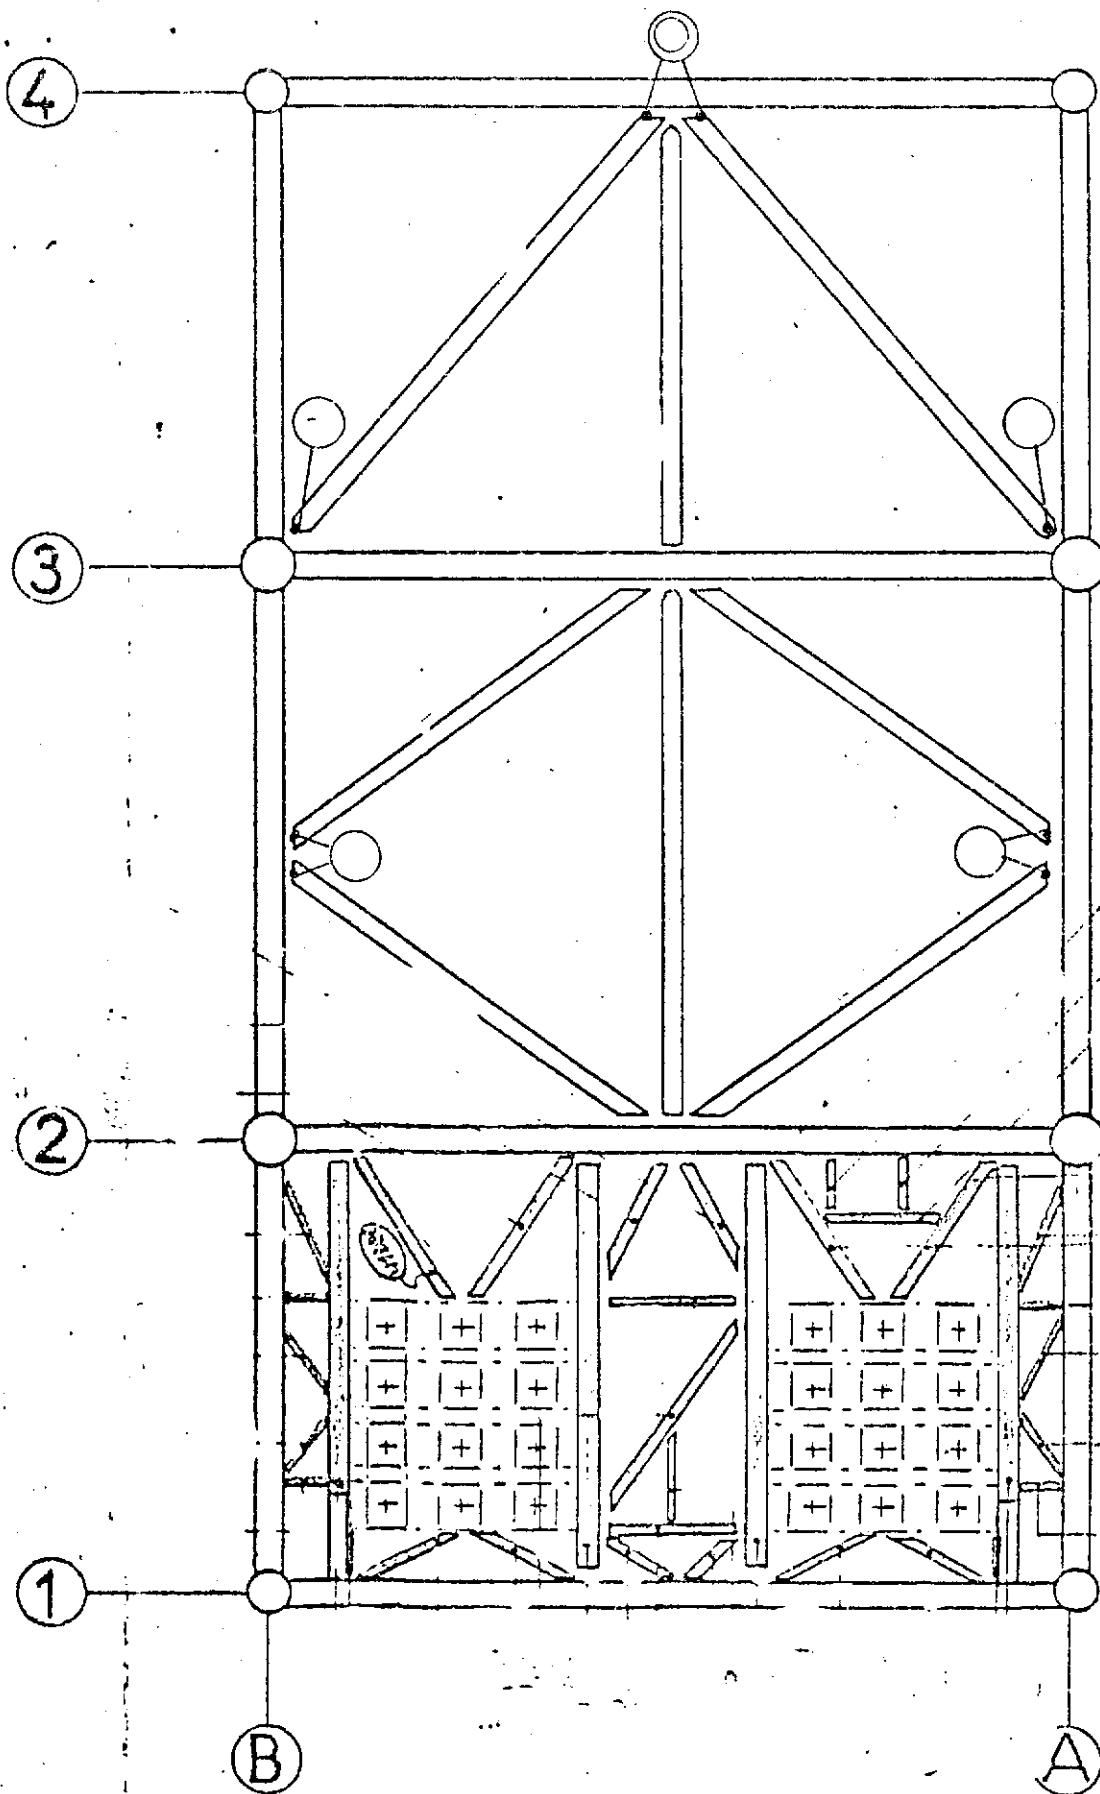
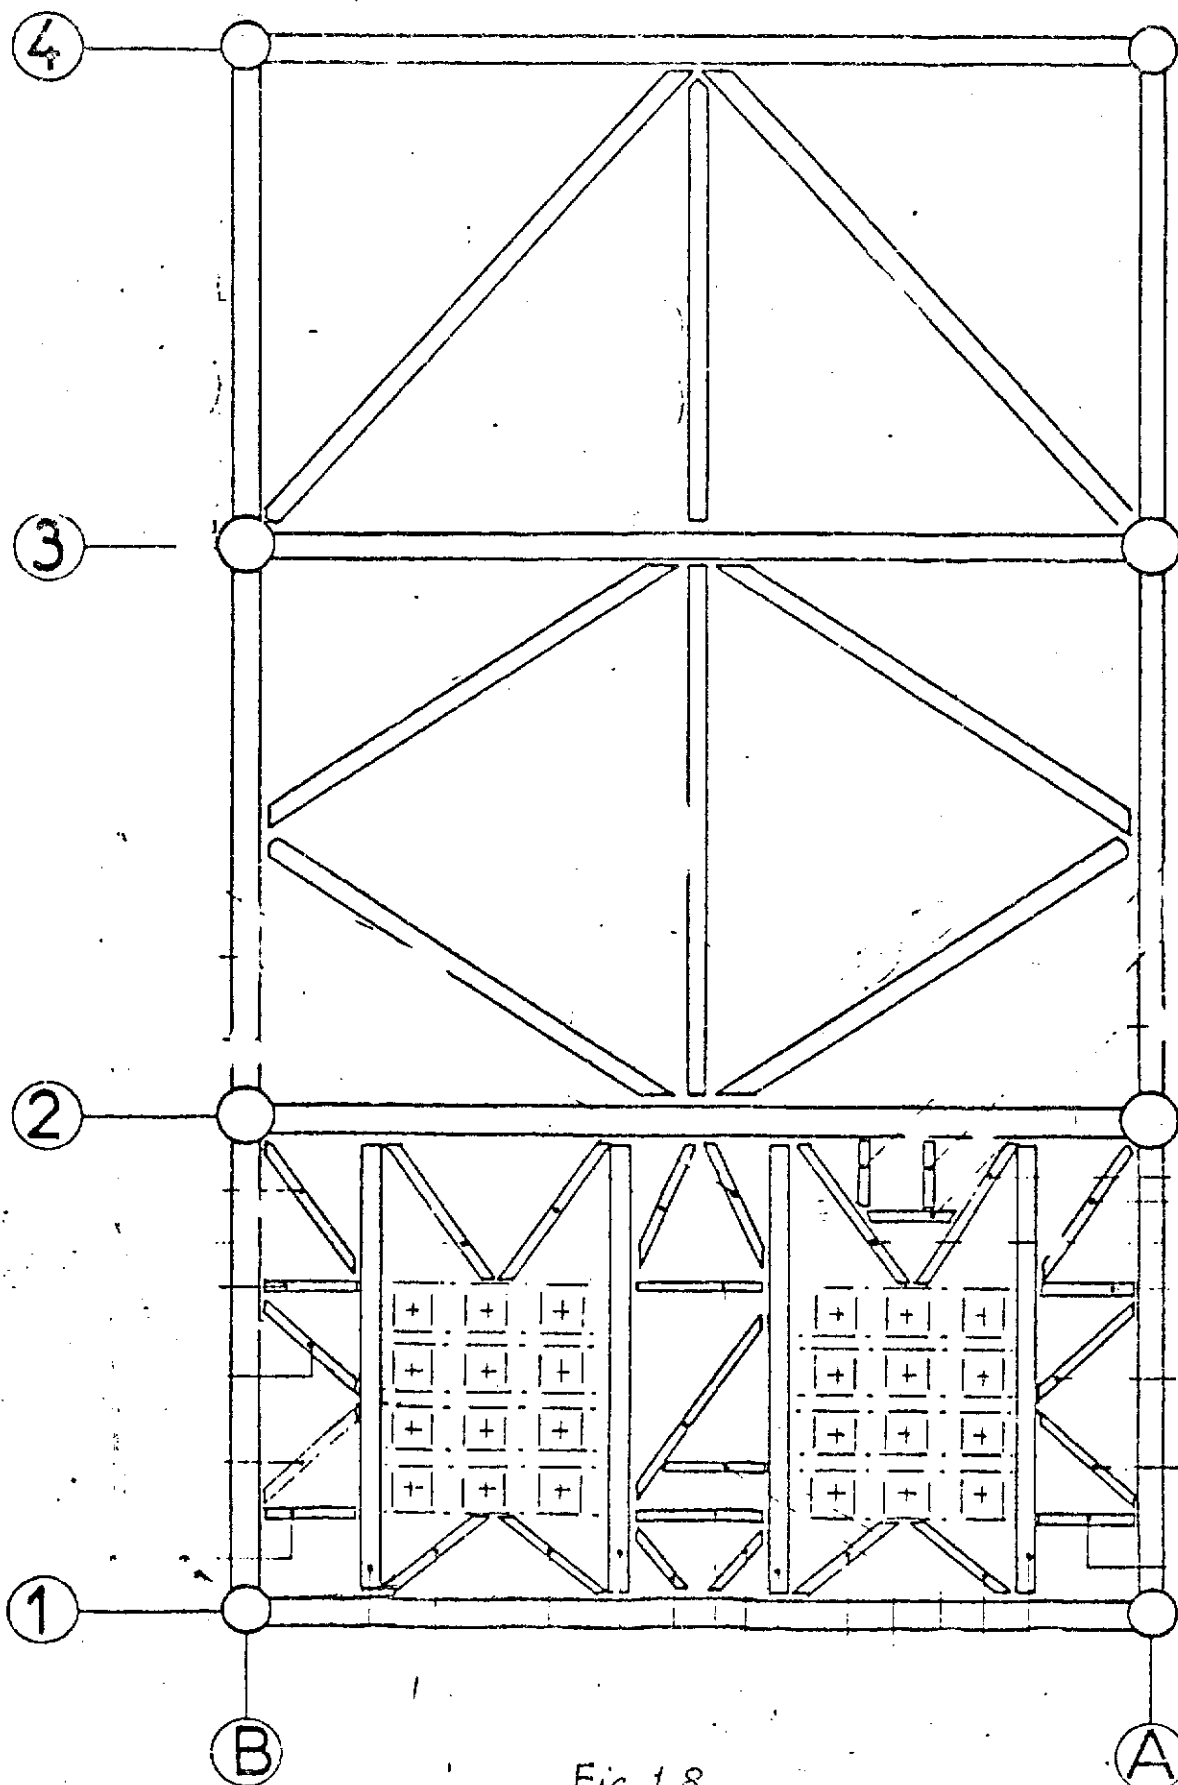
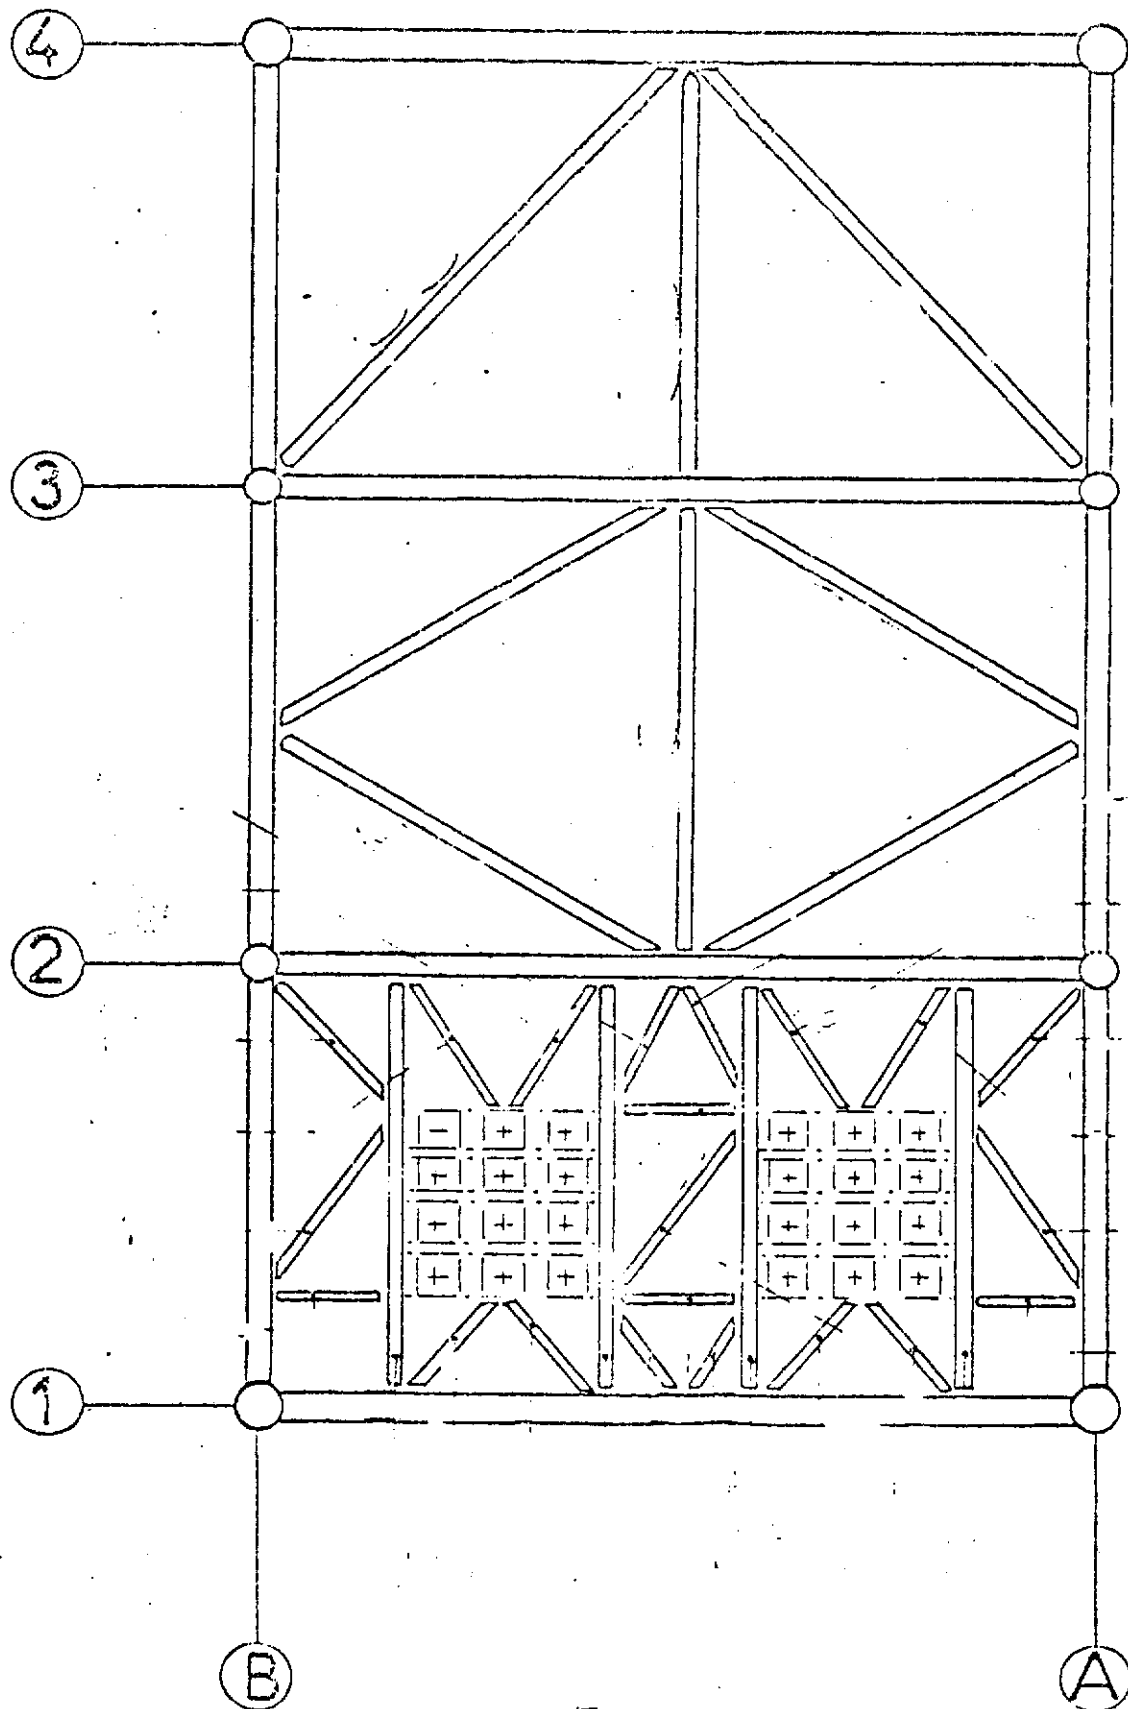
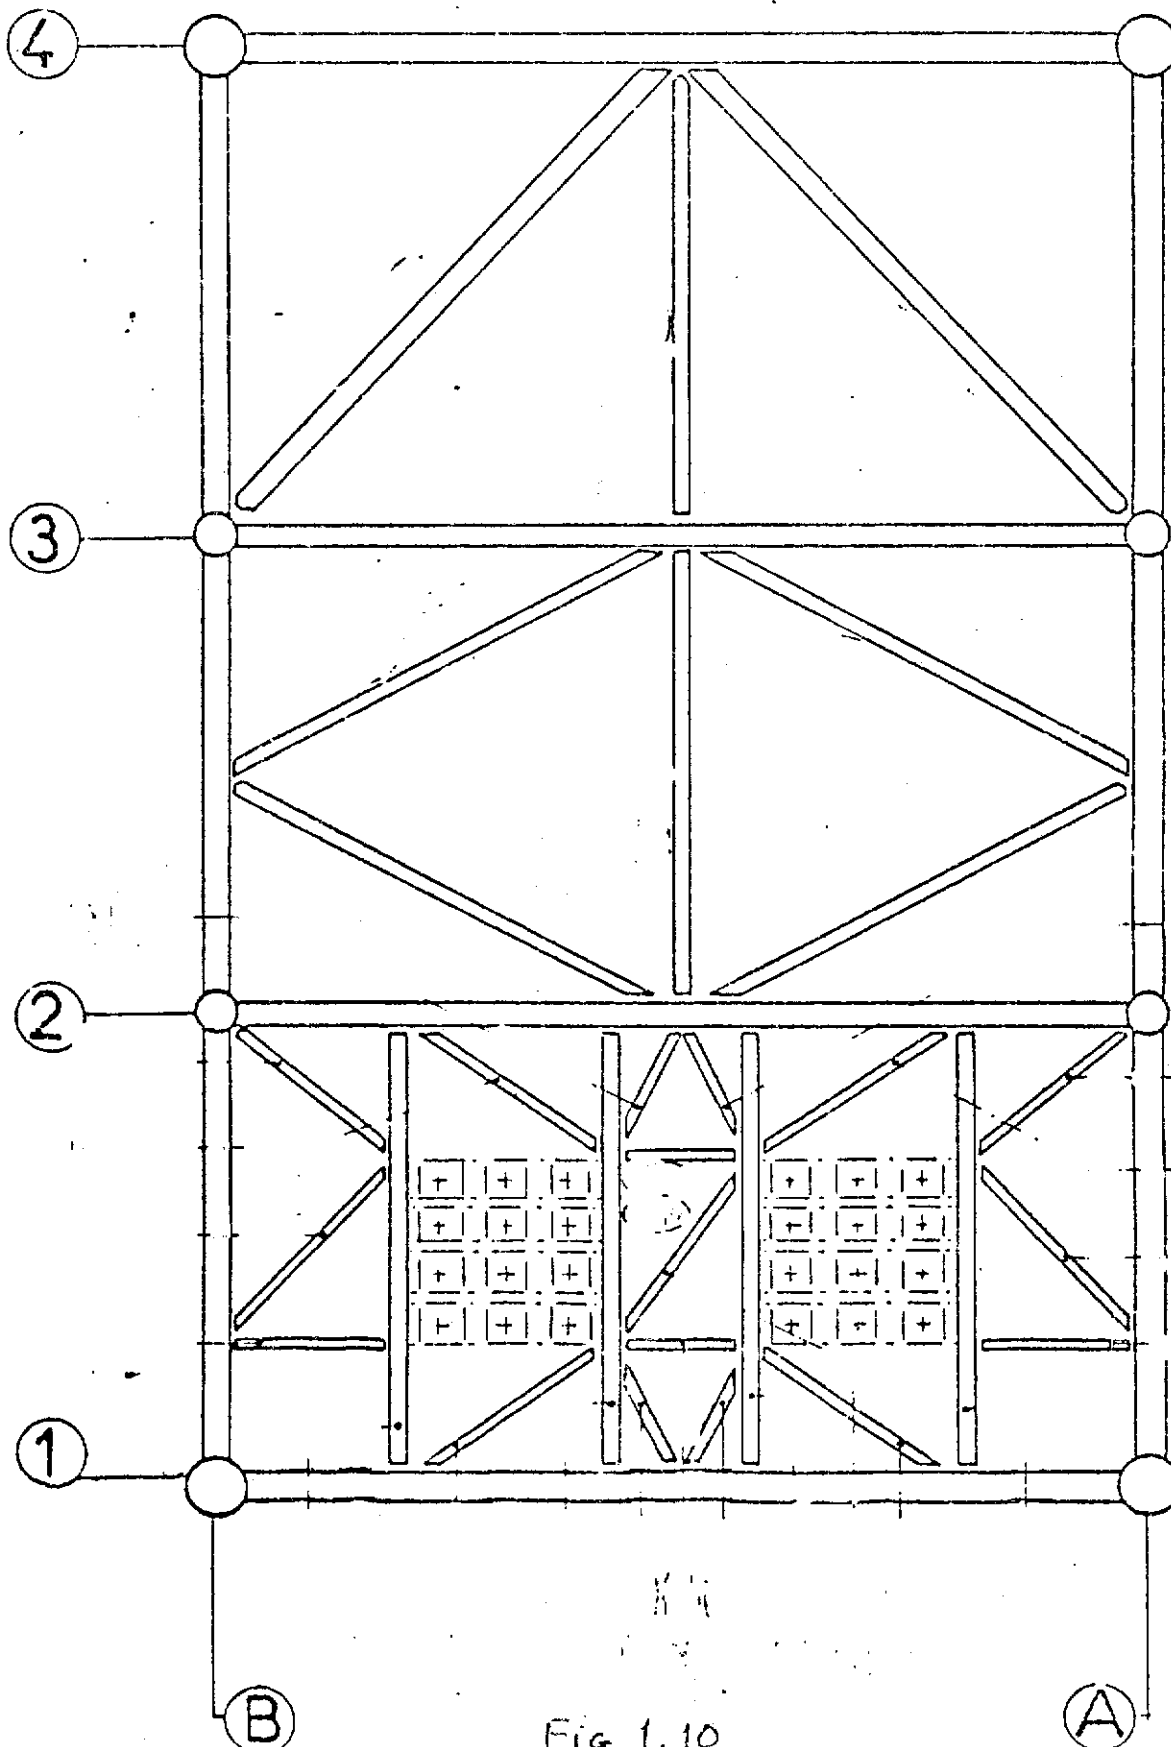
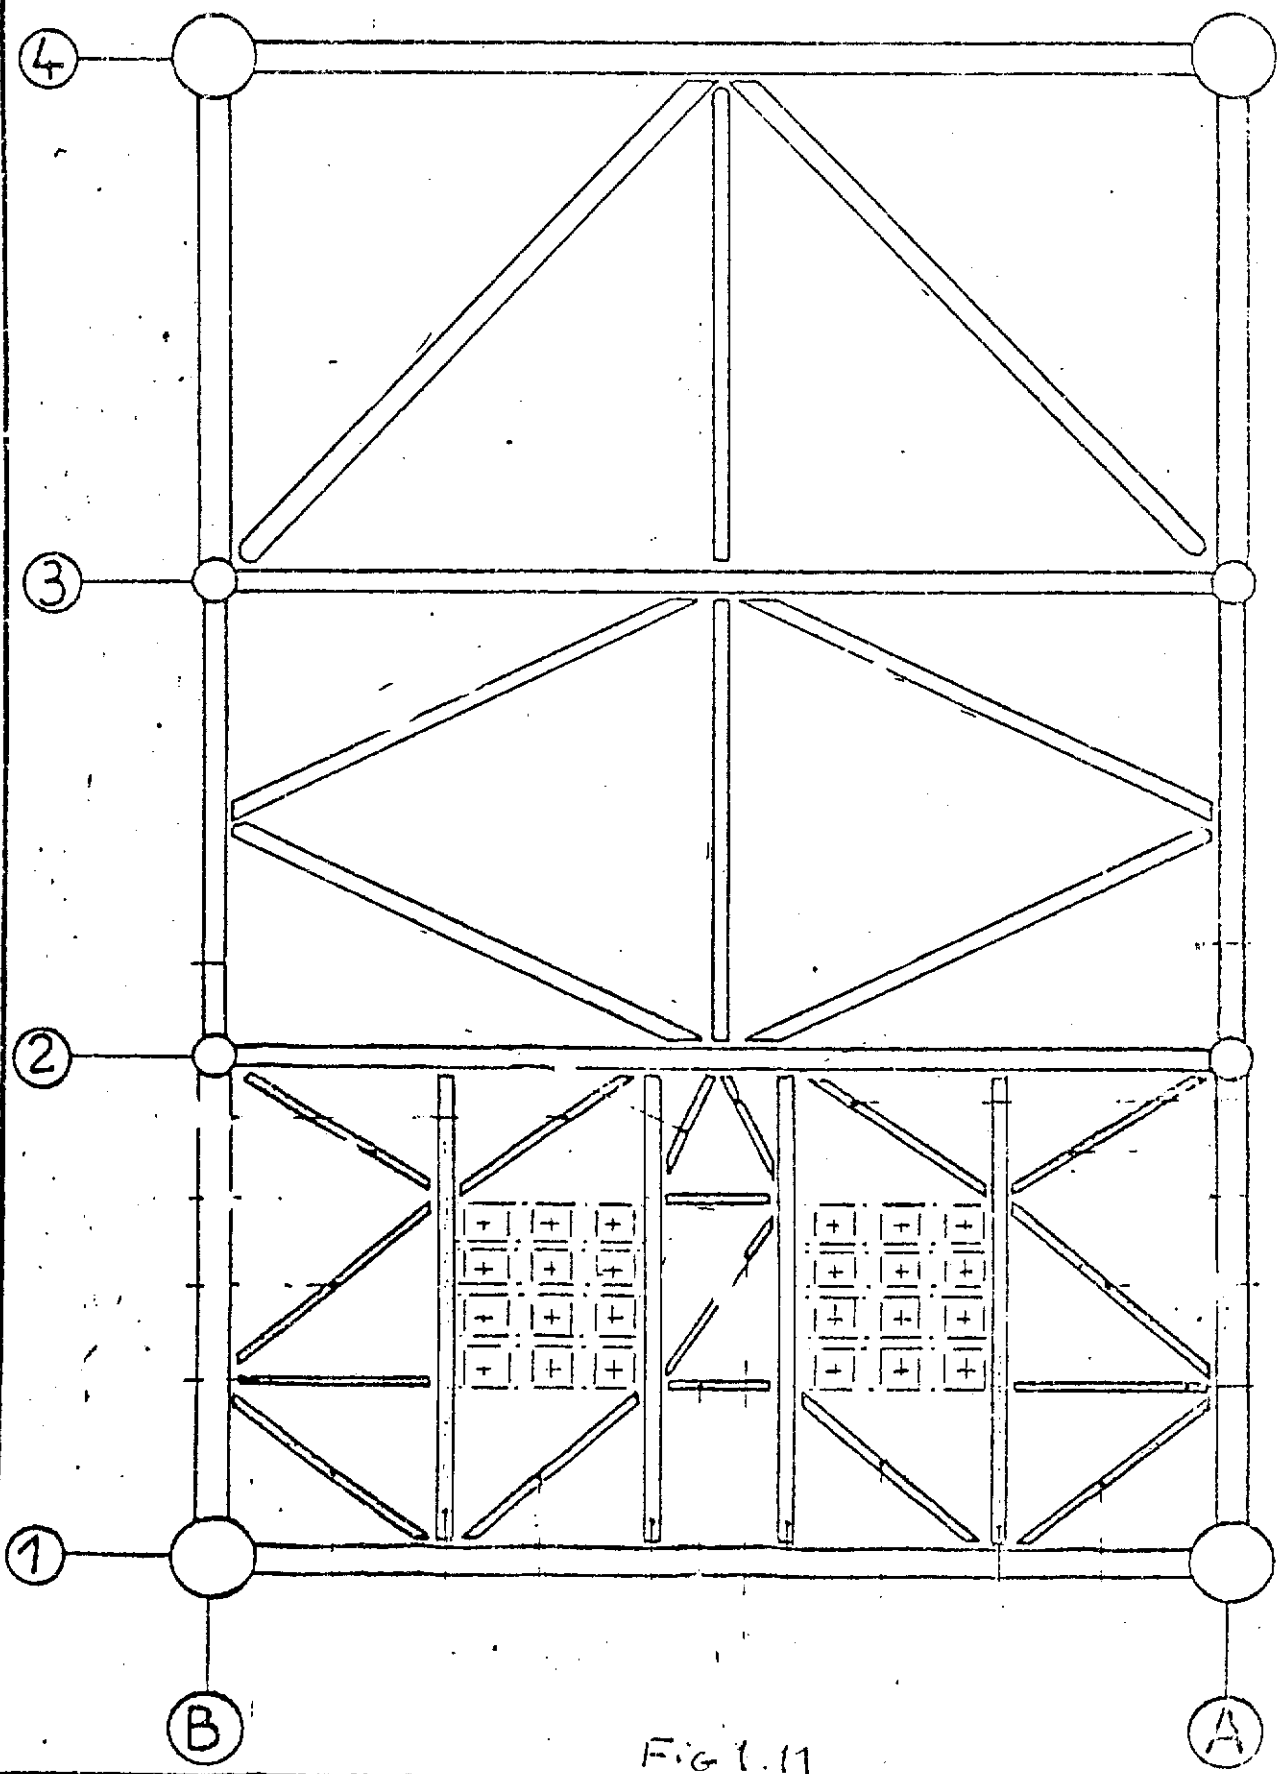
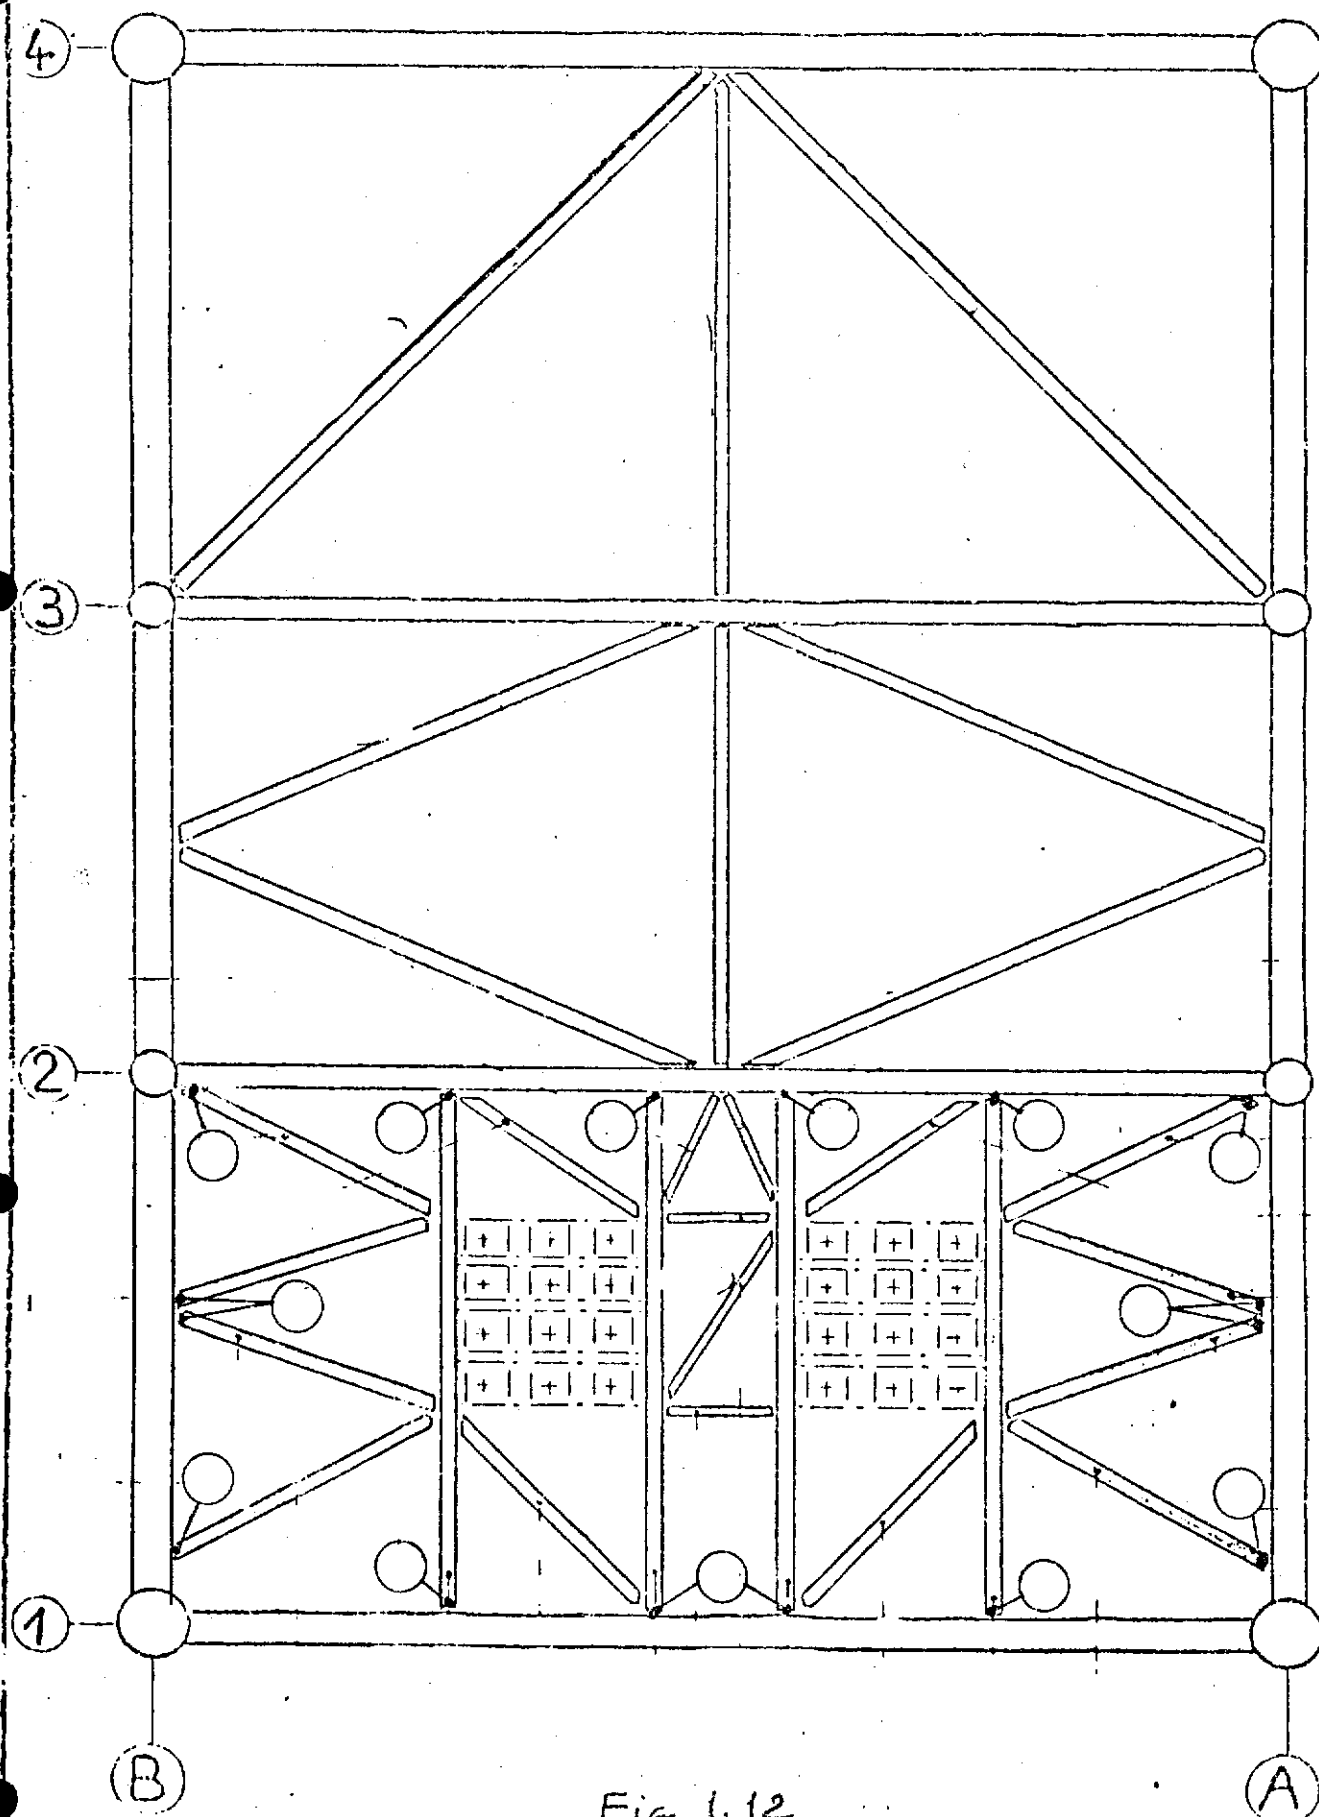
Usage factor is defined as the ratio: actual punching shear / allowable punching shear.

It should be noted that bracing member ends are marked with circle(s). The marking thus refers to the joint formed by this brace and the can to which it is welded. In the event of an overlapping joint it also refers to the weld between the brace and the member being overlapped.
