FRIGG FIELD - DRILLING PLATFORM NO. 2
STRUCTURAL PARTS
DESIGN, FABRICATION AND INSTALLATION
(DFI) RESUMÉ

NORWEGIAN PETROLEUM DIRECTORATE

DET NORSKE
VERITAS

Date November 1, 1977	
Department 57	Project No. 601636
Approved by <i>S. H. Olsen</i>	
Client/Sponsor ref.	
Reporters sign. <i>Oddvar Alfstad</i>

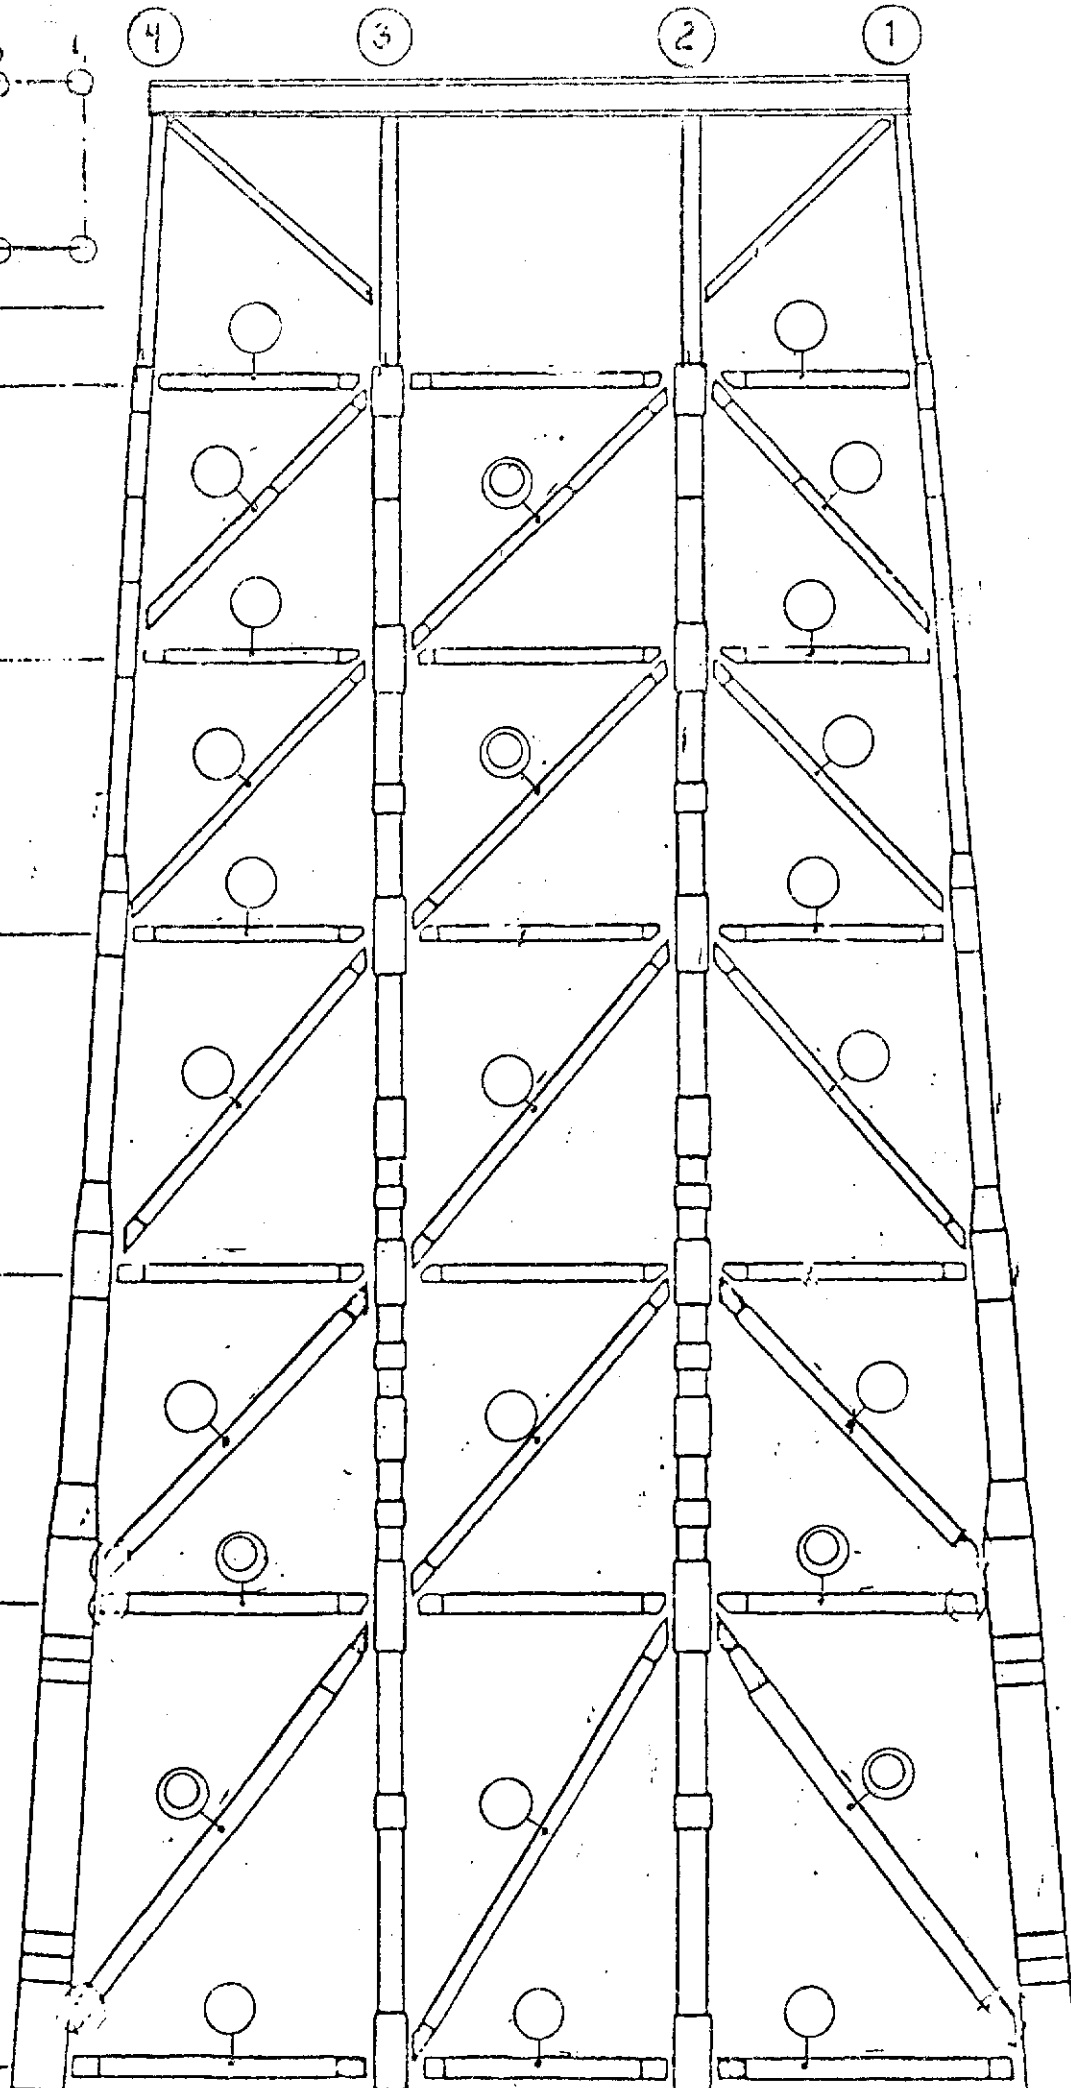
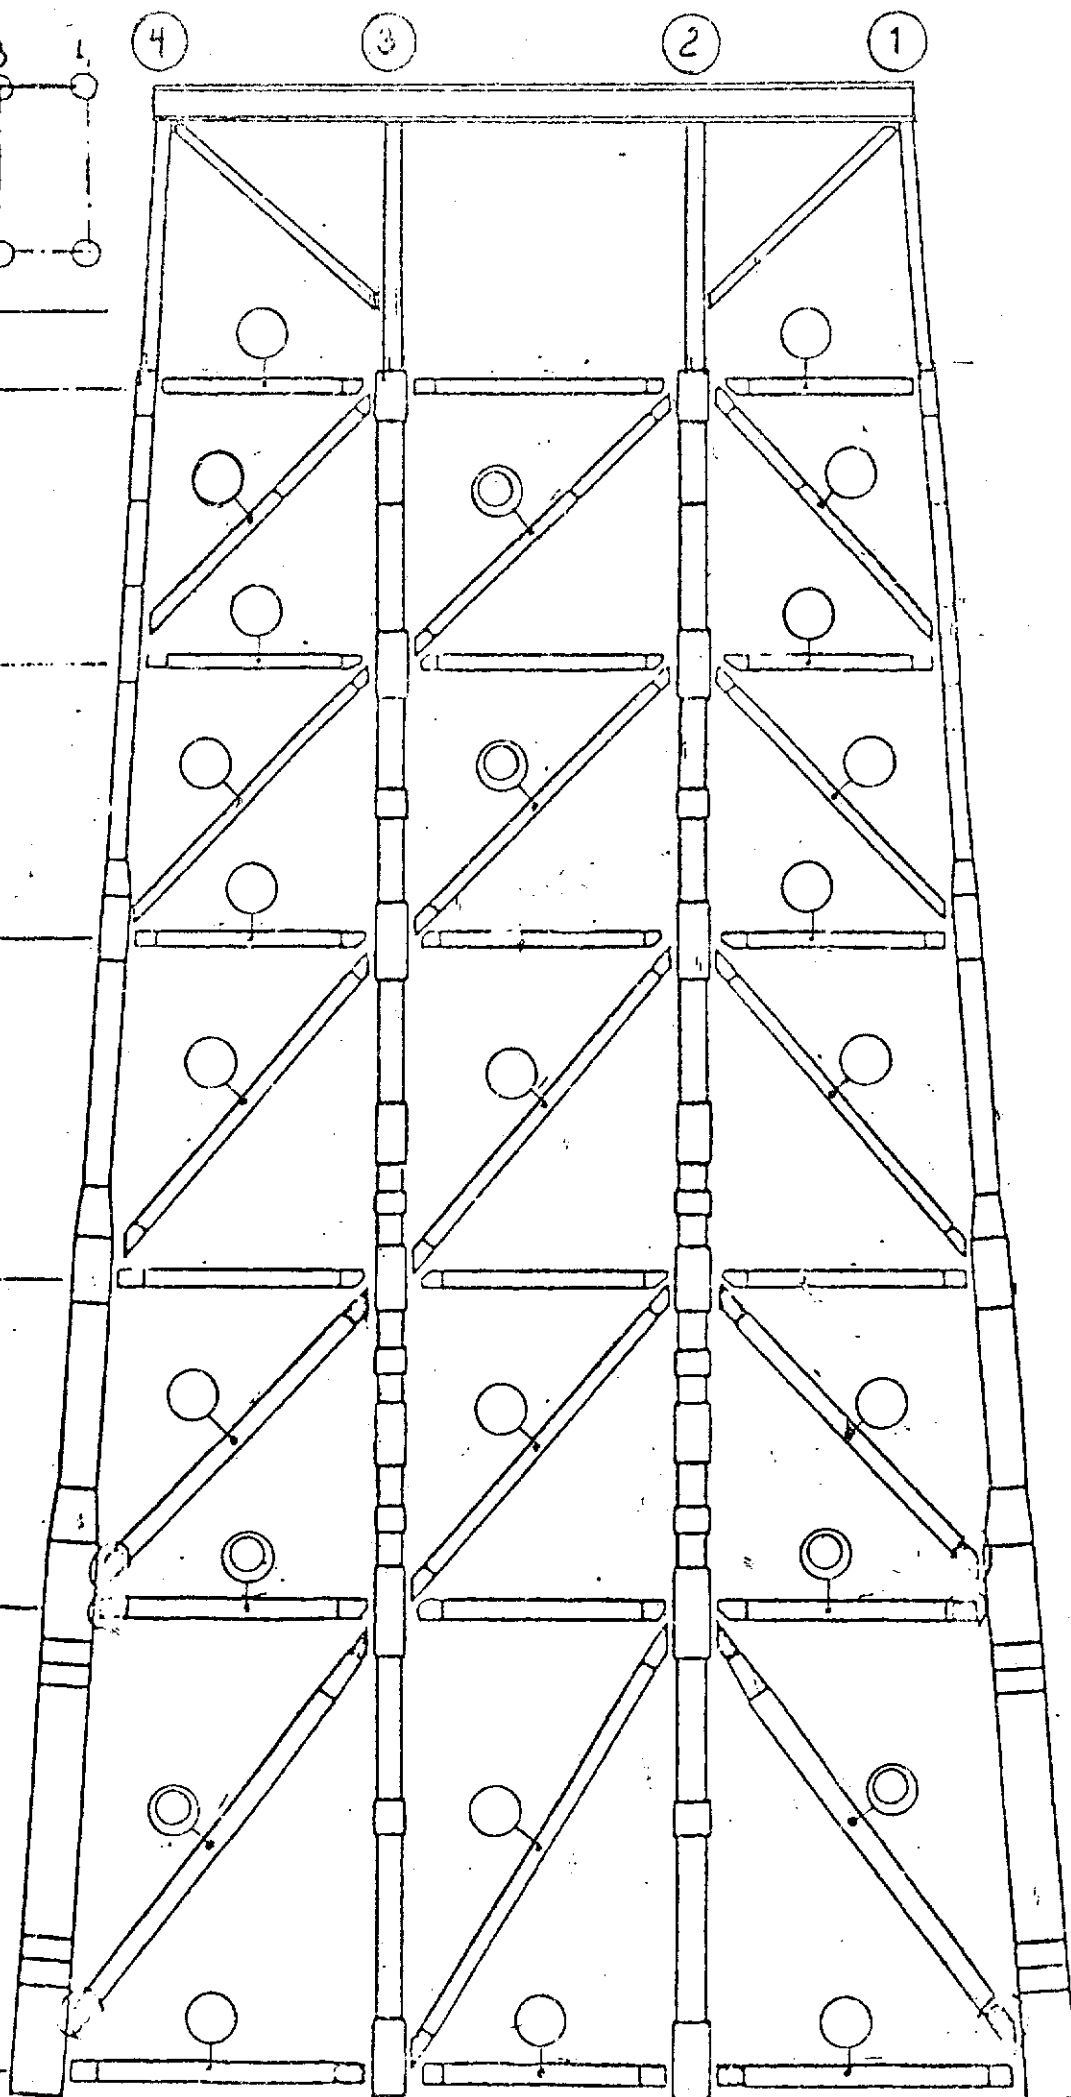
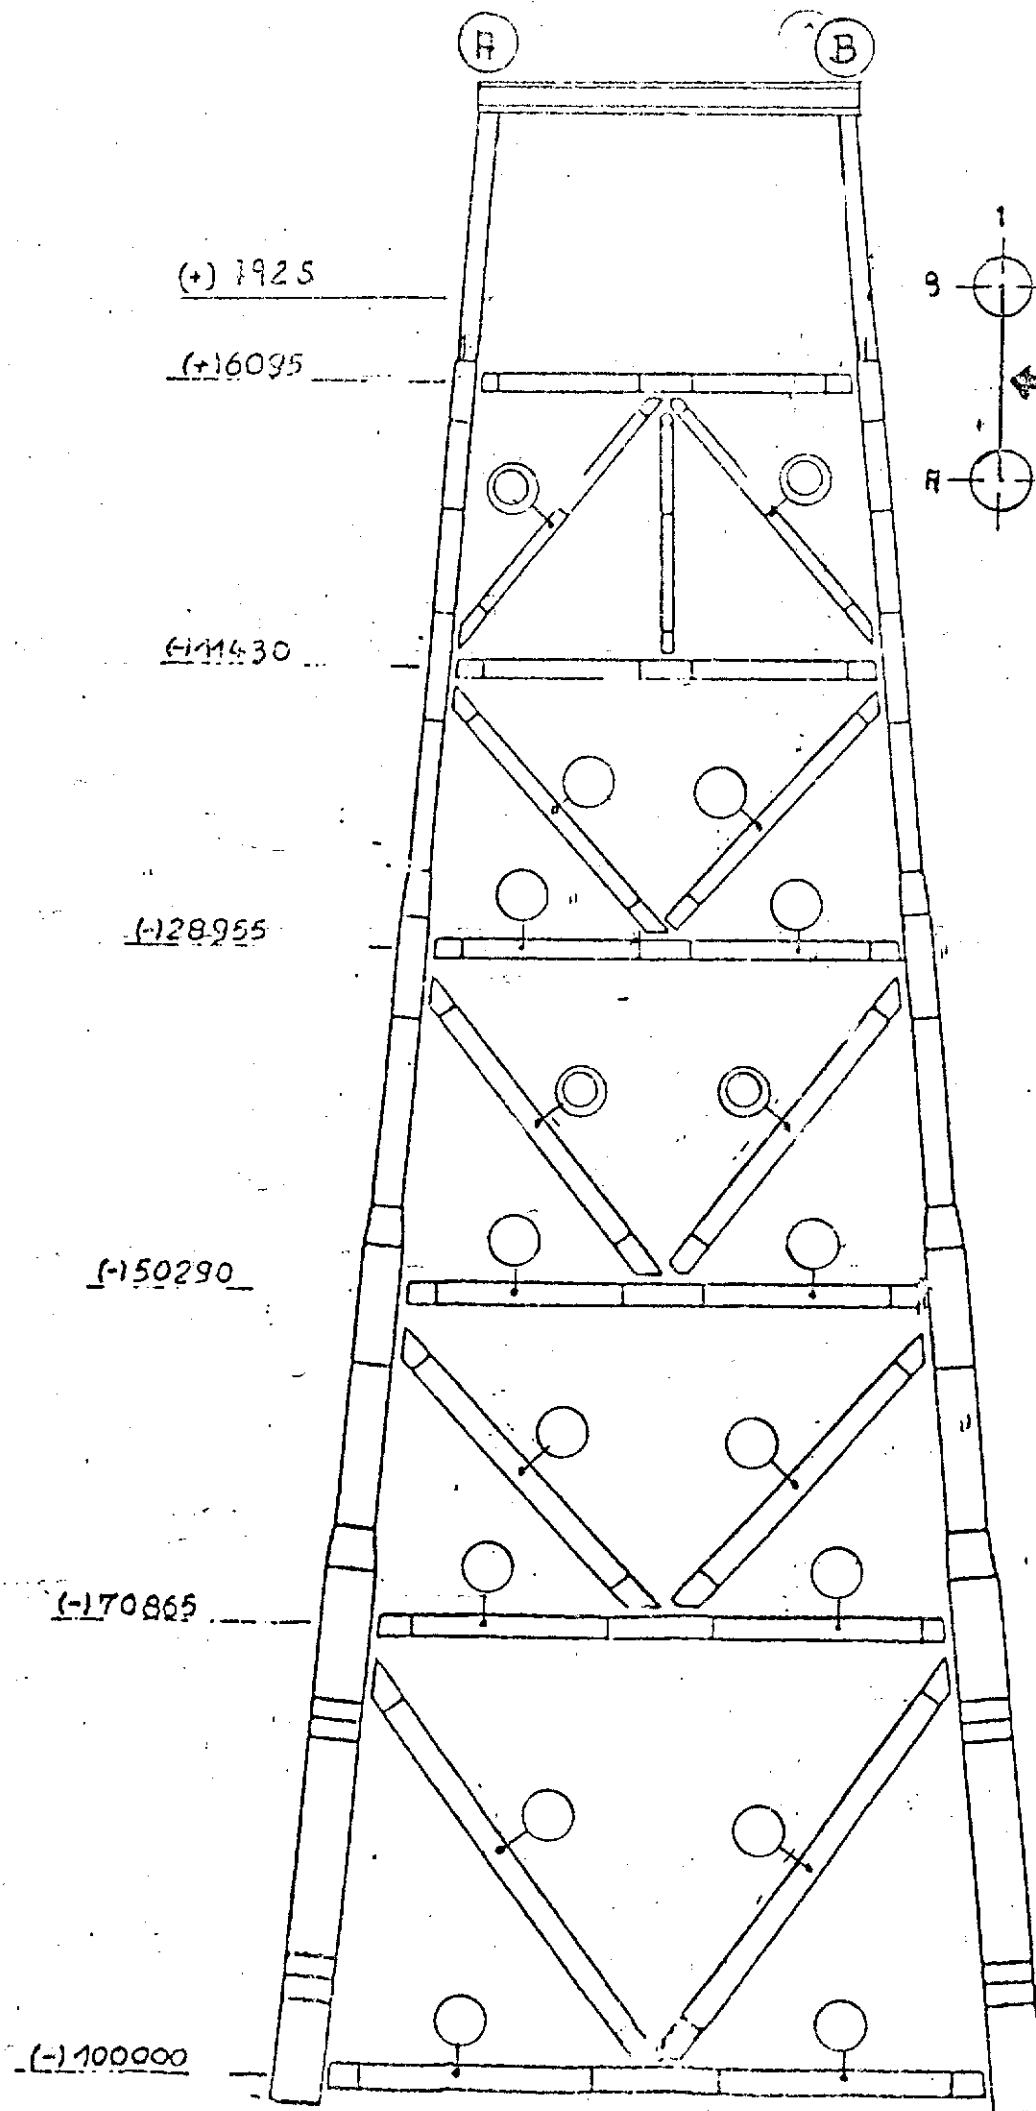
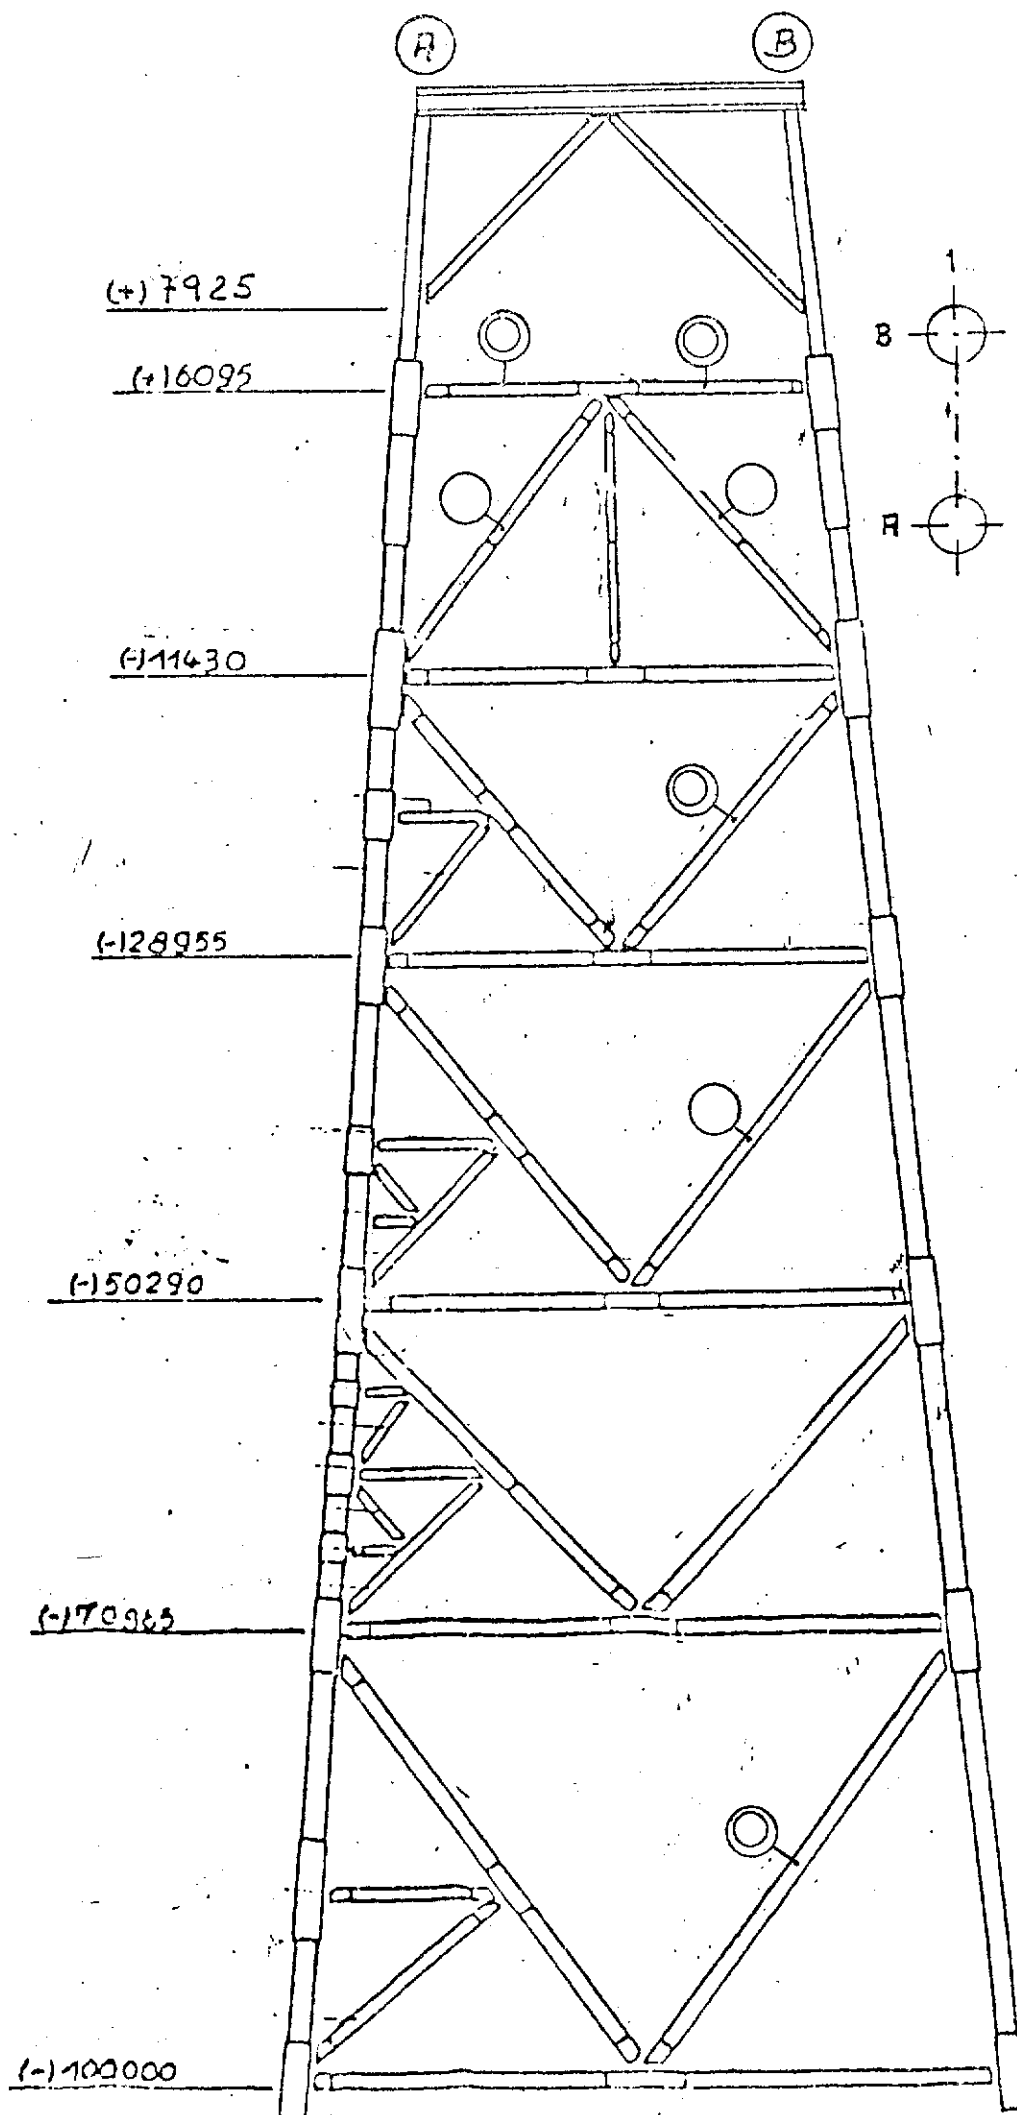
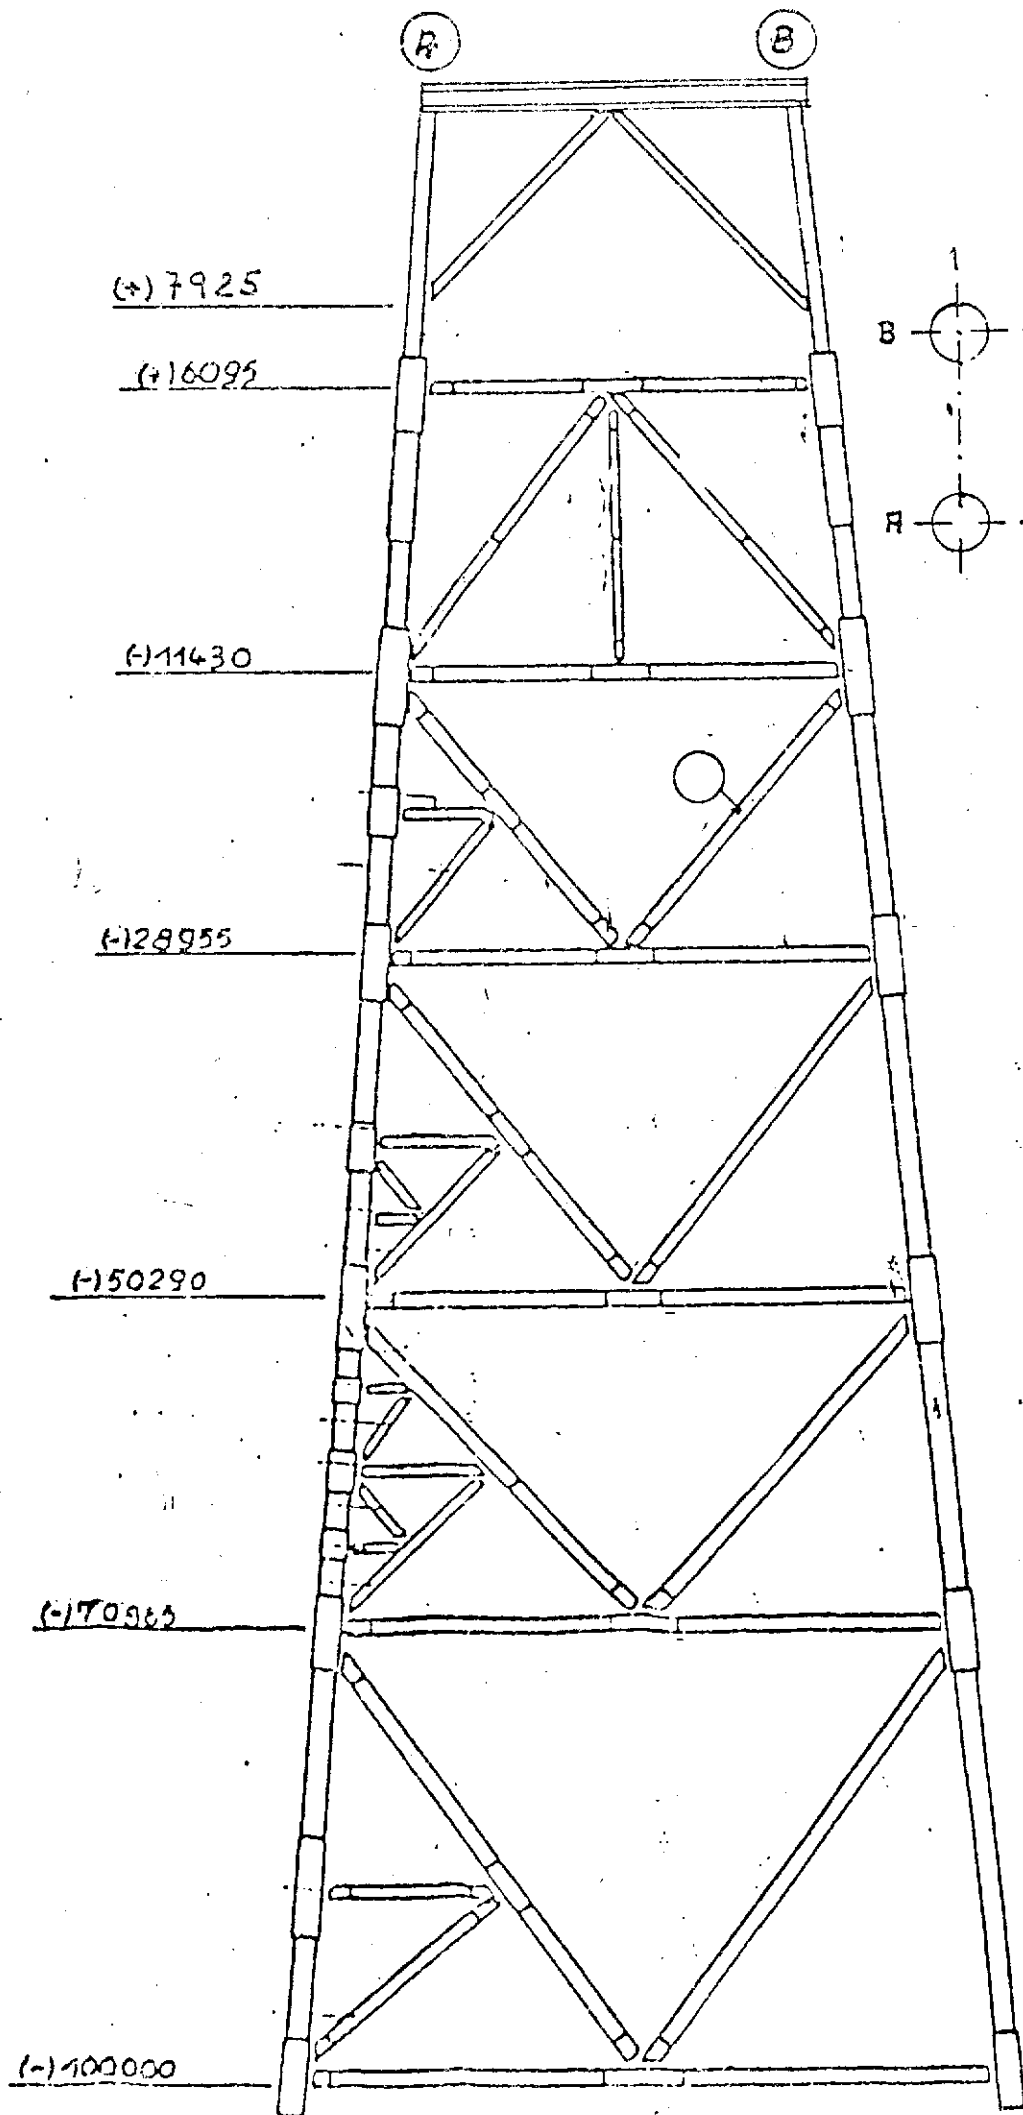
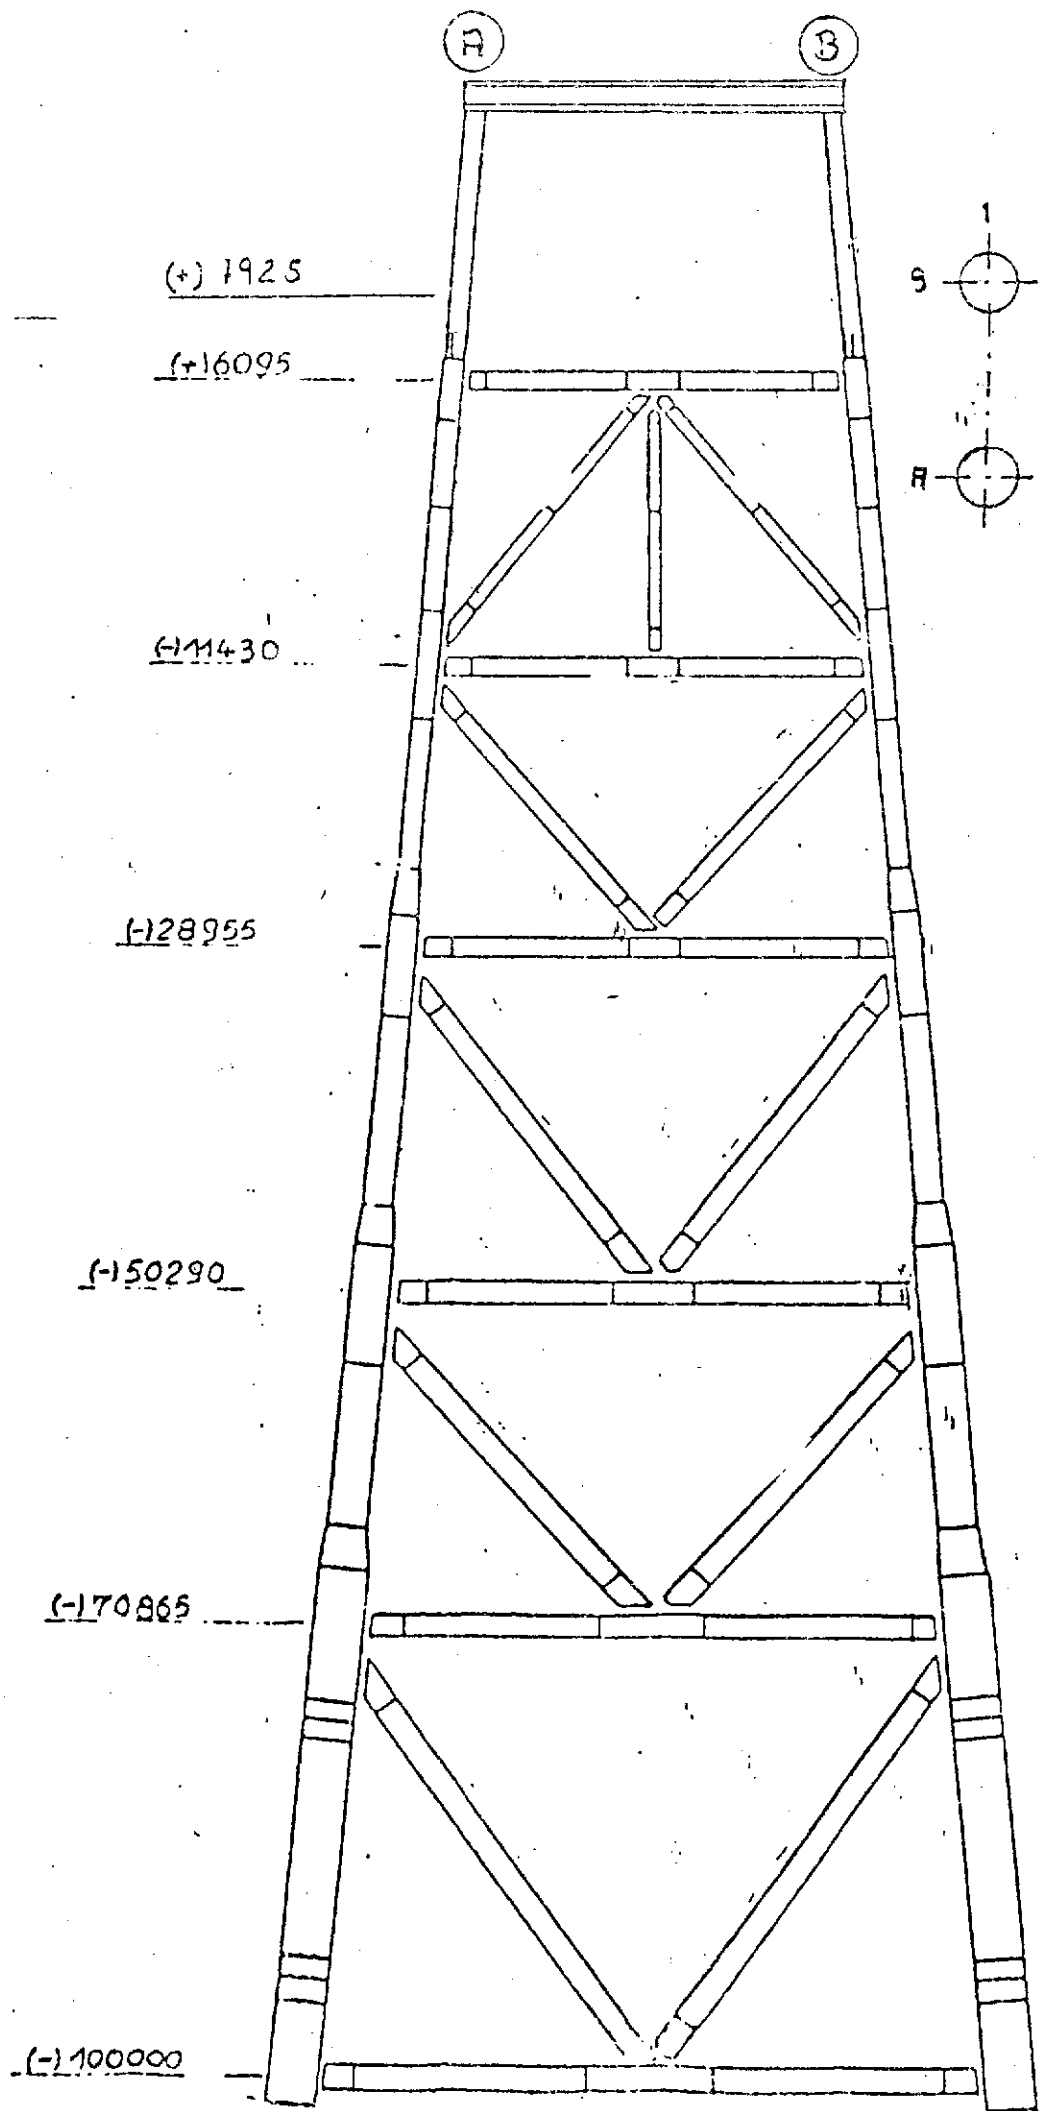
Members marked with a double circle (\bigcirc) have a buckling ratio equal to or greater than 0.9 in the extreme environmental condition.

Members marked with a single circle (\bigcirc) have a buckling ratio between 0.7 and 0.9 in the extreme environmental condition.

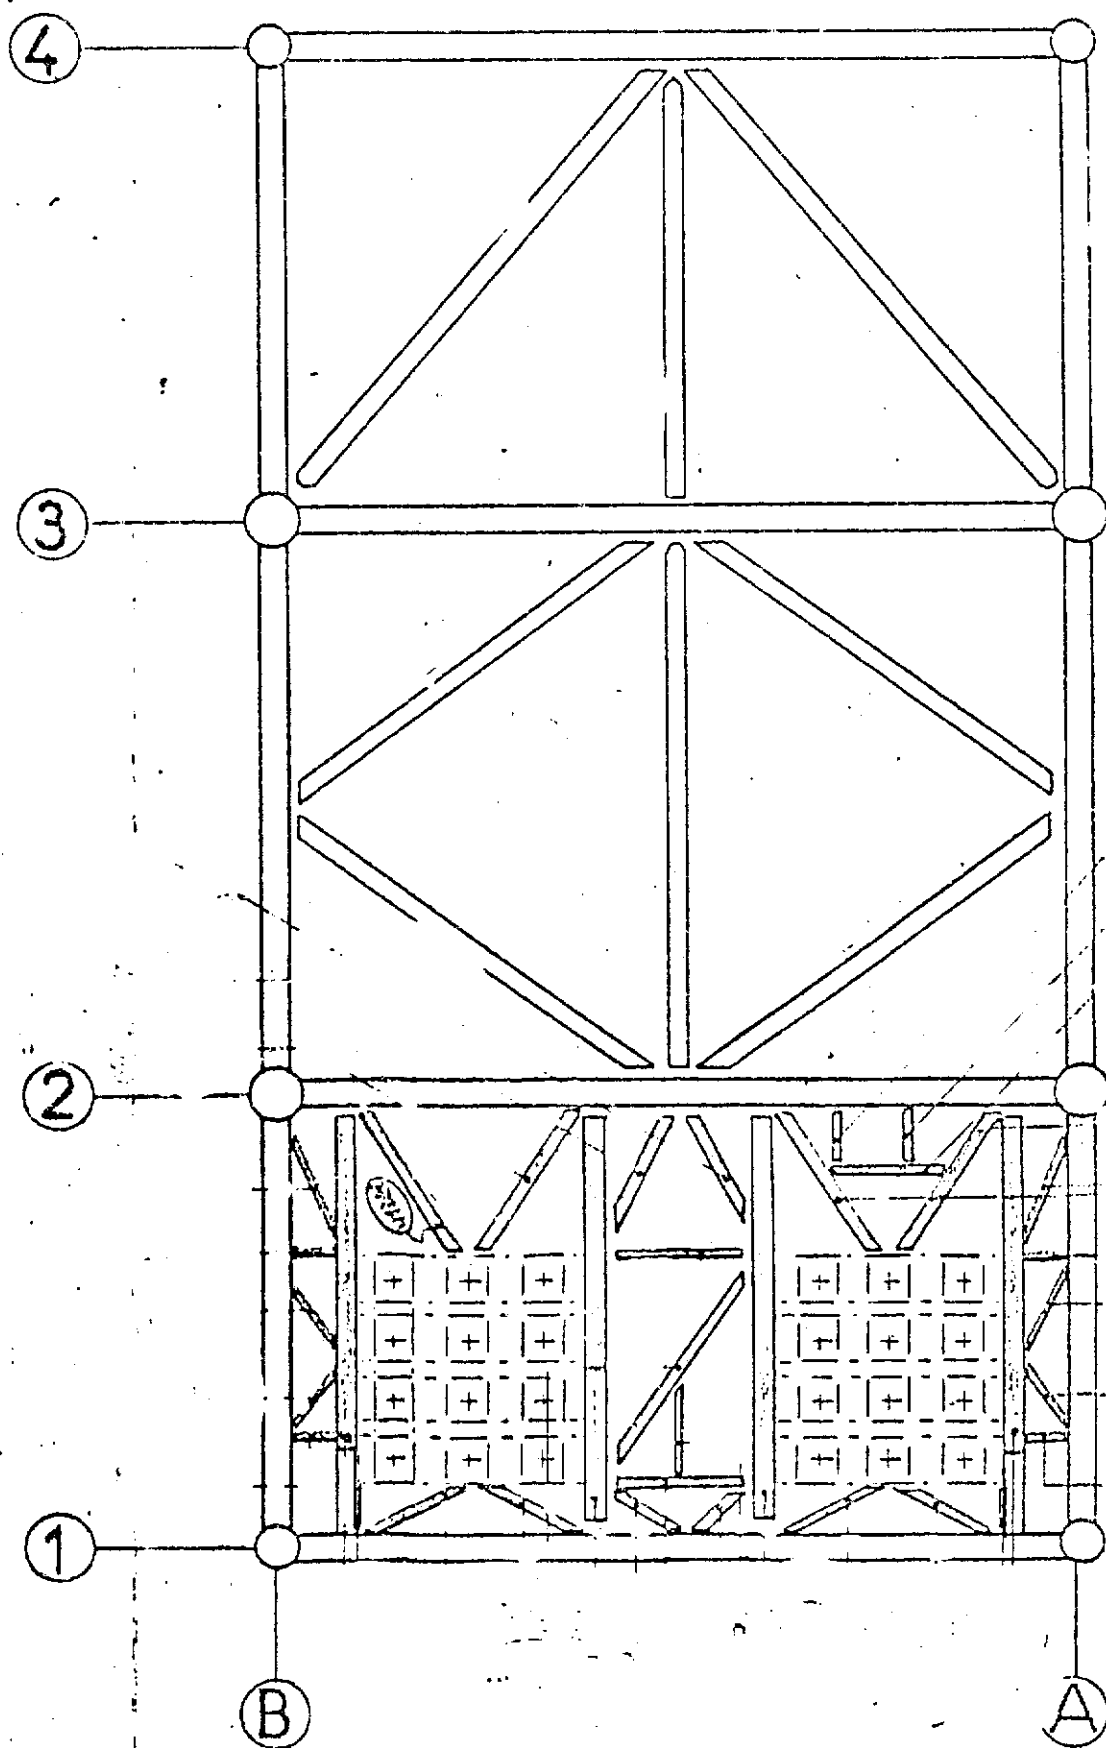
Fig. 3.7

It should be noted that the members located on elevation (+)6.095m may be subjected to wave slamming loads possibly leading to fatigue failure. These members should therefore be subject to future inspection and the most critical joints have been marked with a double circle (◎), even if the calculated usage factor in all cases does not exceed 0.4.

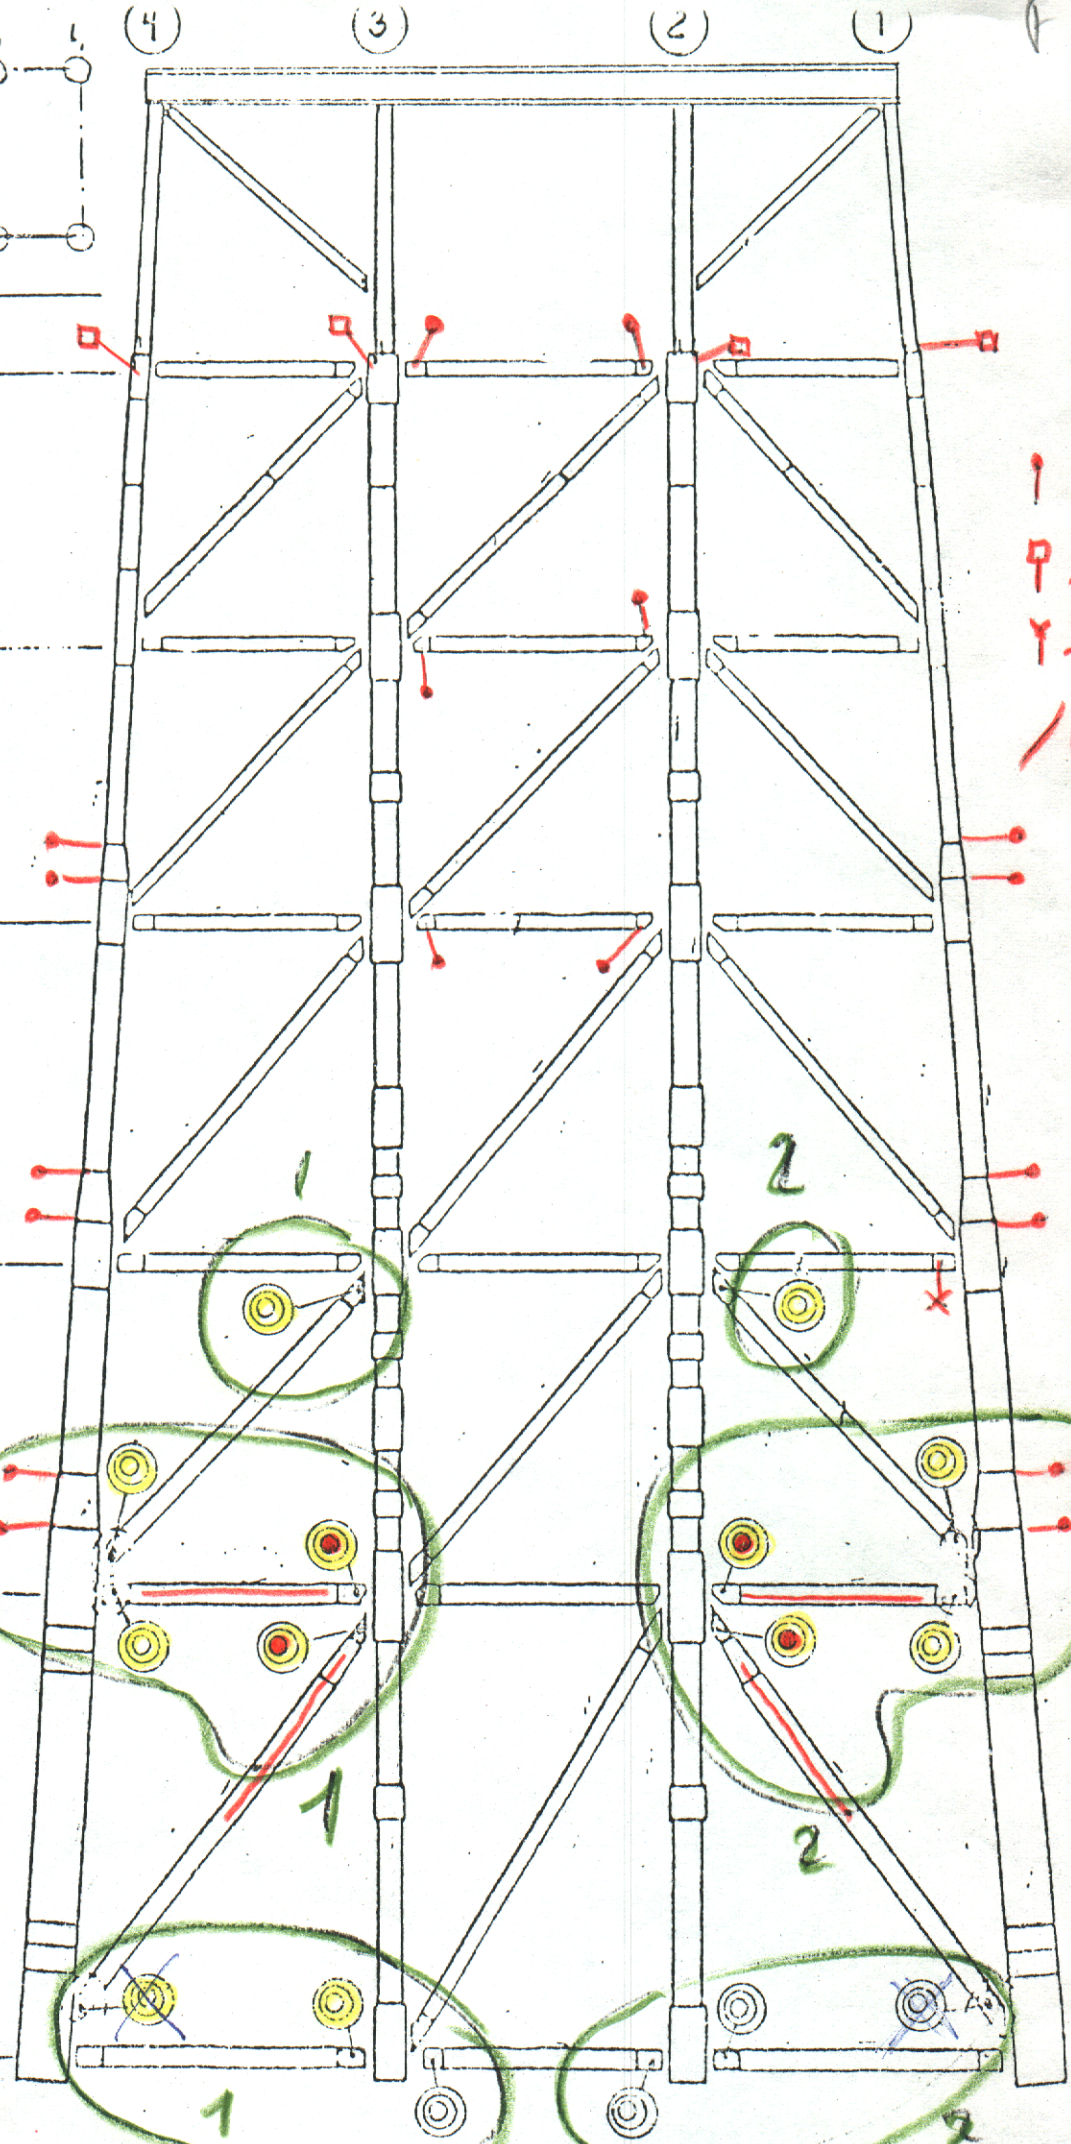
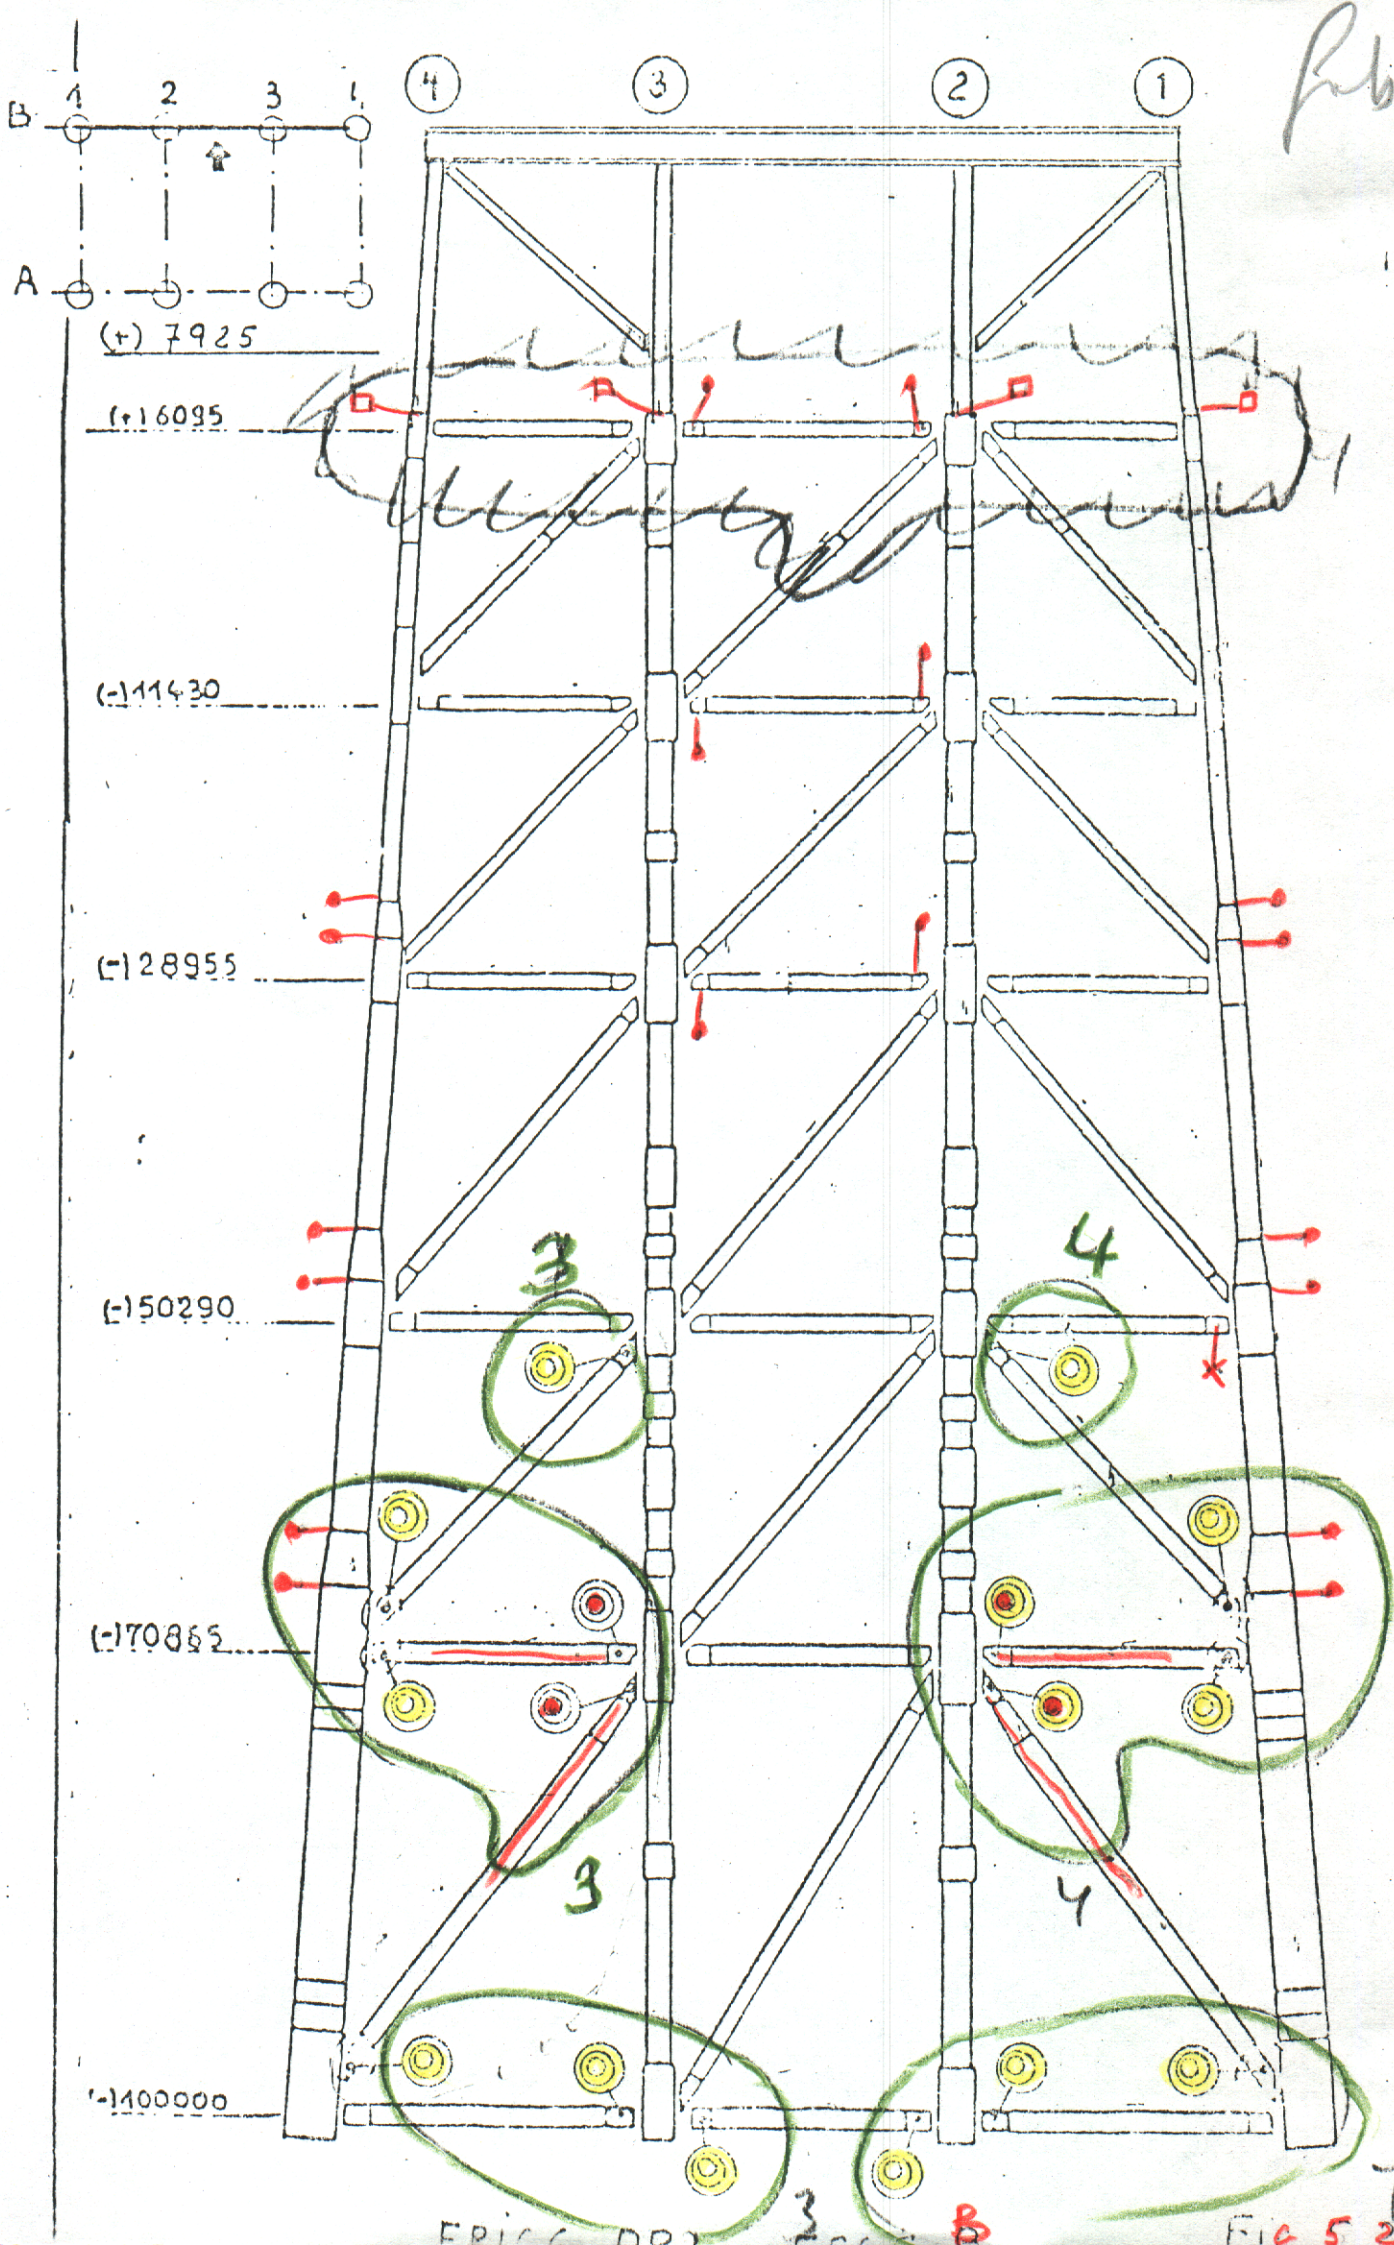
! stress
○ fabrication
- fatigue
/ buckling
