VERITAS Report No. 78/039	Subject Group
Title of Report FRIGG FIELD - QUARTERS PLATFORM DESIGN, FABRICATION AND INSTALLATION RESUME (STRUCTURAL PARTS)	
Client/Sponsor of project ELF AQUITAINE NORGE A/S	
Work carried out by Odd Torset et.al.

QUARTERS PLATFORM
FRIGG FIELD
DFI RESUME

**DESIGN-FABRICATION-INSTALLATION**

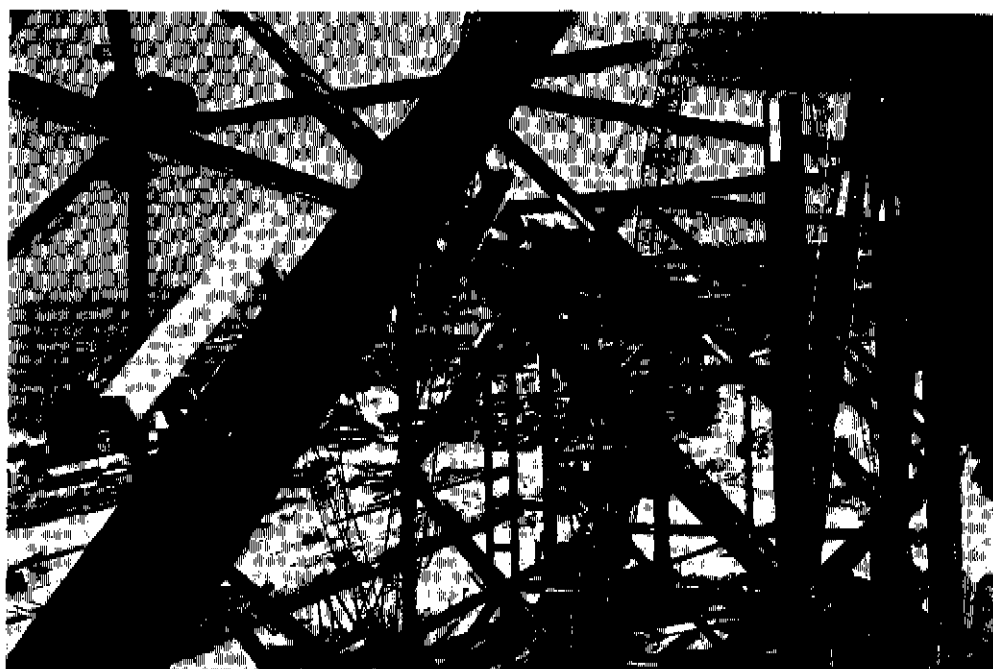
PHOTO 1

Typical anode configuration on QP Jacket

An initial potential survey to check the performance of the cathodic protection system and an initial visual examination of the coating condition in the splash zone is strongly recommended.

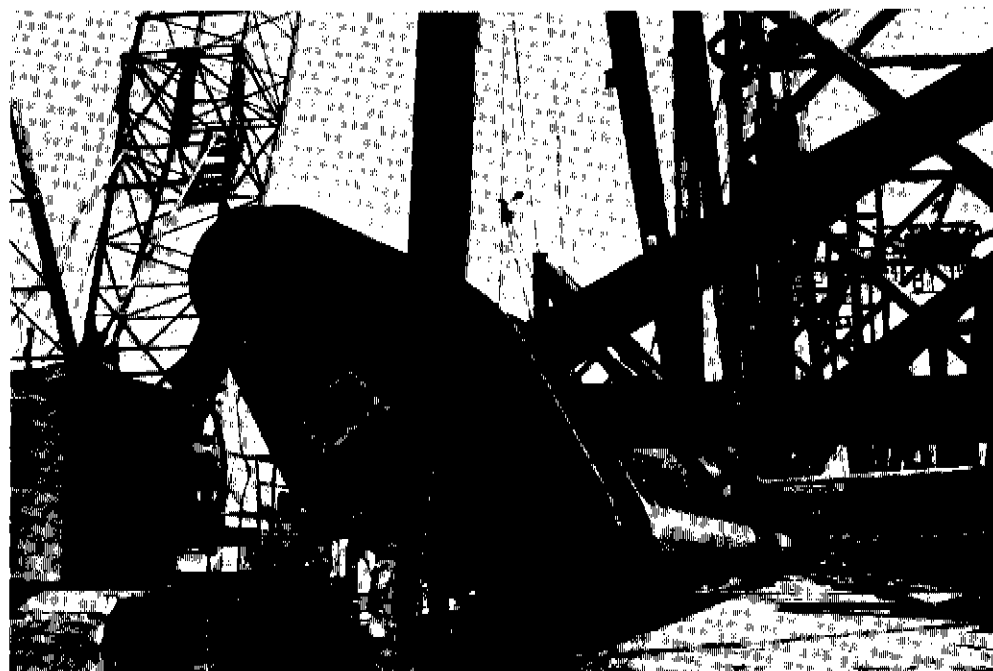
PHOTO 9

Bottle A 1 - Underside of bottle A 1.

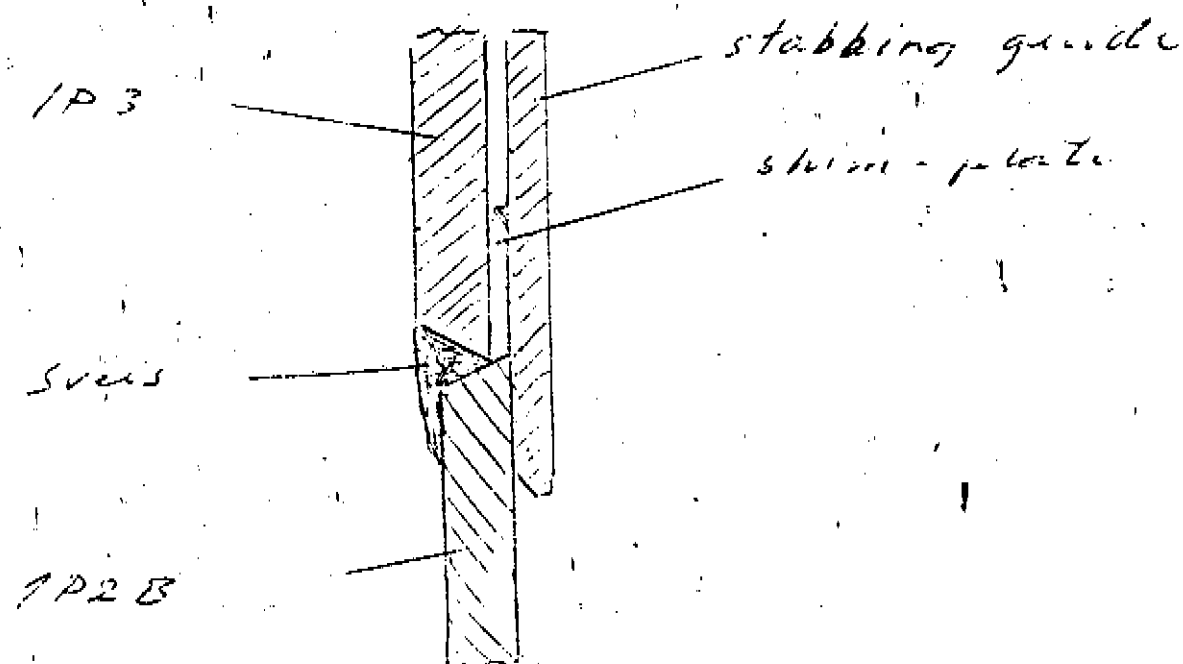
Snitt av sveise-forbindelsen
mellom IP2B og IP3.

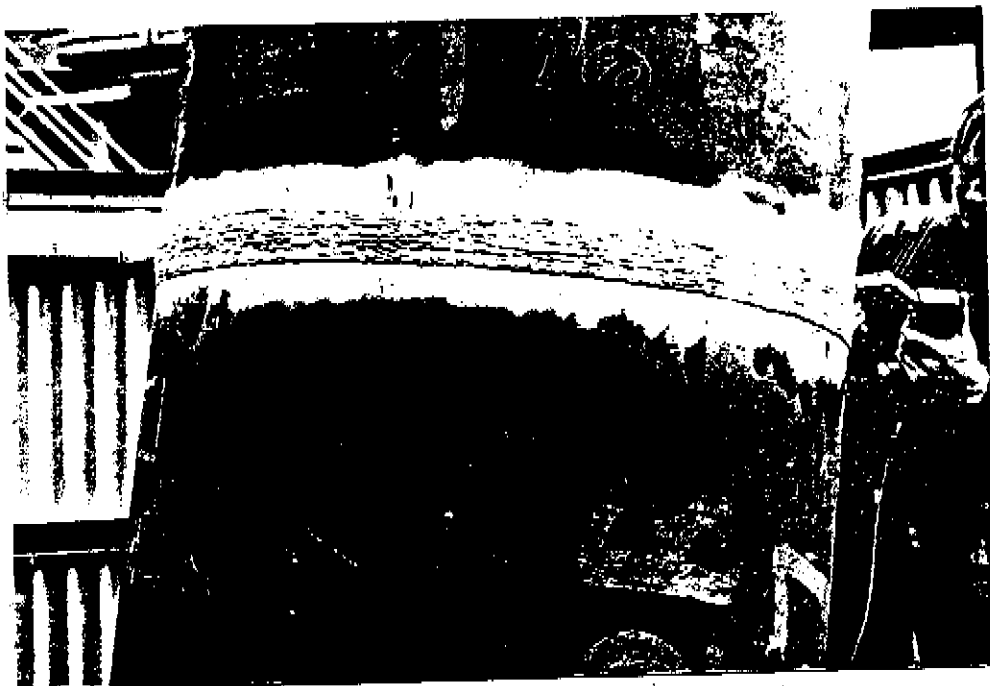
Sveise forbindelsen mellem
 1P2B og 1P3, pile B1-2.
 QP-plattform.

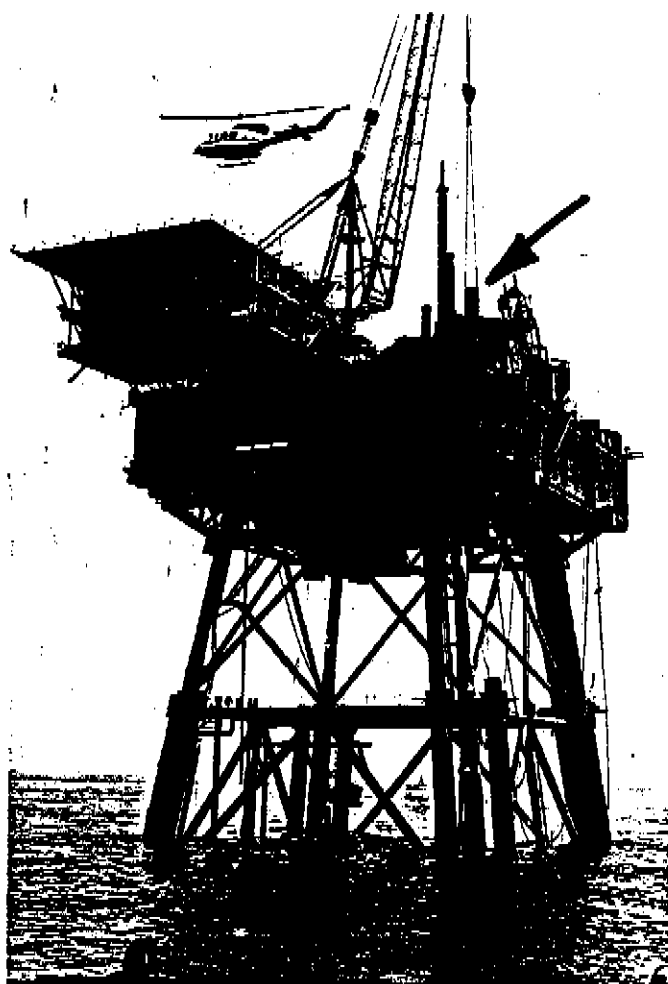
Fjerning
 av follower
 til main-
 pile B1-2,
 QP-plattform
