# Frigg Field Concrete Substructures

An Assessment of Proposals  
for the Disposal of the Concrete Substructures  
of Disused Frigg Field Installations  
TCP2, CDP1 and TP1

6 August 2002

**TOTAL FINA ELF**  
TotalFinaElf Exploration Norge AS

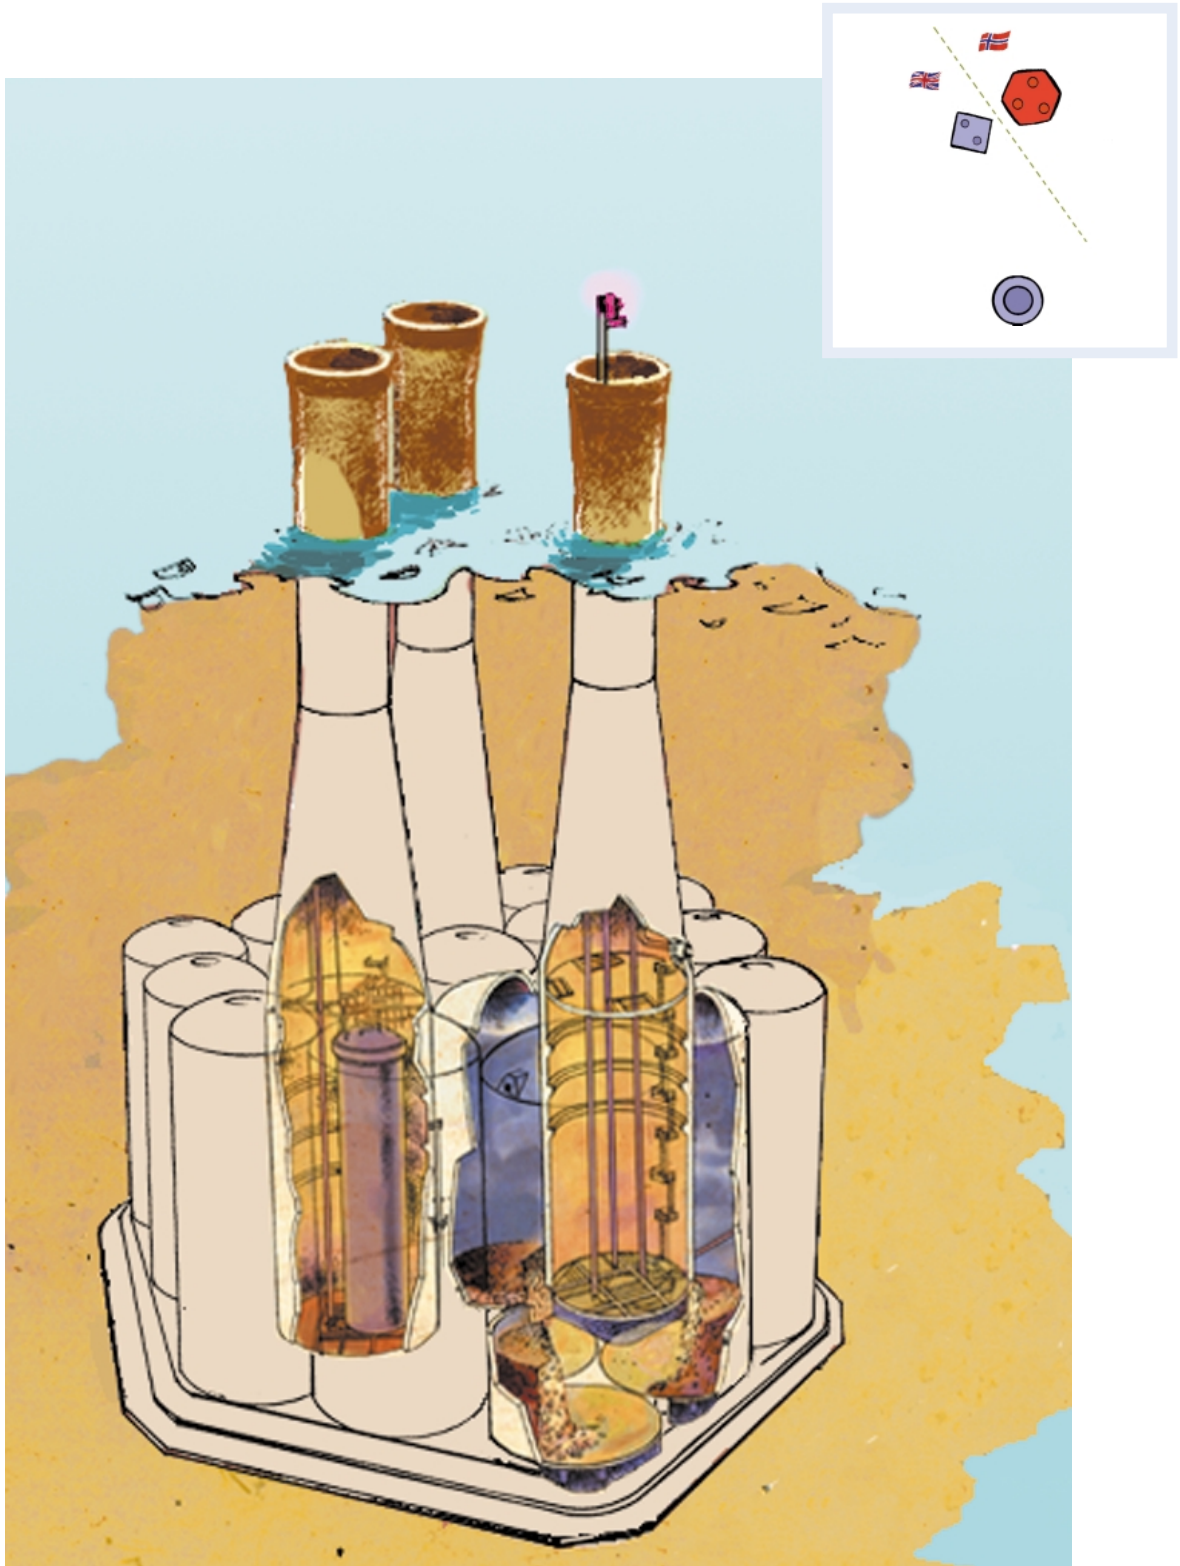
Figure 4.1 Concrete Substructure of Treatment and Compression Platform 2 (TCP2)

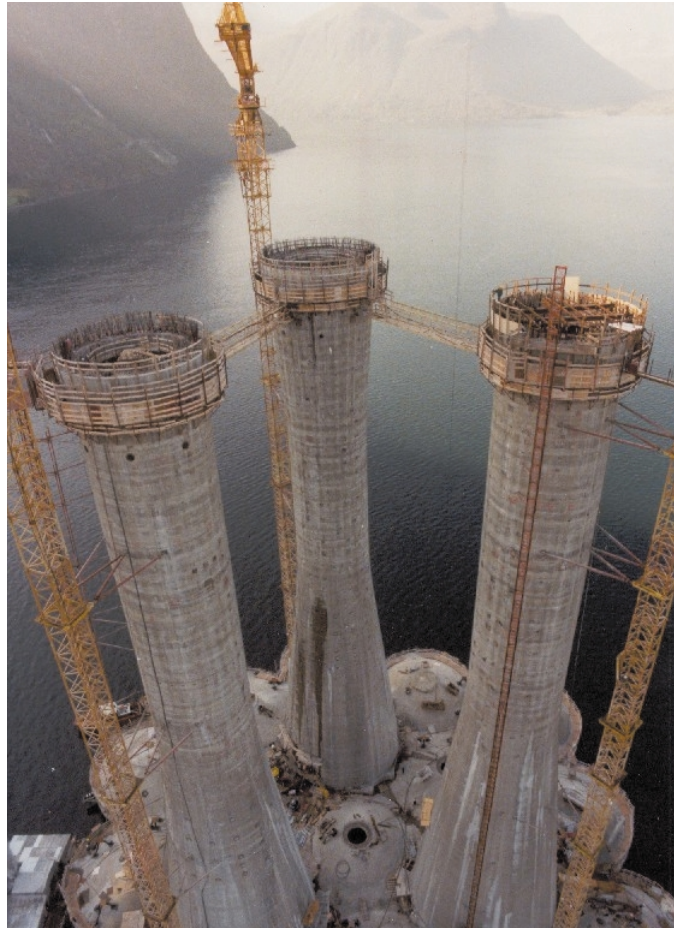
Figure 5.5 TCP2 During Construction

A further aspect that requires consideration when assessing the condition and strength of the tri-cell walls is that during the life of the structure the columns have been pumped dry a number of times for inspection of the risers. In addition, the substructure has had to withstand periods of adverse weather and emergency ballasting when severe weather was predicted during times when the columns were dry. It is believed that over-stressing of the reinforcing bars at particular locations in the vicinity of the tri-cells has occurred at these times and that the concrete in these areas is **likely to already be cracked**. These cracks

do not impair the strength of the structure as it stands, but could have an important effect during refloat operations. It is not considered possible to accurately inspect the inside of the tri-cell for cracks.

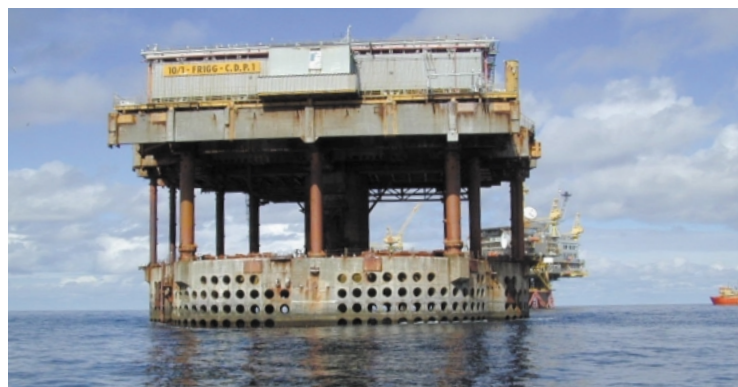
Figure 5.6 Present Condition of CDP1

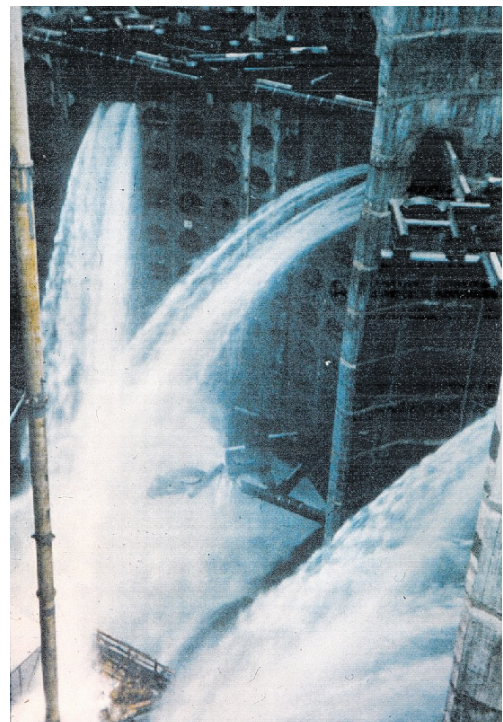
Figure 5.8 Leaks through the External Wall during the Installation of CDP1

In addition to the holes for the wells, there are a number of other penetrations in the base slab principally for the instrumentation pipes used to monitor the bearing pressure under the platform. The condition of the pipework penetrating the base slab is unknown, as the system has not been used for many years. Two instrumentation pipes are reported to be broken and lost in the solid ballast. It is not possible at the moment to inspect these items as they are covered with solid ballast and lean mix concrete, the condition of which is unknown. It is unlikely that the lean mix concrete can be relied upon to prevent leakage from the instrumentation pipework. It would be necessary to **find and plug all the penetrations** in the base slab, including the conductor sleeves and instrument connections, before refloat operations could be started.

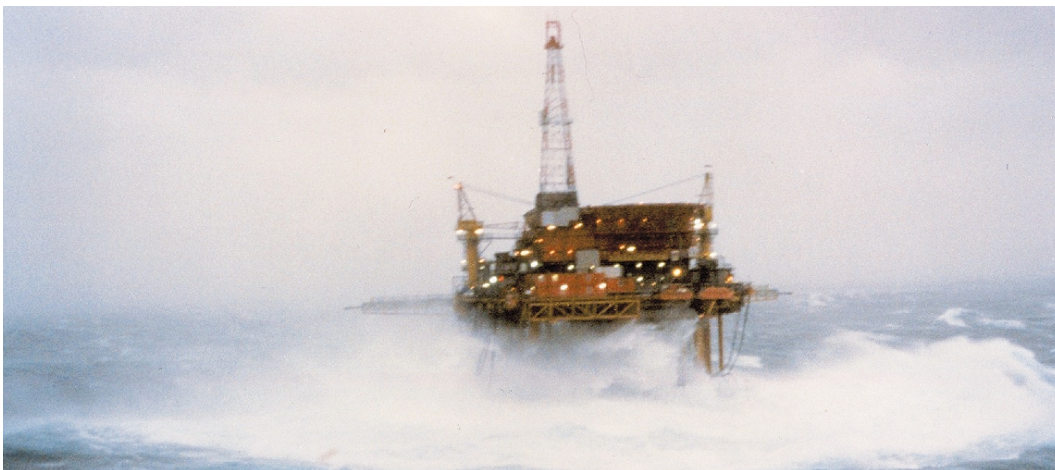
Figure 5.10 CDP1 During a Winter Storm

If, due to leakage or other operational problems, it were not possible to refloat the platform in the same summer season that the cofferdam was installed and the ballast removed, then there is a high probability that the substructure would be severely damaged by winter storms.

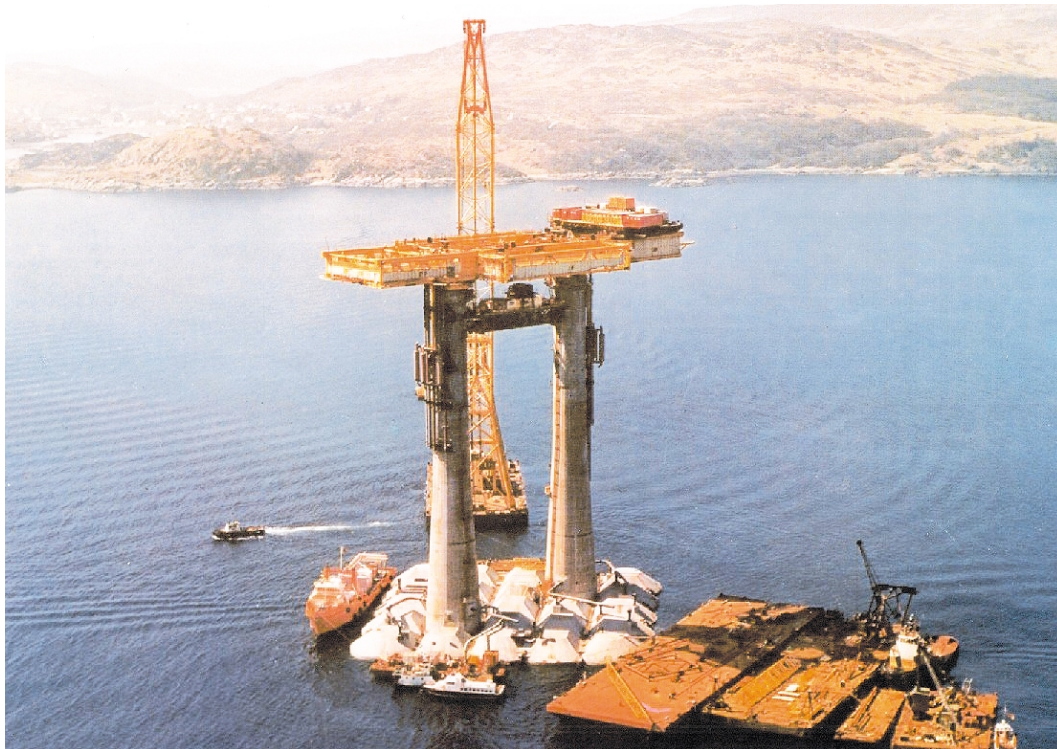
Figure 5.11 Construction of TP1 after Installation of the Deck Structure

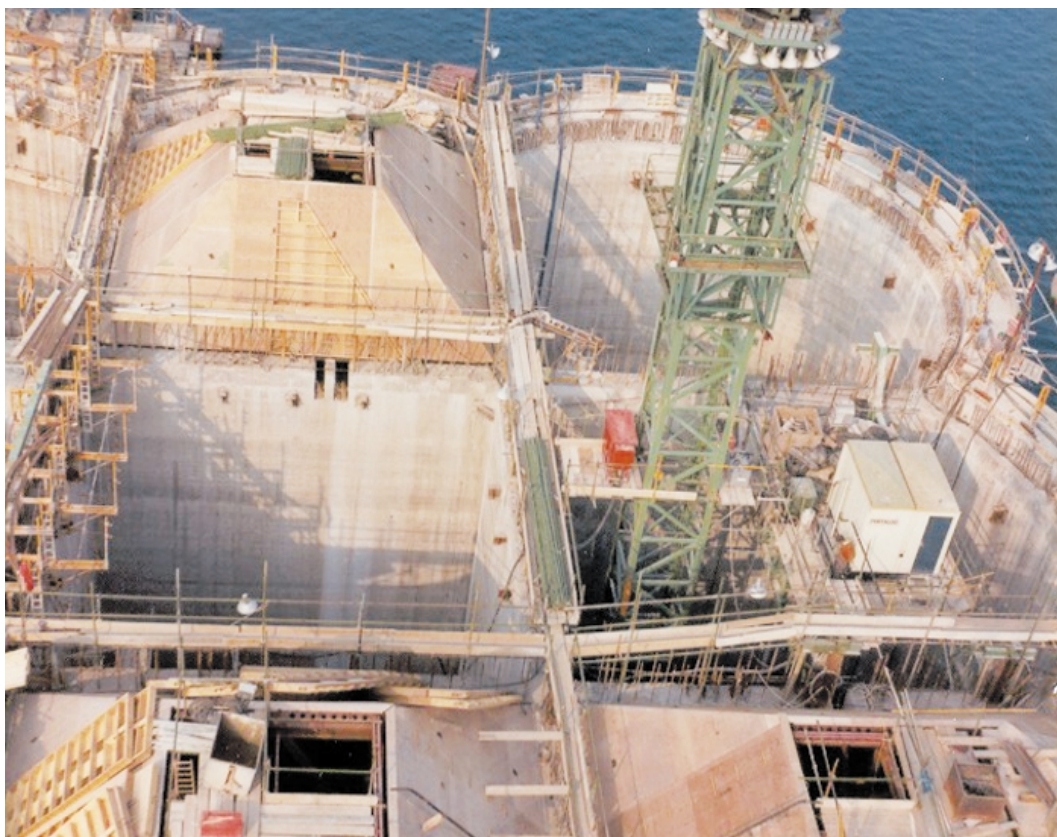
Figure 5.14 Construction of the TP1 Substructure showing the Internal Walls and Cells

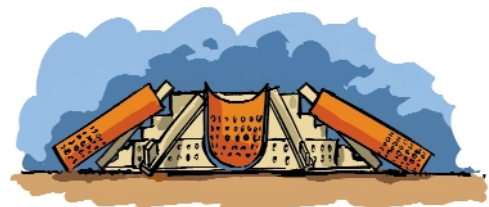
For TCP2 and TP1 this disposal method would entail cutting the columns just above the top of the cells, lifting the sections of column away and placing them on the seabed adjacent to the base. For CDP1 the procedure would be much more complex involving cutting and toppling both the external walls and the radial walls to give the requisite shipping draft.

Several methods of cutting the concrete columns were evaluated, including various combinations of drilling, diamond wire sawing and explosives. The cutting methods were considered feasible in principle but considerable development work would be required to achieve commercial applicability. It is also likely that a large amount of diving work would be necessary to support the cutting operations, much of which would be in particularly hazardous conditions.

The possible methods for cutting down the substructures have been carefully studied and specialist companies retained to assess the practicalities of such operations. The technical risks associated with cutting down the substructures are generally similar to those occurring if the substructures were removed and deconstructed onshore. For TCP2 and CDP1 the risks to personnel involved in cutting down the substructures are higher than the removal and onshore disposal alternative but for TP1 the risks are somewhat lower. The UK and Norwegian fishing industries were particularly opposed to this disposal alternative. Although full assessments of technical, safety, environmental and cost aspects have been made, only limited information about the cutting down disposal alternative is presented in this document. Full details of the studies and assessments made for the cutting down disposal alternative may however be found in the Frigg Field Cessation Plan.

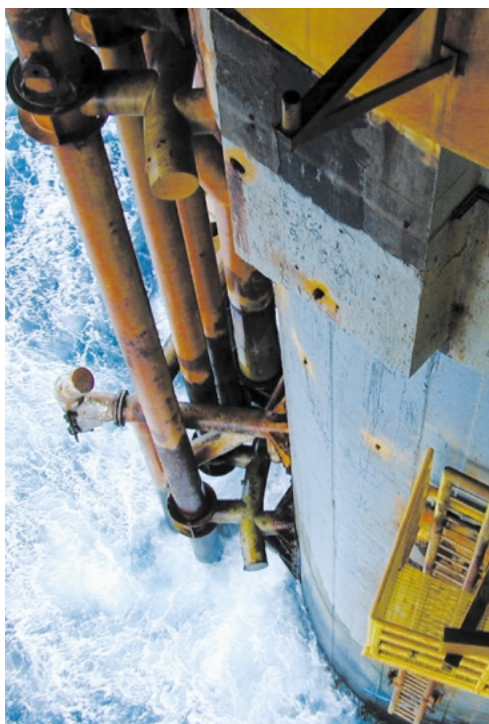
Figure 6.2 Risers and External Steelwork on the Outside of TP1 Column

There are a number of steel items such as risers, riser clamps, stairways, landings etc attached to the outside of the concrete substructures of TCP2 and TP1 (See Figure 6.2). If these steel items were left in place, over time they would corrode and fall on to the seabed around the substructure where they would become a hazard to fishing operations. It is therefore proposed to remove these steel items from the outside of the concrete substructures as part of the decommissioning process for the platforms. In addition the steel walkways and stairs below the deck level of CDP1 will also be removed (see Figure 6.3).

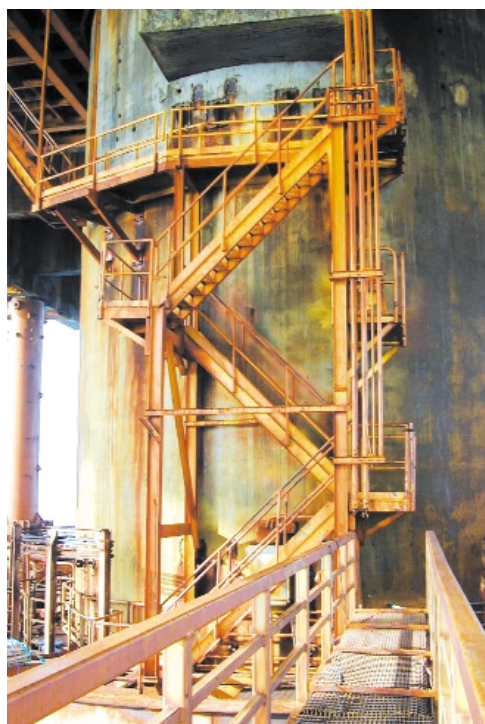
Figure 6.3 Stairways and Walkways Below Deck Level on CDP1
