Date 10. Aug. 1982	
VERITAS Report No. IOD 32/82/106	Subject Group
Department 032	
Project No. 322852	
Title of Report FRIGG FIELD FLARE PLATFORM REVISED DESIGN, FABRICATION AND INSTALLATION RESUME	
Approved by

This report is a revision of the original design, fabrication and installation resumé of the Frigg Field Flare Platform. The new revision includes all changes, repairs and modifications compared with the original structural design.

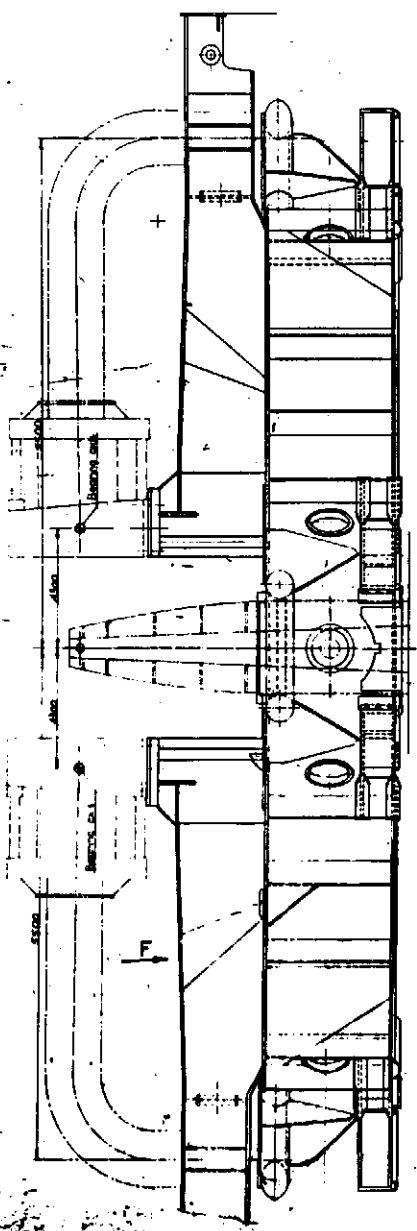
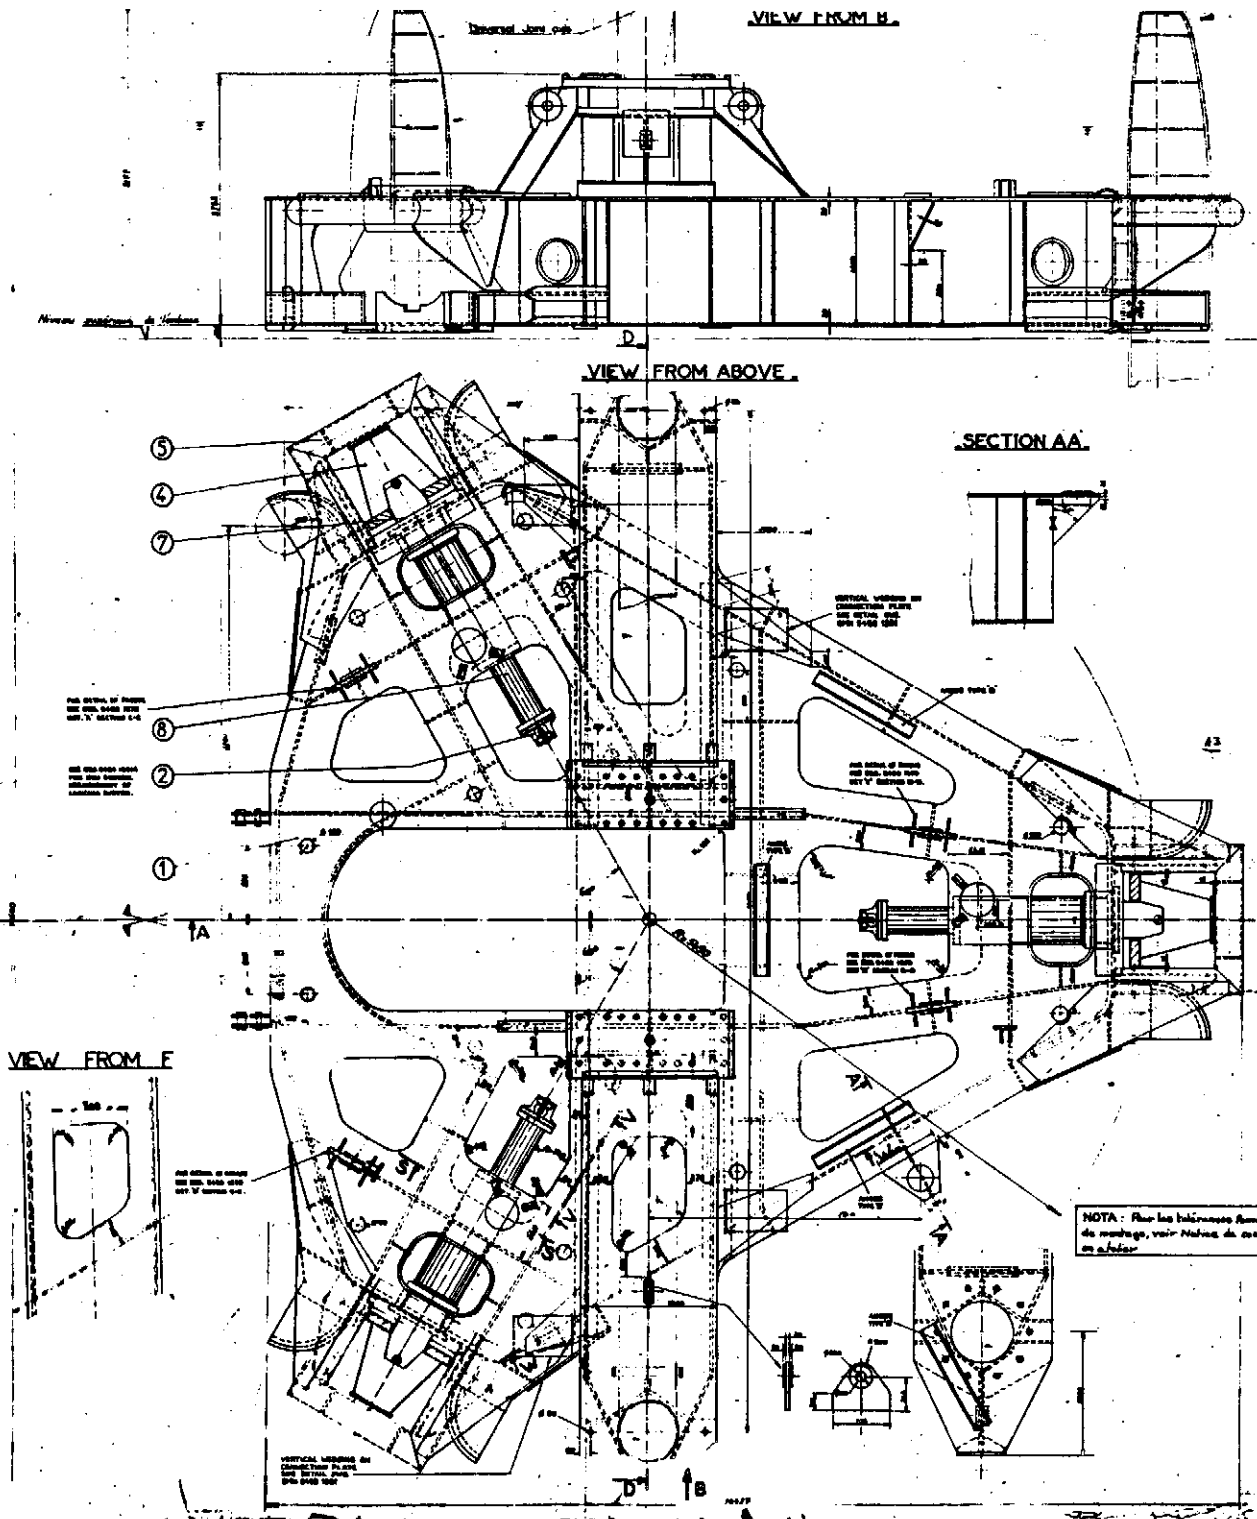
VIEW FROM C
FIG. 3.1

A completely new locking system has been designed and manufactured. Ref. fig. 3.1. It consists of the following main parts:

- Guide bolts (3 off)
- Locking bolts (3 off)
- Hydraulic cylinders (3 off)
- Hydraulic pipes for maneuvering the bolts and lubrication pipes.

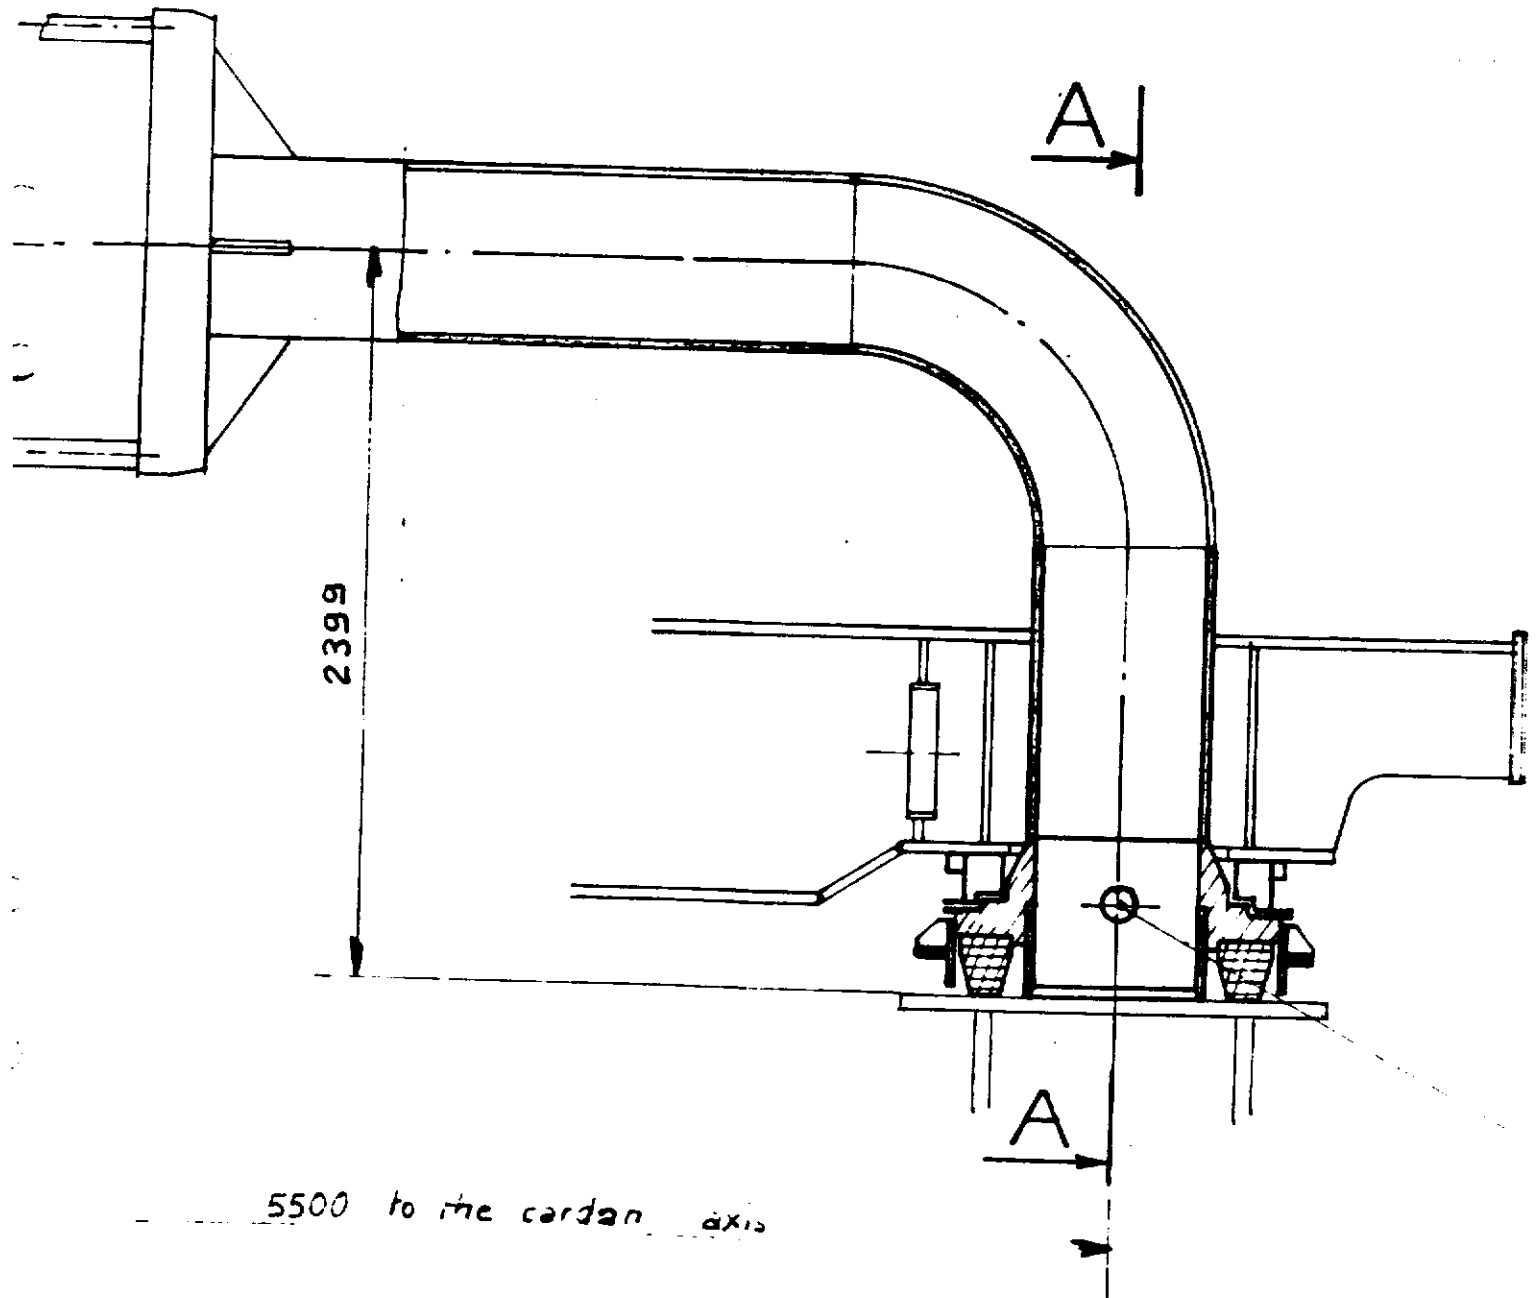
Fig. 3.2

The joint is still under the same as 1975.
 A completely new connection joint has been designed. The modifications were done to improve the pipe embedment in the connection plate, see fig. 3.2. The new flange is not fastened to the connection plate except for two bolts in way of the axes. *(which have been removed afterwards)*

Material in pipe welded to the underside of flange is TT St. E 36 with yield point $355 - 512 \text{ N/mm}^2$ and tensile strength $535 - 602 \text{ N/mm}^2$.

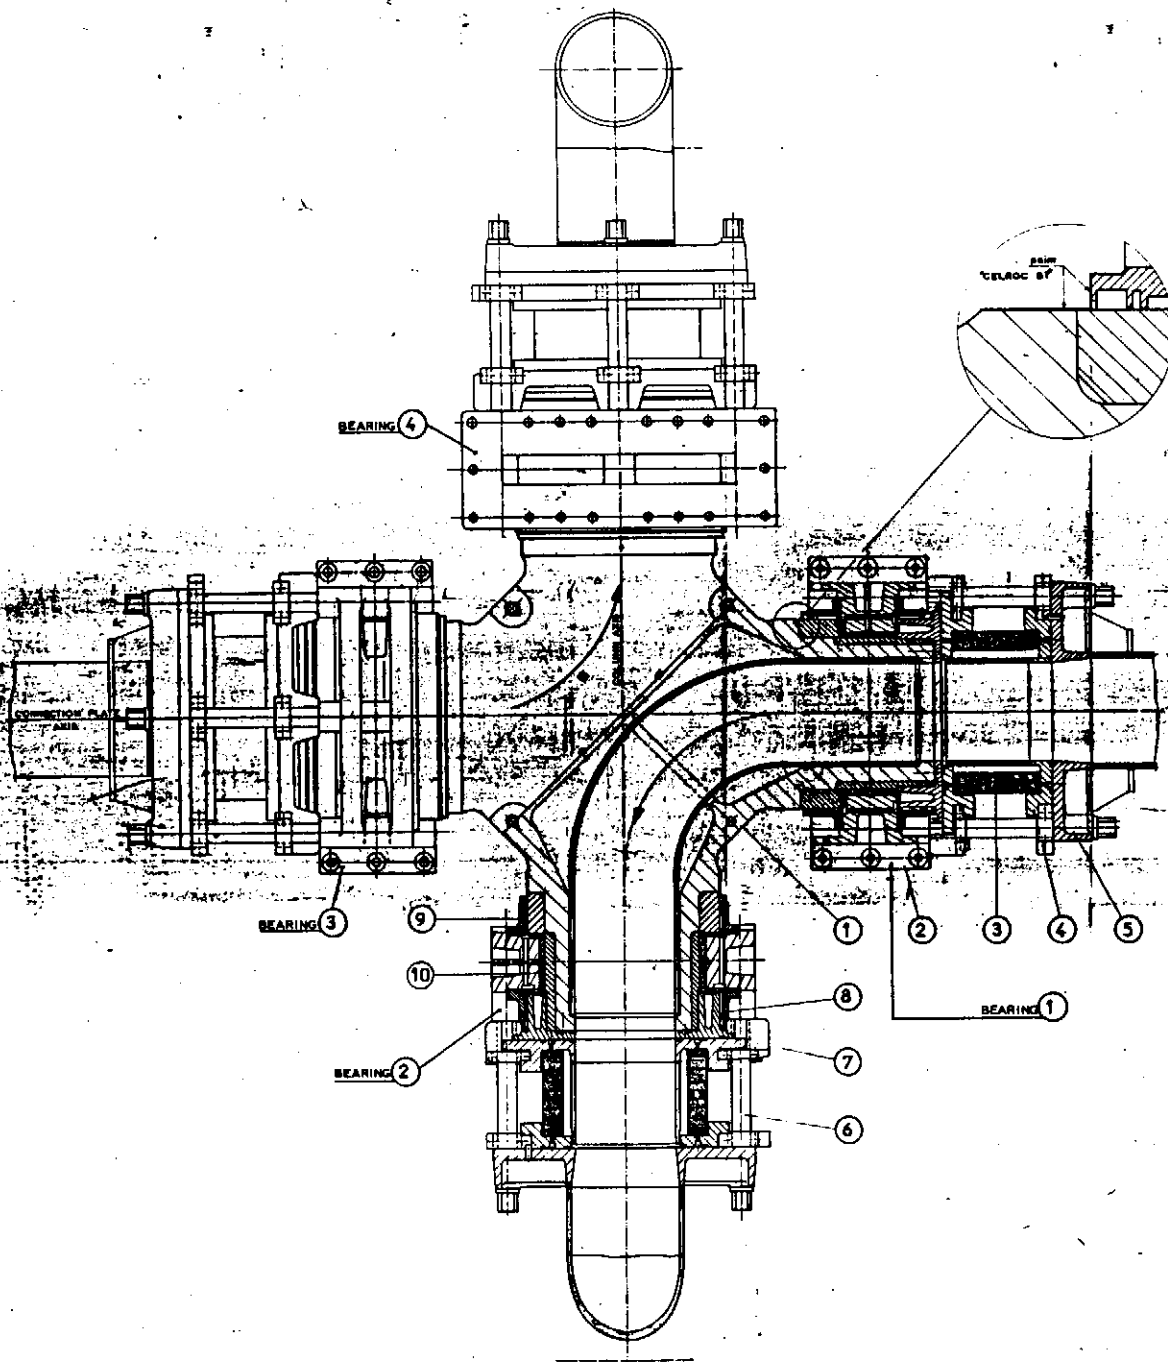
FIG. 3.3

A complete universal joint was manufactured. Only few modifications were made compared with the original design. However, there were some discussion regarding the minimum gas ¹⁰⁰temperature occurring in the system. DnV did state that a calculation of the temperature at the universal joint, corresponding to a pressure of 150 atm and a temperature of + 35° C in the gas on TP 1, should be carried out and submitted for approval. A study performed by Technip indicated the lowest temperature to be - 18.6° C. This study were not based on the proposed values, thus DnV performed a rough analysis of the temperature of the universal joint during flaring based on:

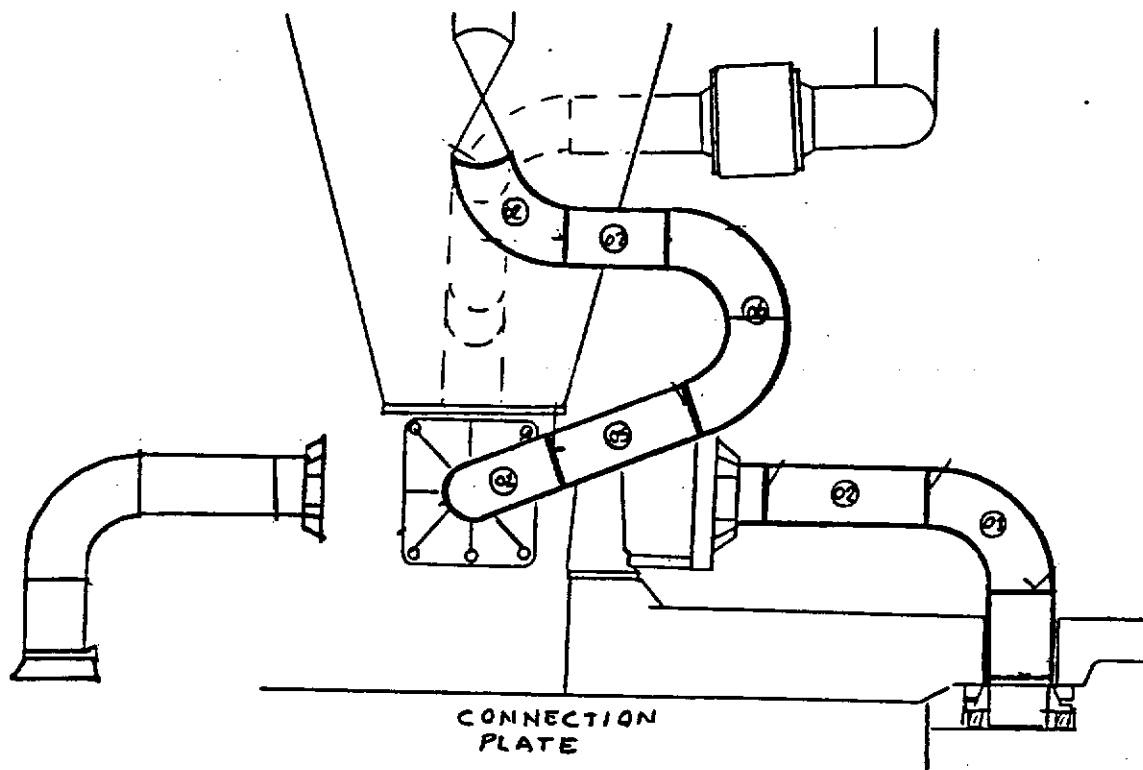
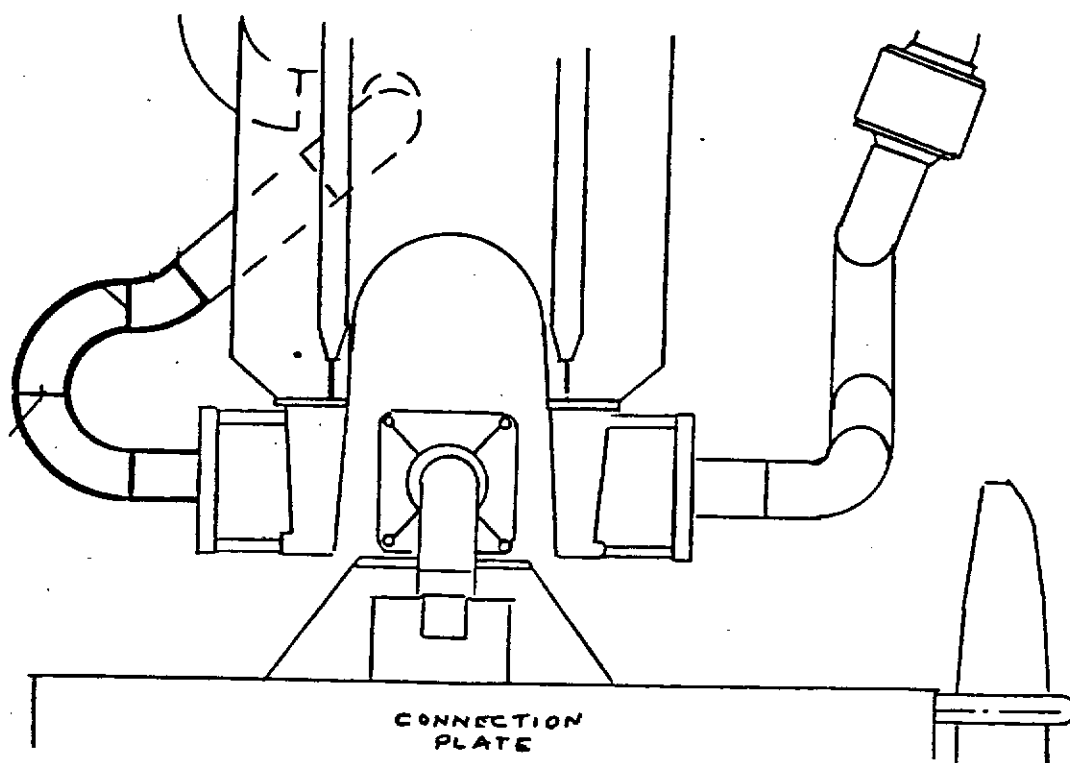
Fig. 3.4

The piping was modified to reduce the loads on the pipe, thus reducing stresses in struts, bearings and supports. The inlet pipe has the same shape as the original. It is not embedded in connection plate arm to be free to slip under temperature shrinkage of the pipe. However, there is little clearance between pipe and hole in connection plate to avoid too much deflection in case of horizontal movements of the connection plate. The improved embedment will reduce the loads somewhat, but the main characteristics of the pipe will be the same. See fig. 3.4.

Material in elbows and tubes is TT st E 36 with yield point $355-512 \text{ N/mm}^2$ and tensile strength $535-706 \text{ N/mm}^2$. This material is equivalent to the specified St.52-3N.

Thickness in tubes is 20 mm and 17.5 mm in elbows.

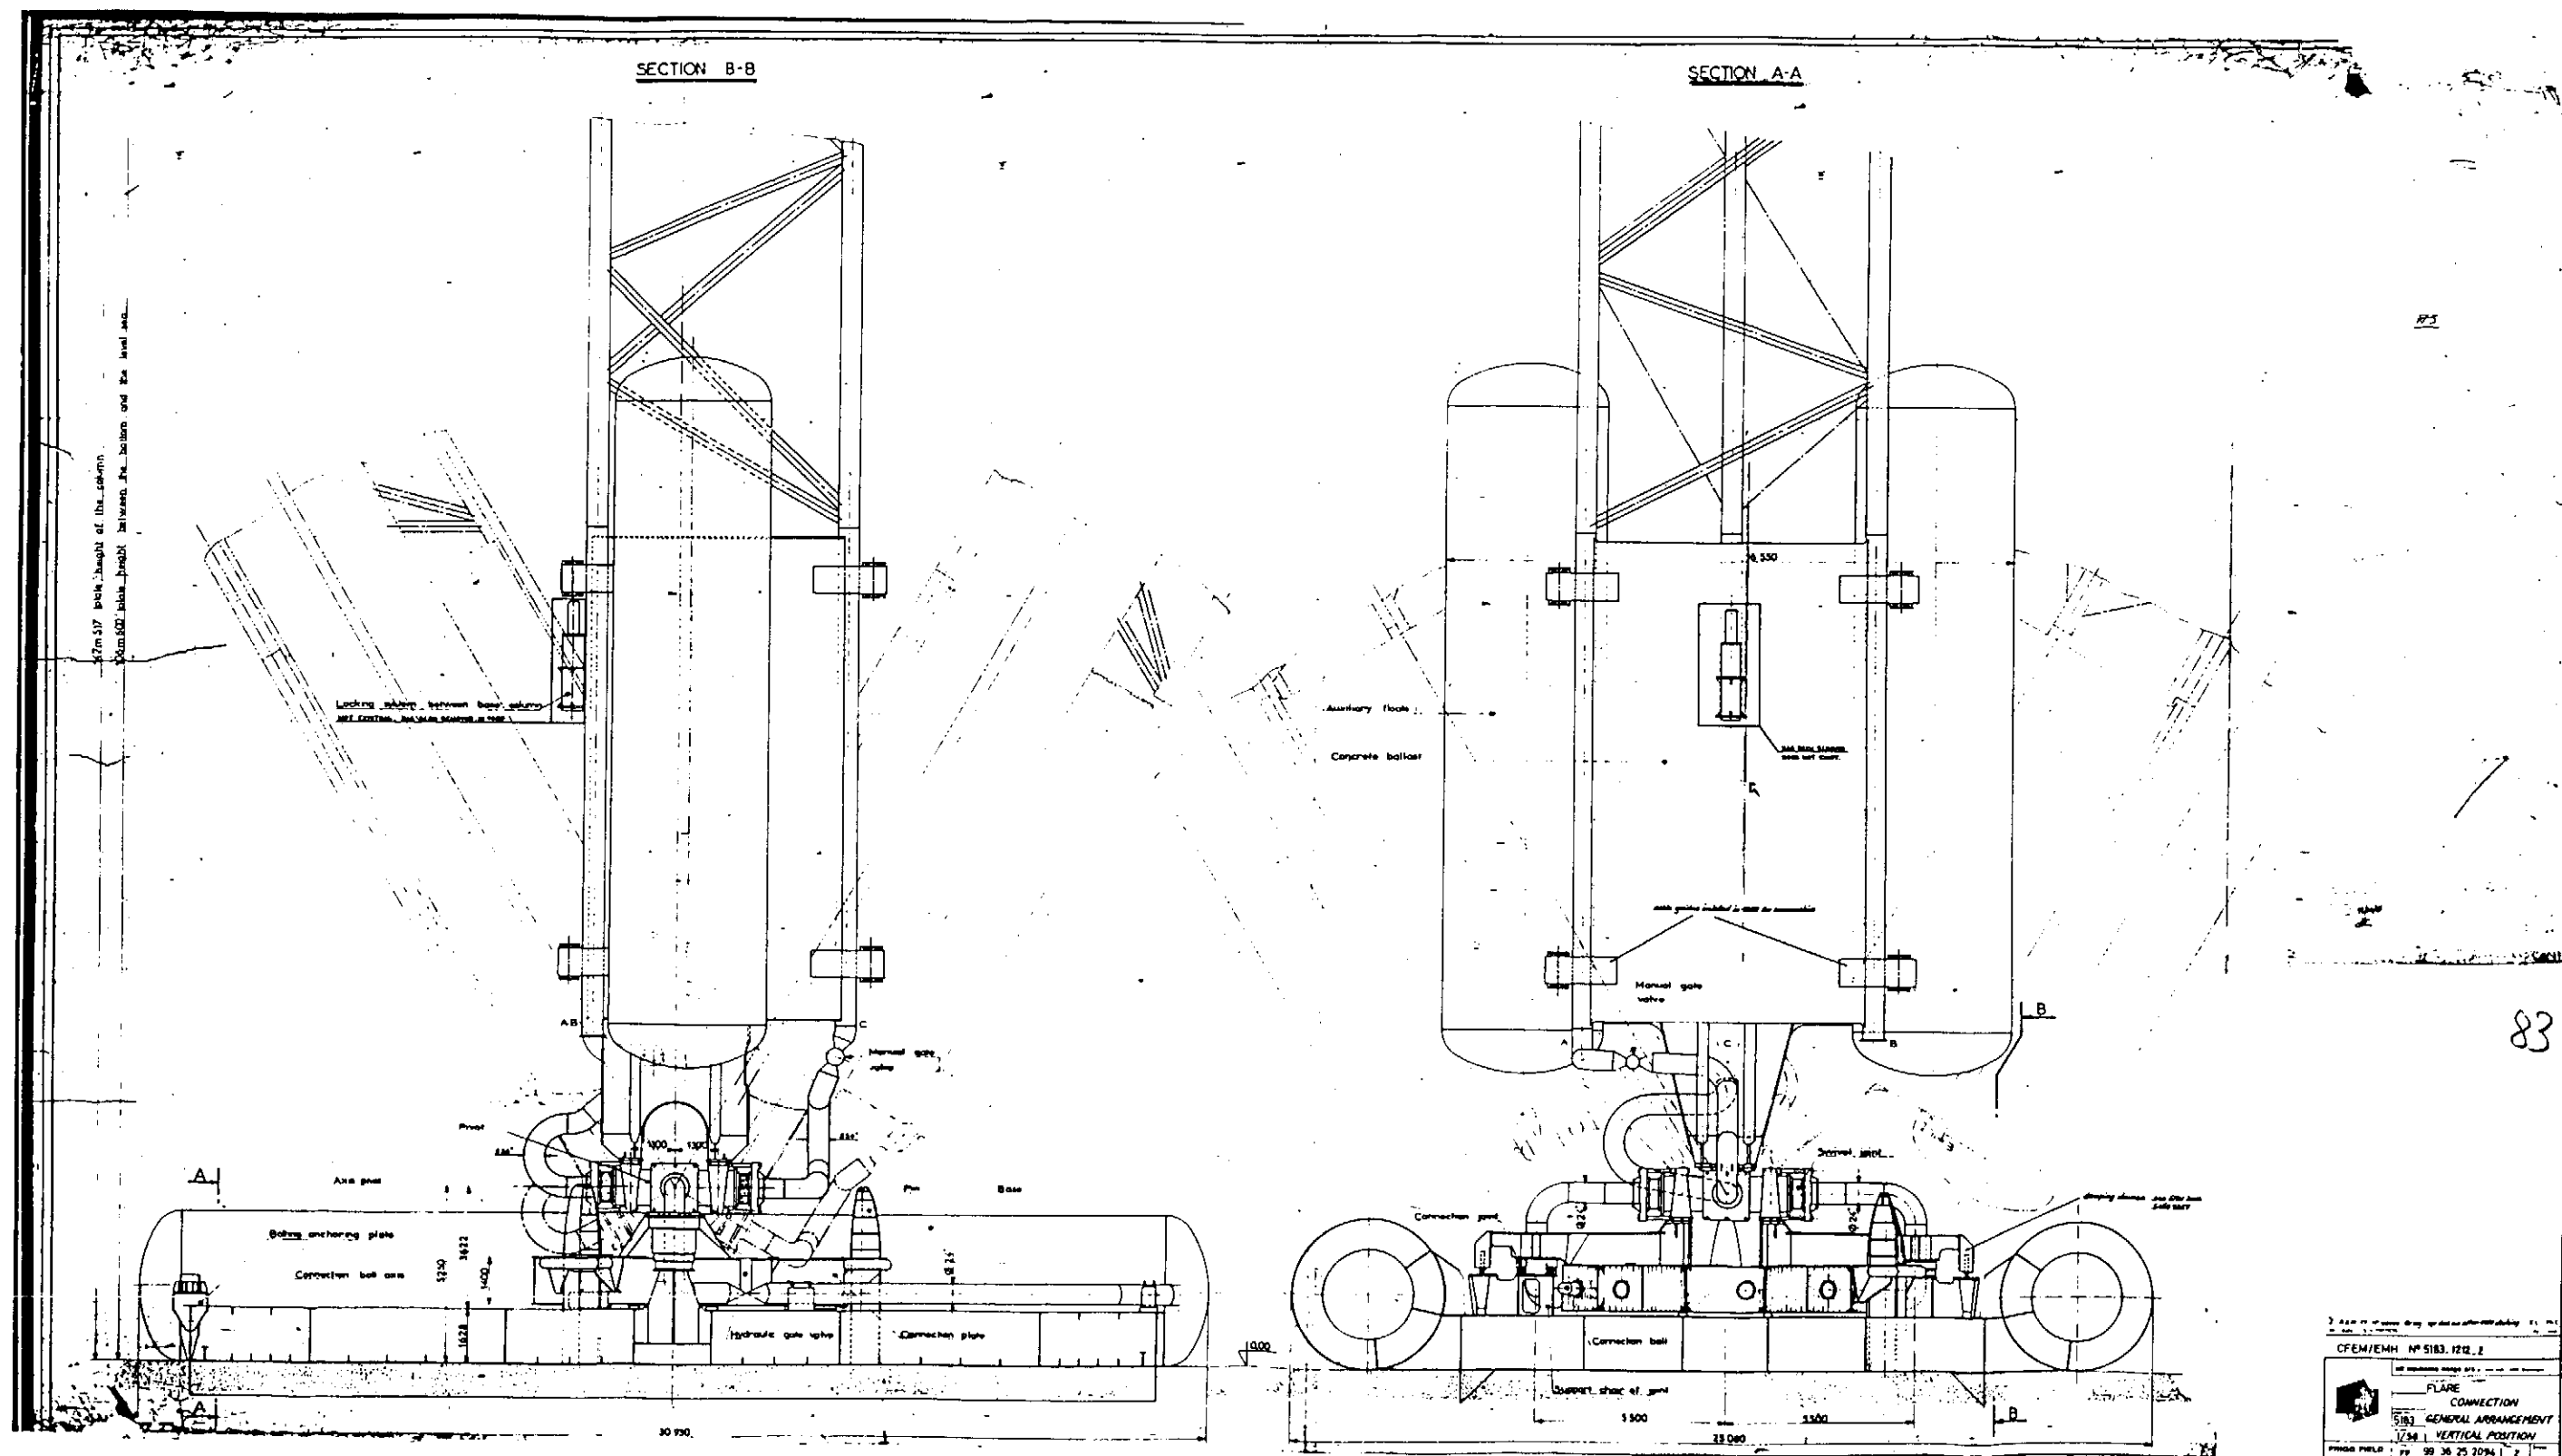
F16. 3.5

2 padeyes were welded to bottom of concrete ballast. These were used for clamping of connection plate to maintain it in perpendicular position with the flare axis during horizontal towing, tilting and vertical towing. Material used in padeyes is st 52 - 3N.

Floor plates around cable guides on MC were modified.

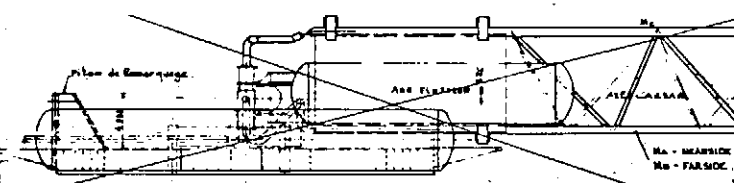
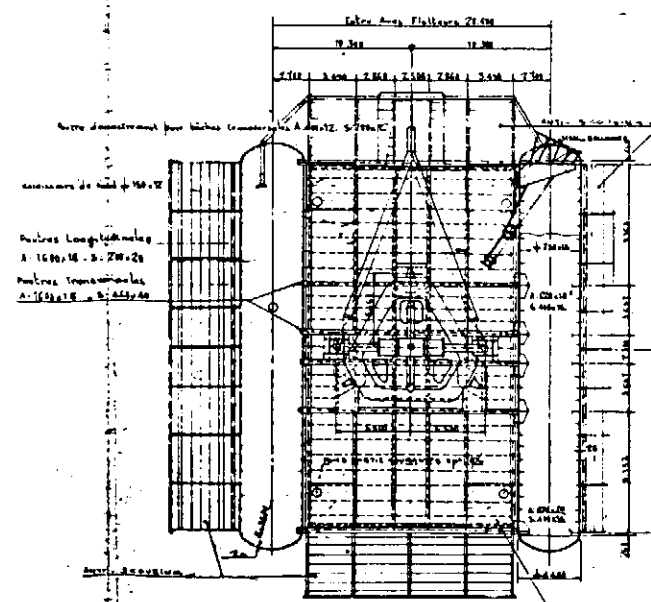
FIG. 3.6

During inspection it was observed that the original lay-out was not in accordance with the actual structure. Updated drawing is shown in fig.3.6.

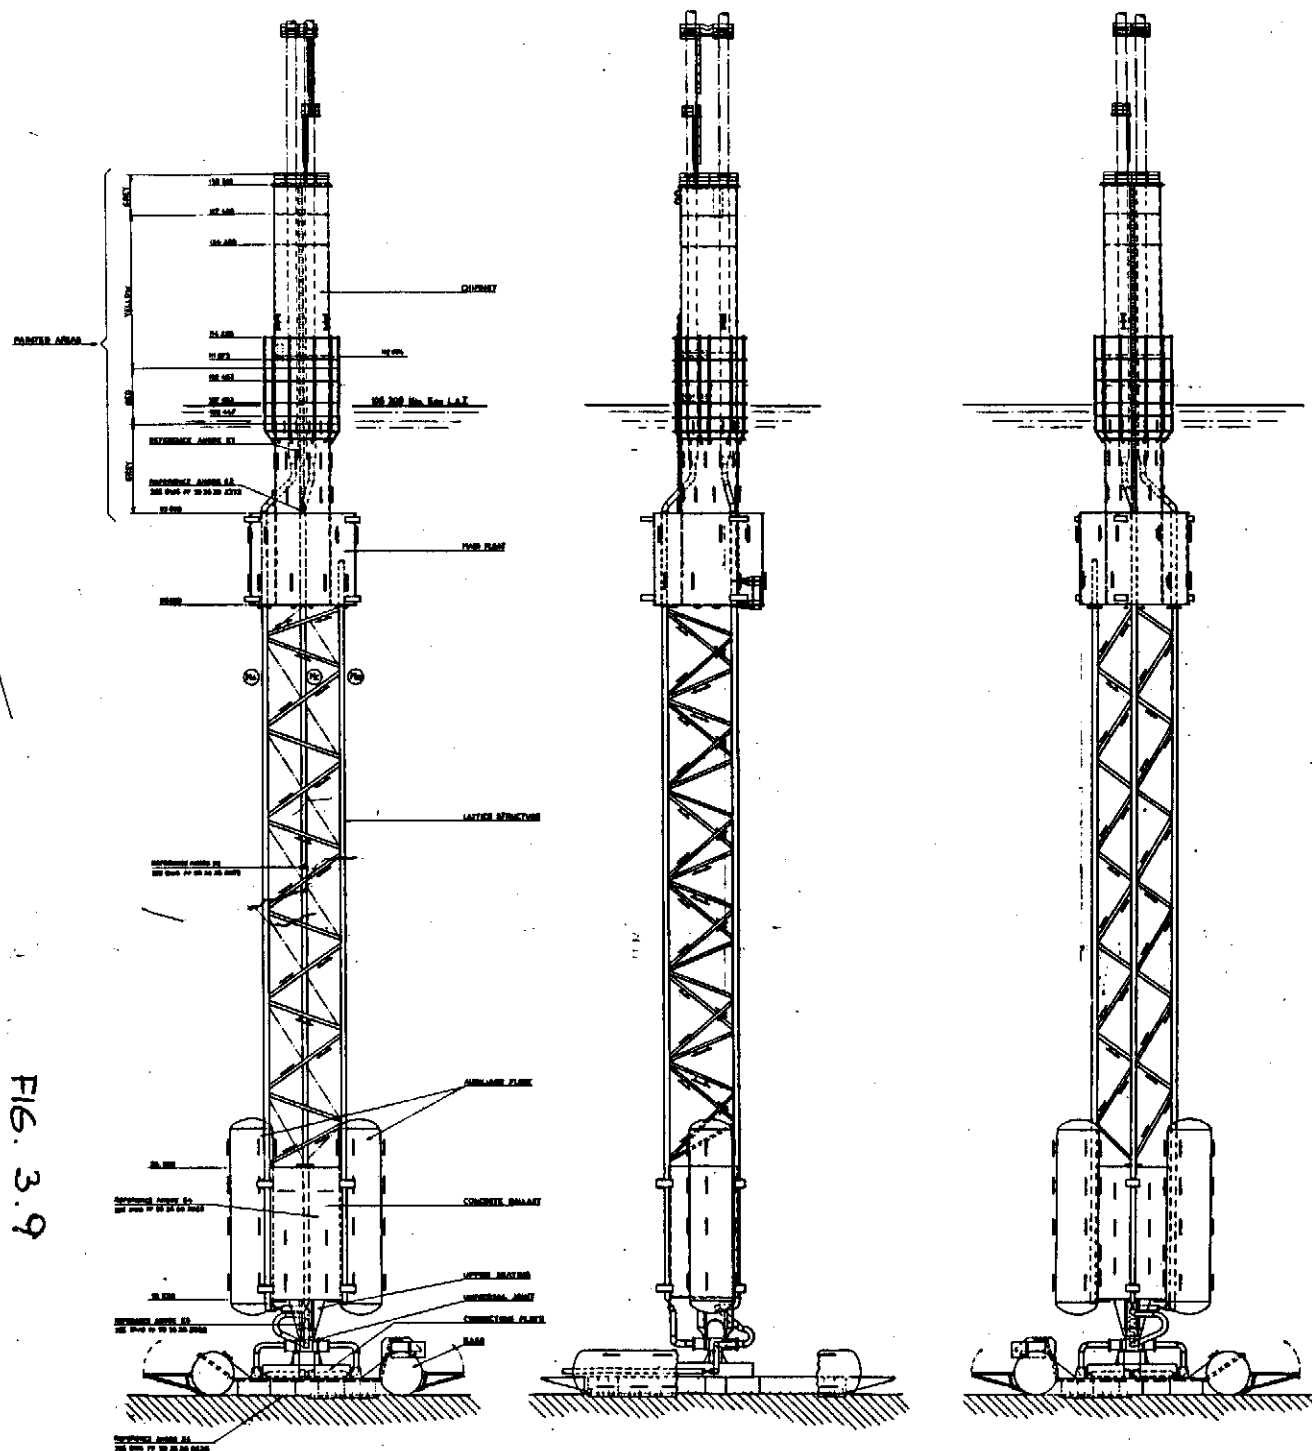
FIG. 3.9

New anodes were fitted on main float, on lattice structure and on lower part of tidal tank. Also both triangular ballast tanks had two new anodes, each installed on the inside. Ref. fig. 3.9.

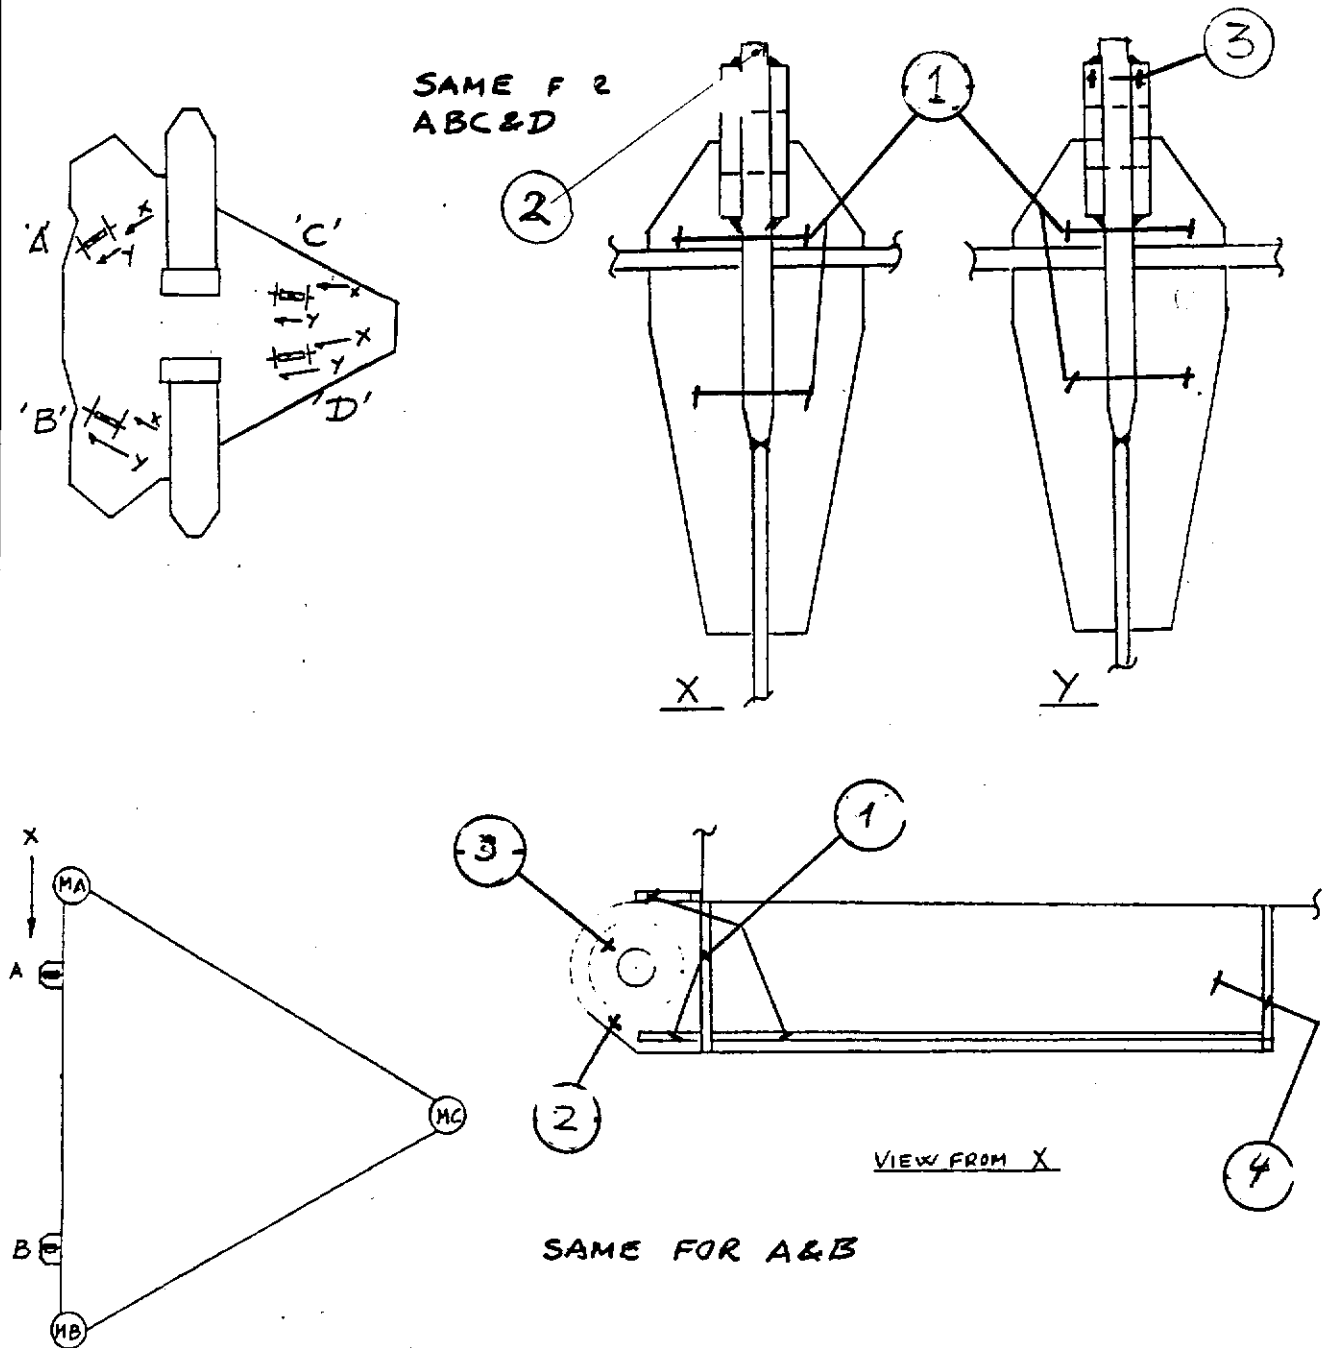
Fig. 4.1

DESCRIPTION	FABRICATION	MATERIAL	DNV, INVOLVED
Connection plate, padeyes: (Fig. 4.1)			
1	Rautaruukki oy	St 52-3N	DnV
2	Thyssen Henrichshutte, W.Germany	Grade 3 SP-JJ-001 Rev. 1	DnV, Essen
3	Kawasaki steel works	St 52-3N	DnV, Yokohama
