FRIGG FIELD - DRILLING PLATFORM NO. 2
STRUCTURAL PARTS
DESIGN, FABRICATION AND INSTALLATION
(DFI) RESUMÉ

NORWEGIAN PETROLEUM DIRECTORATE

DET NORSKE
VERITAS

Date November 1, 1977	
Department 57	Project No. 601636
Approved by <i>S. H. Olsen</i>	
Client/Sponsor ref.	
Reporters sign. <i>Oddvar Alfstad</i>

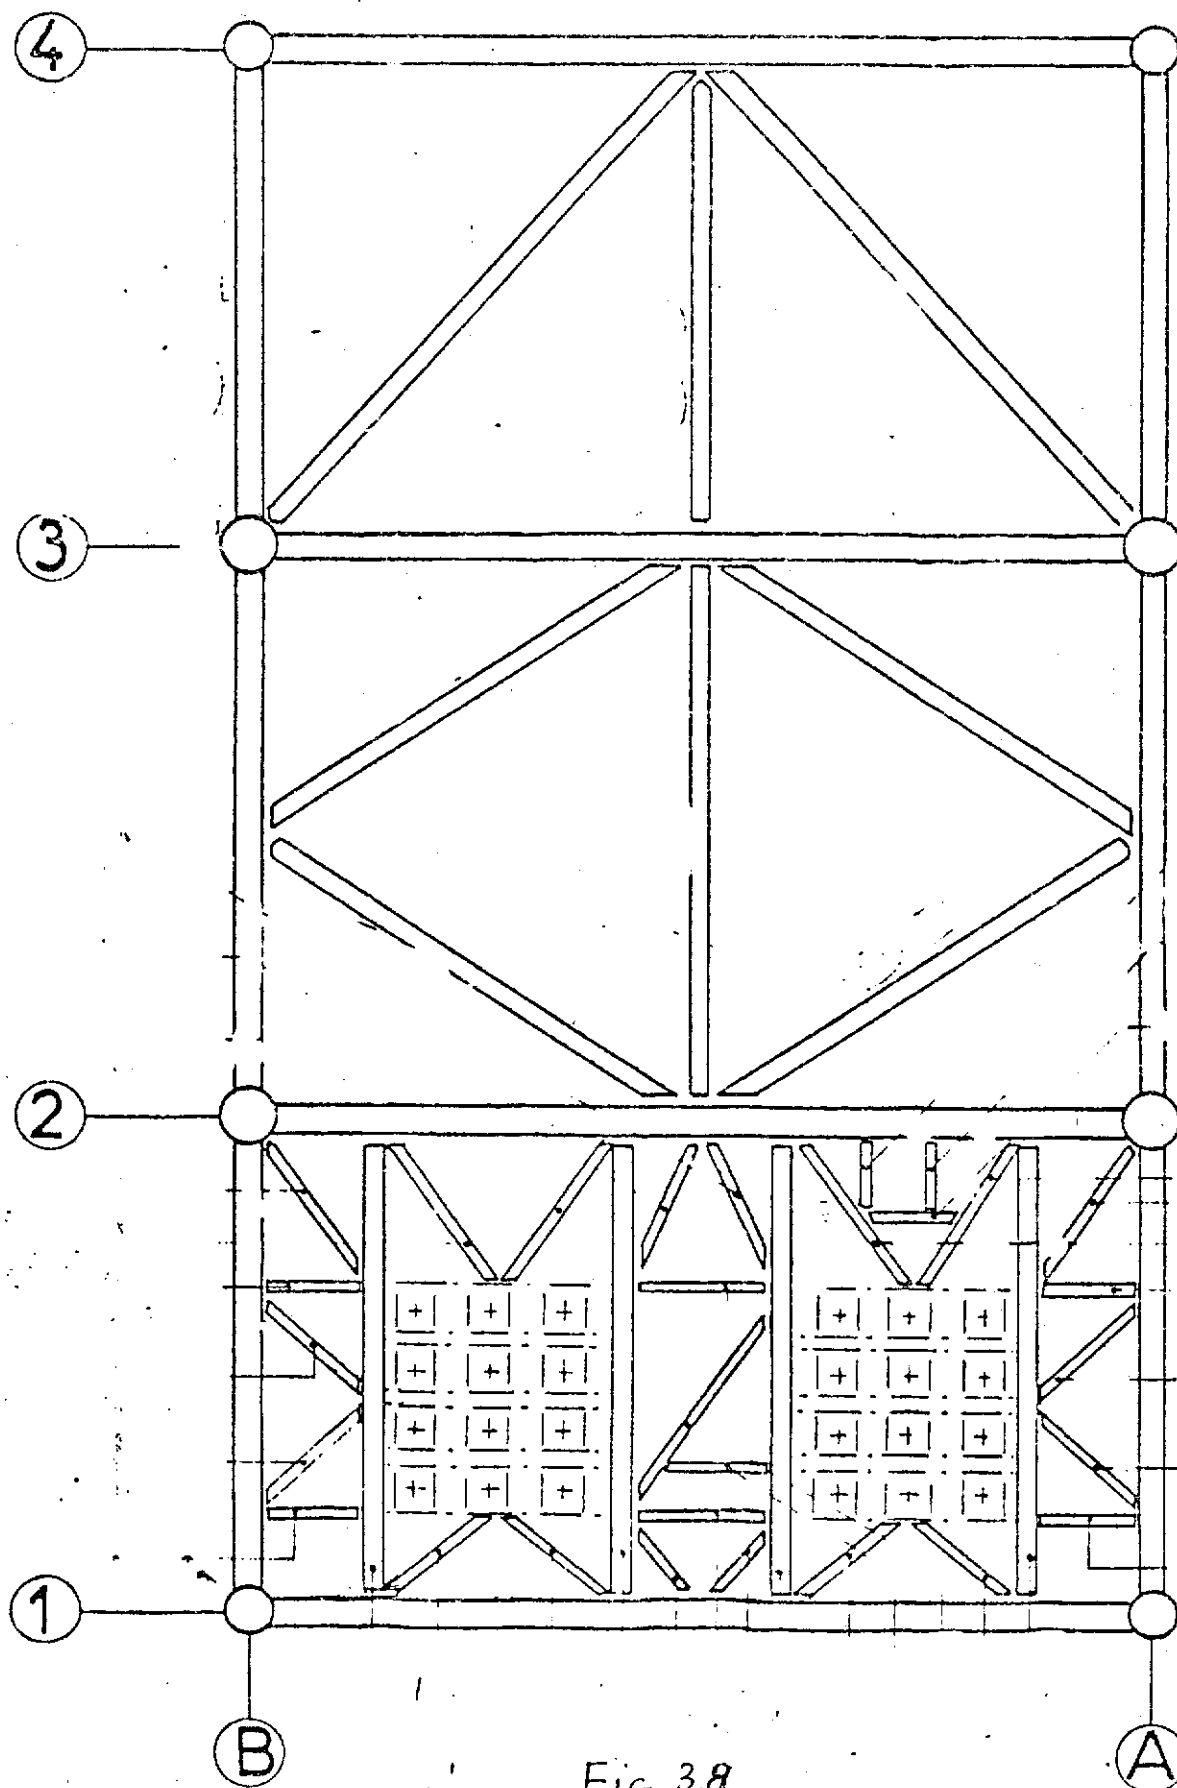
Fig 3.8

FRIGG DP2
Niveau (+) 6095

It should be noted that the members located on elevation (+)6.095m may be subjected to wave slamming loads possibly leading to fatigue failure. These members should therefore be subject to future inspection and the most critical joints have been marked with a double circle (◎), even if the calculated usage factor in all cases does not exceed 0.4.

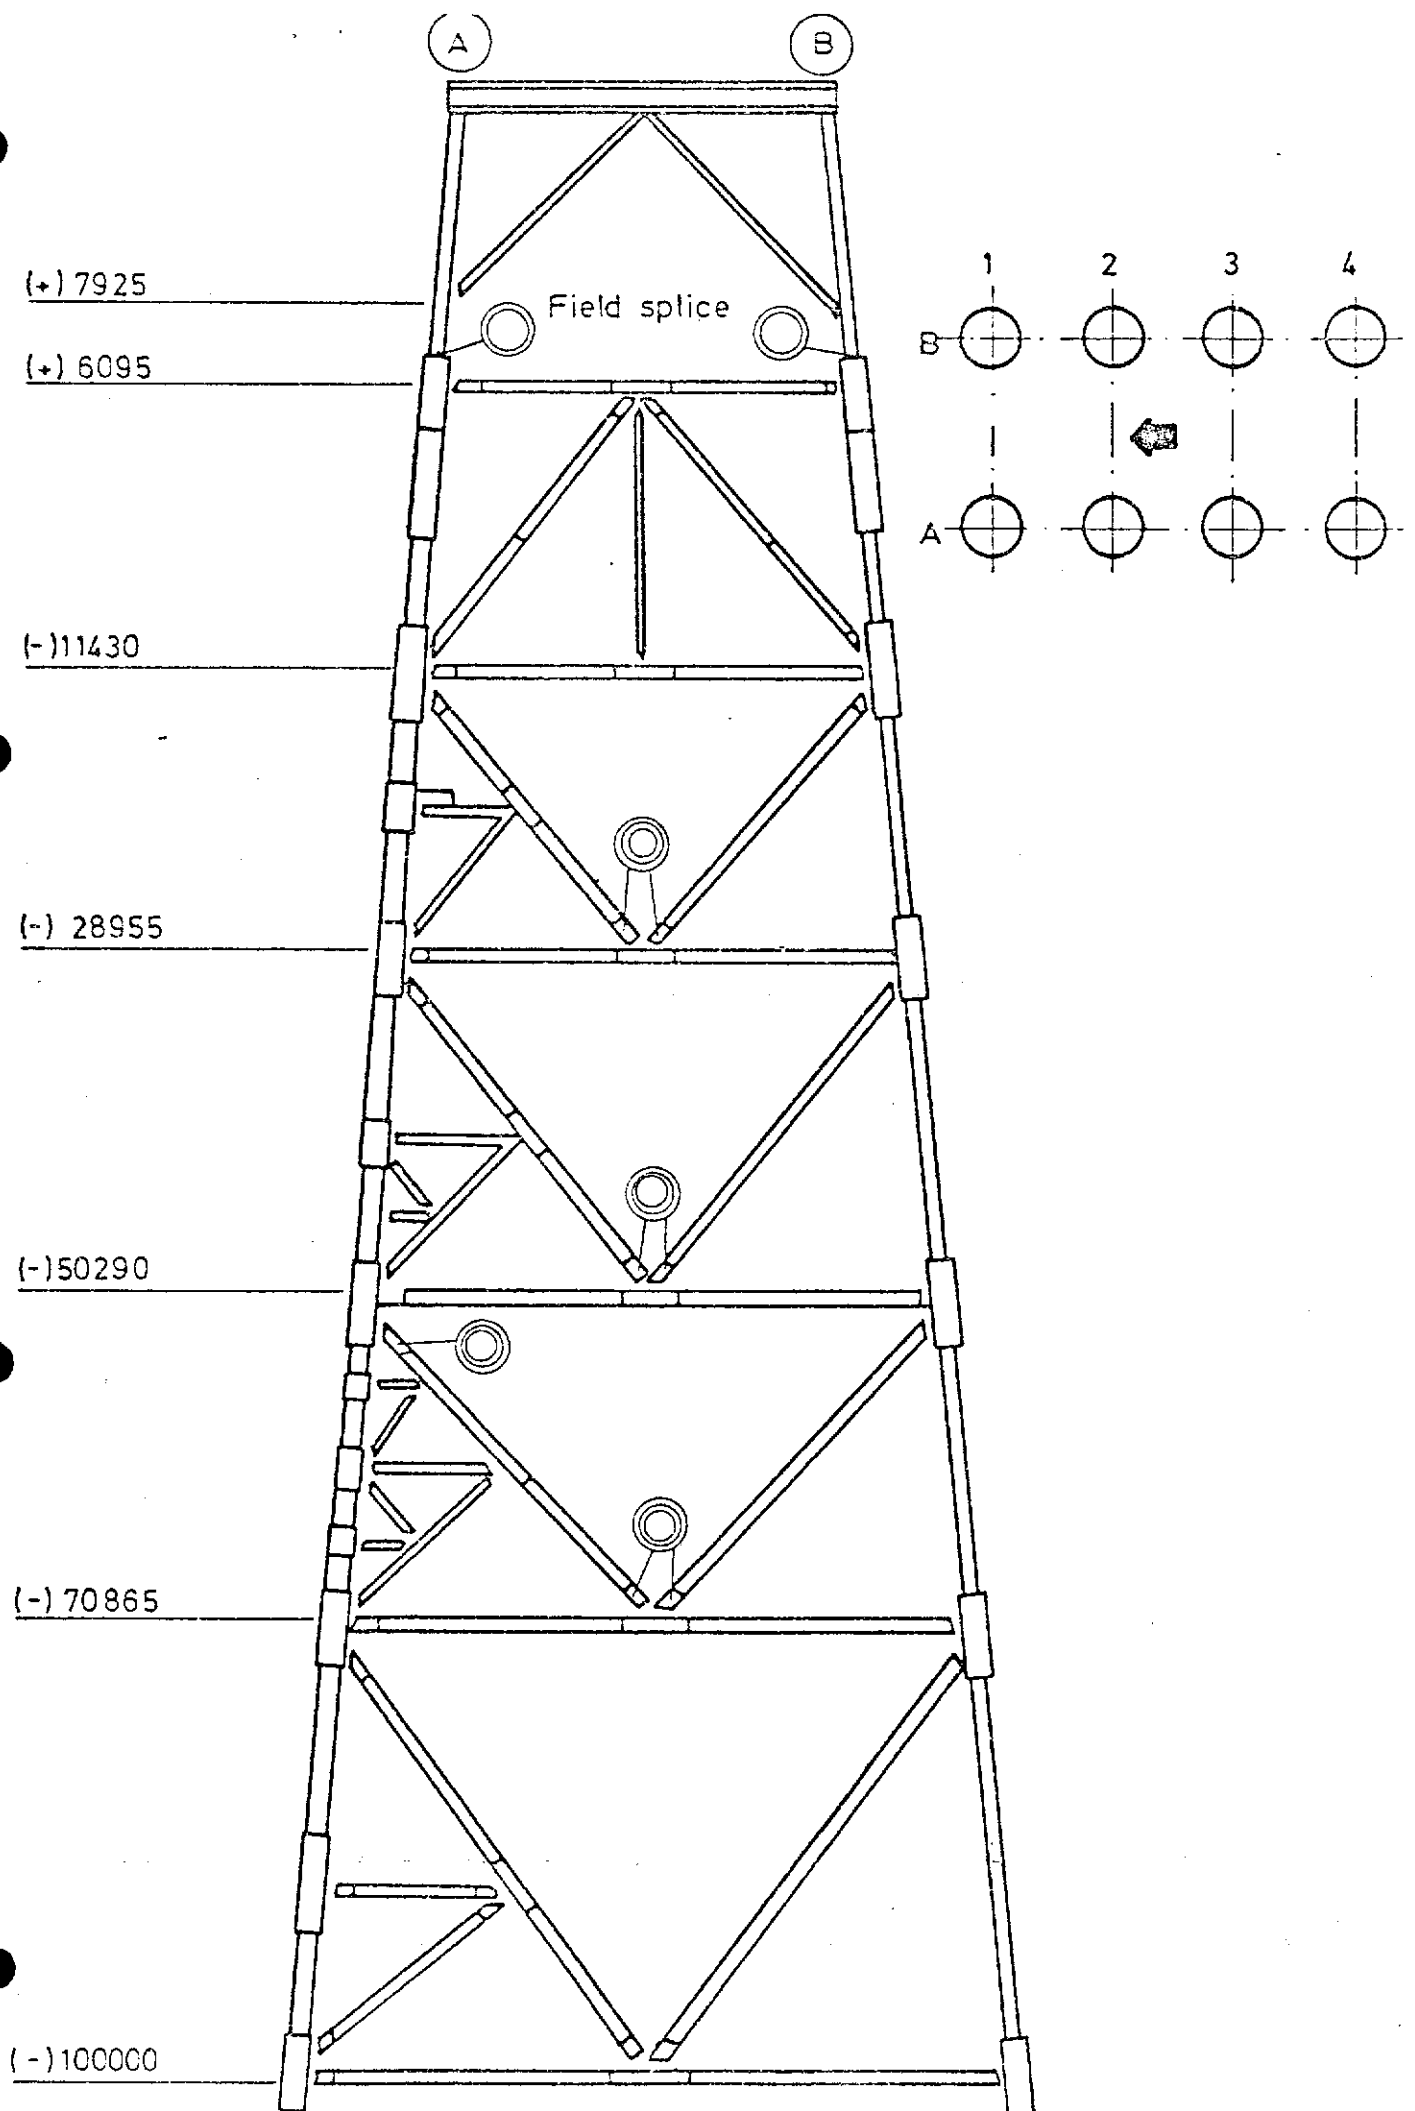
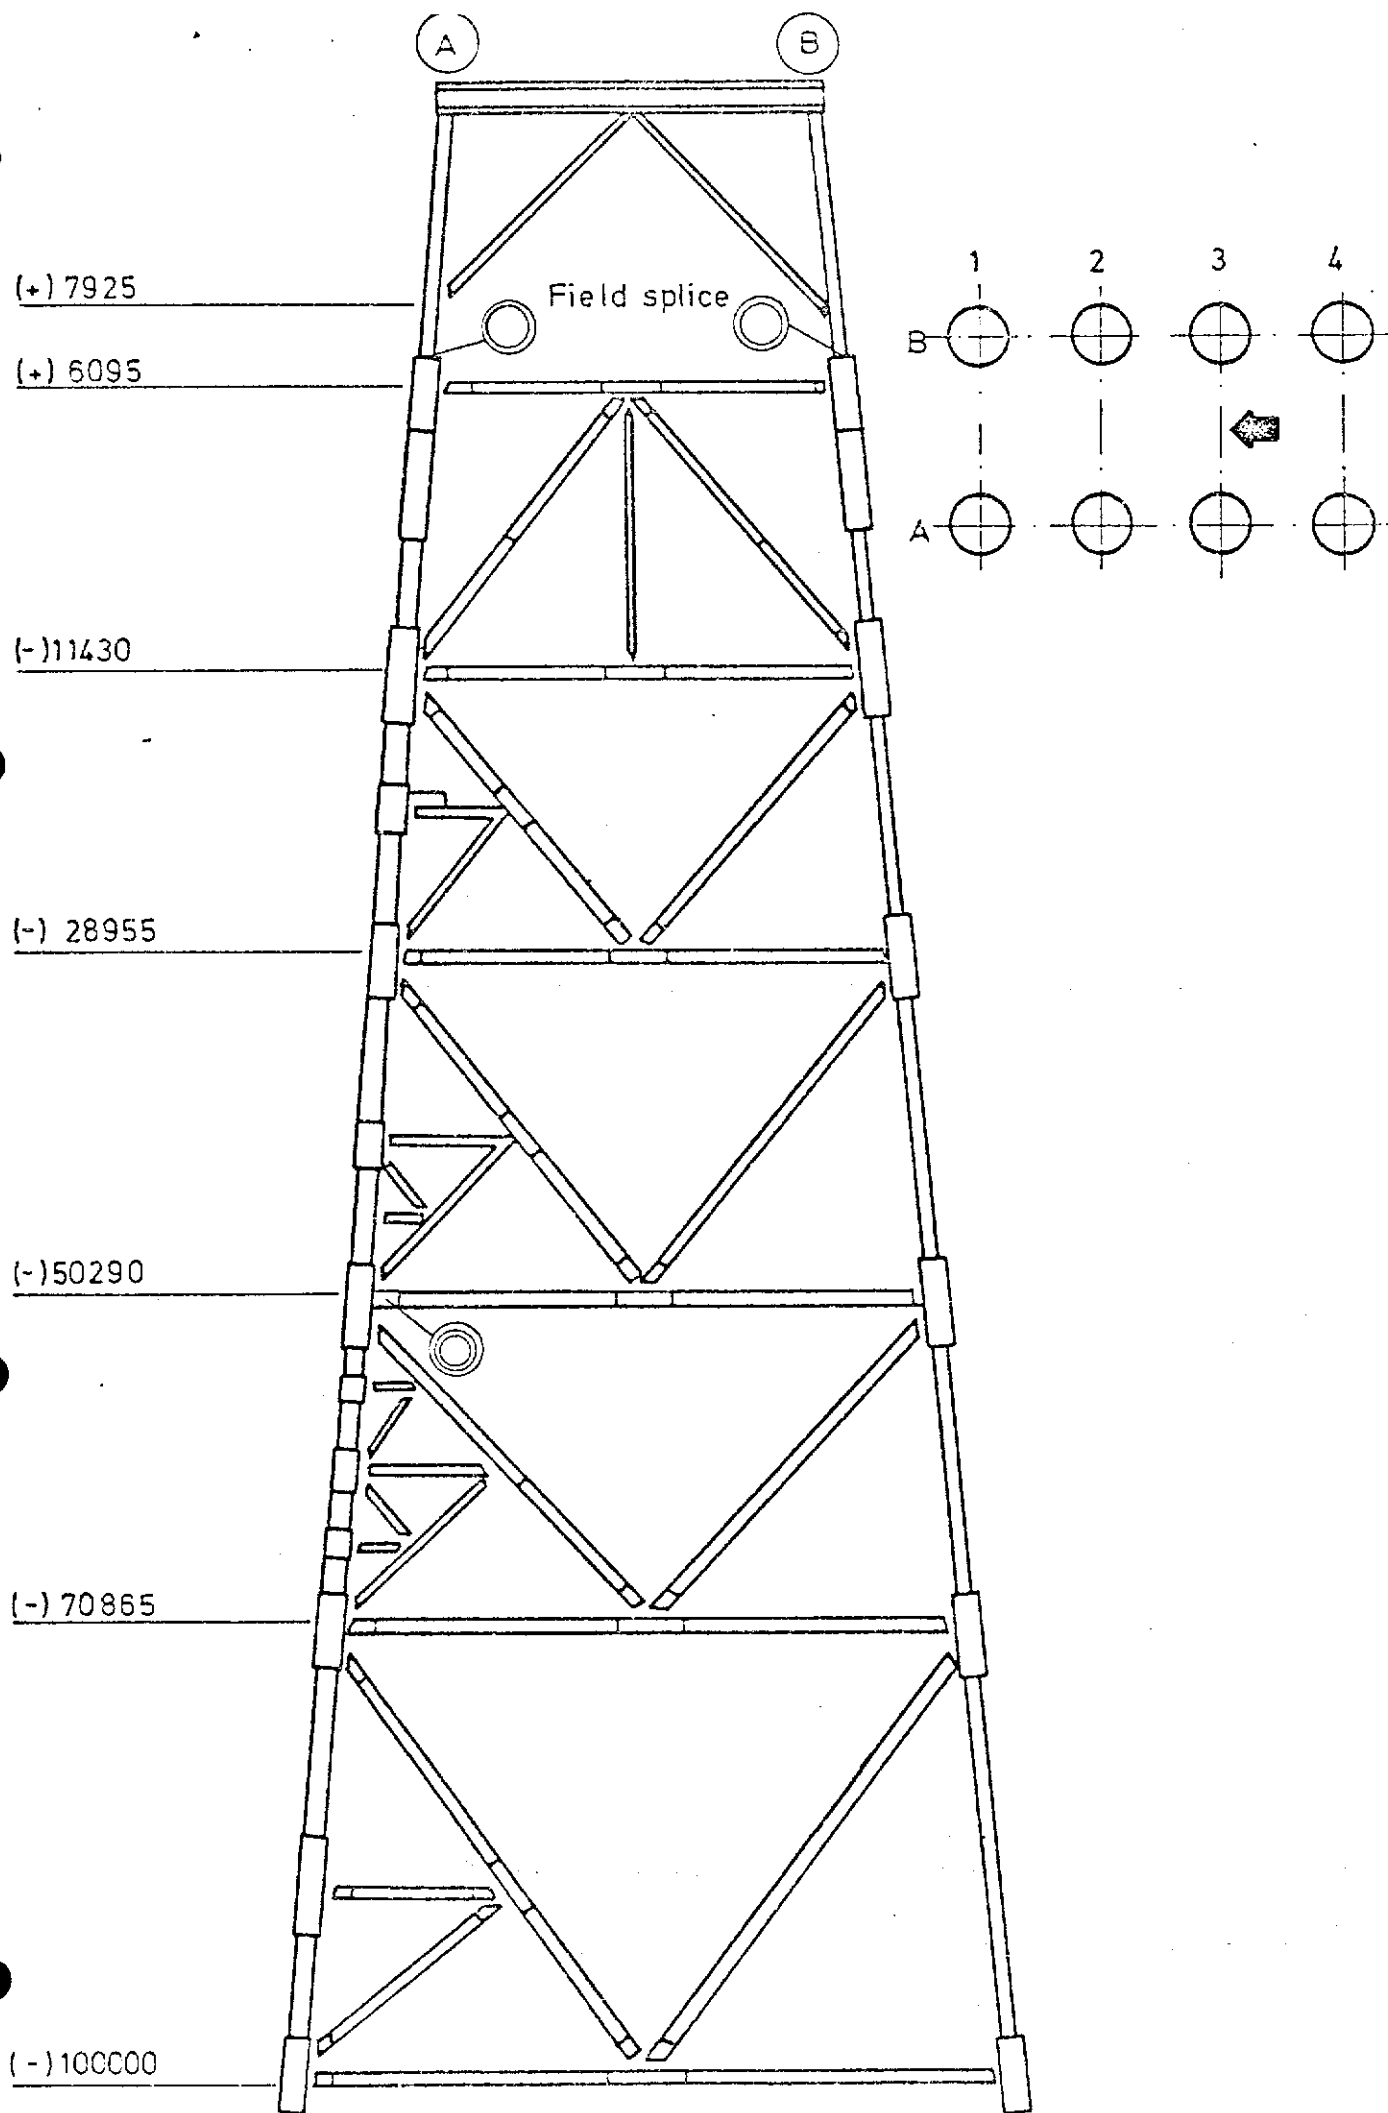
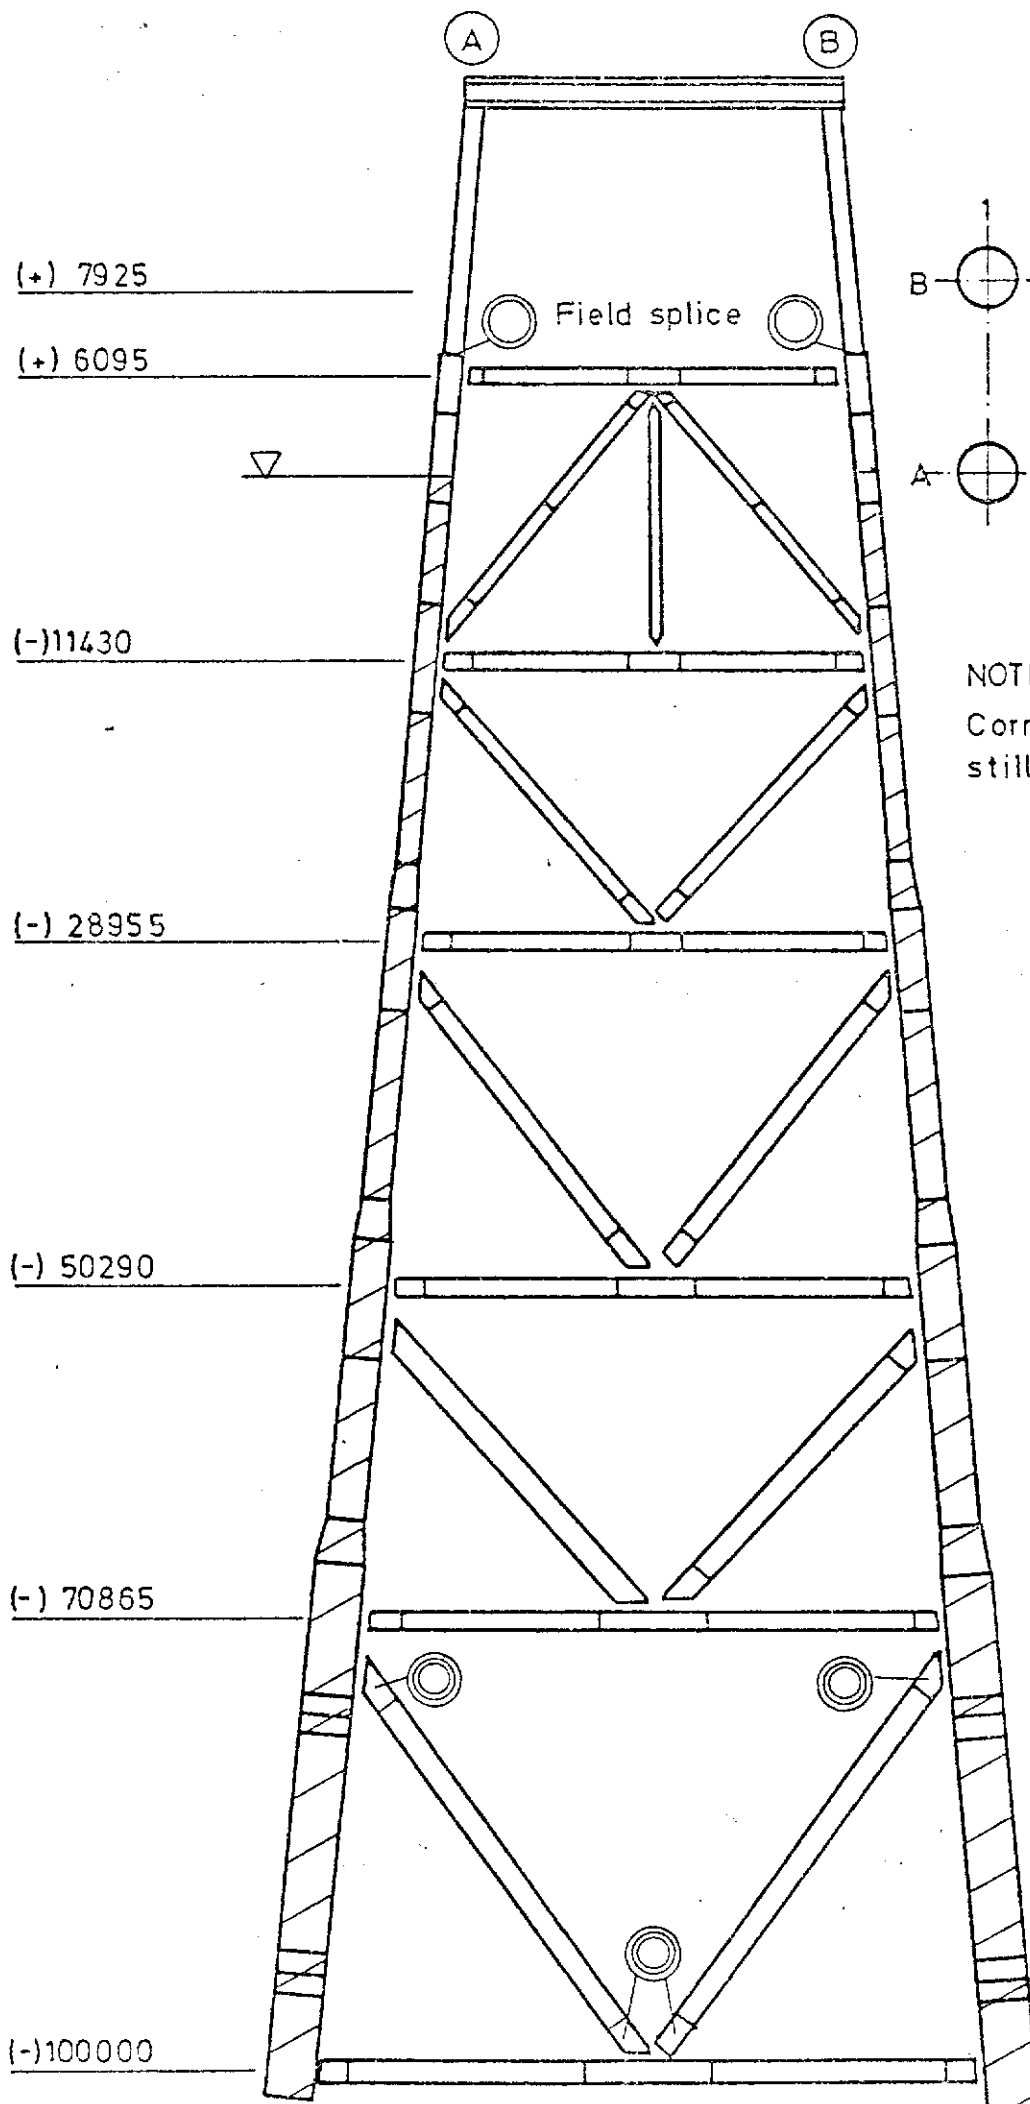
NOTE:

Corner legs flooded to still WATERLEVEL

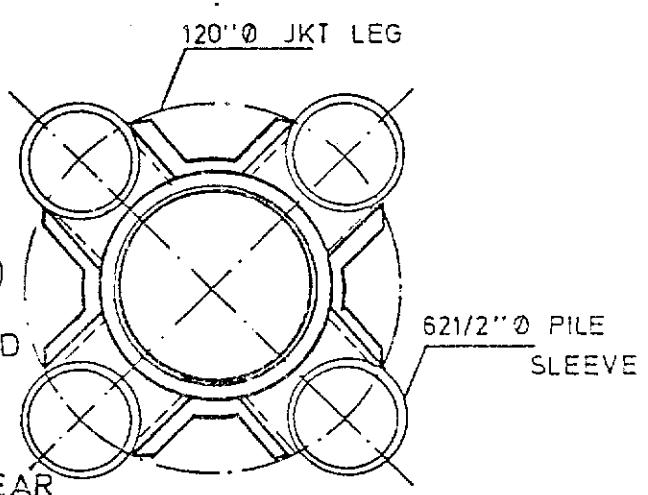
SECTION B-B

SHEAR PLATES (ALL)
WELD BETWEEN
SHEAR PLATES AND
BOTTLE AND PILE
SLEEVE TO BE
INSPECTED.
THICKNESS OF SHEAR
PLATES TO BE
CHECKED
ALL SHEAR PLATES
ON ALL 4 LEGS

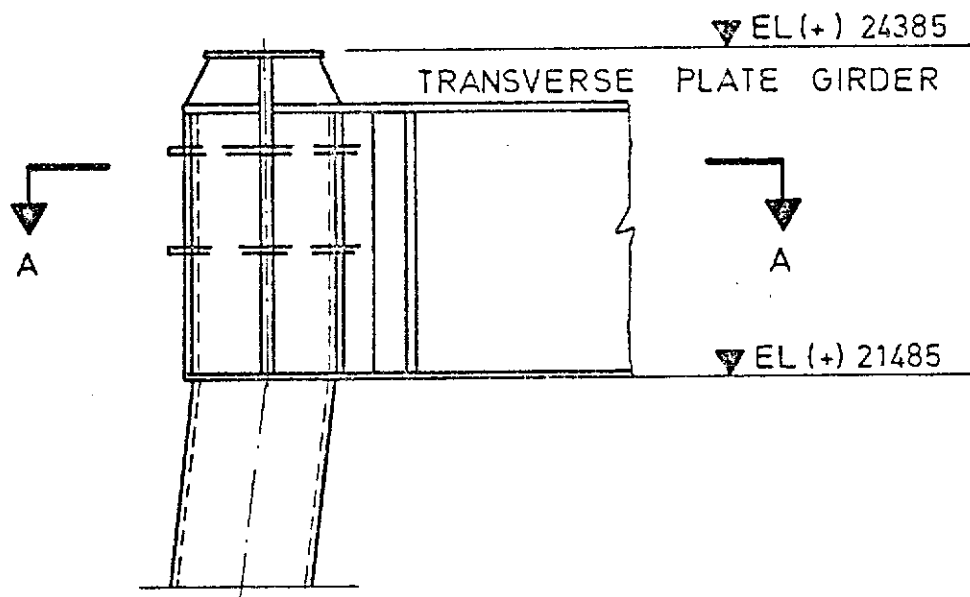
TYPICAL DECK LEG PLATE GIRDER CONNECTION

Attachments and members welded to the flanges of the deck support frame involve areas susceptible to fatigue cracking. This applies to areas where walkways, deck modules, and (+)21.485m horizontal members are welded to the flanges of the deck beams. Also the areas where the storage tanks and pump house is welded in should be regularly inspected.
