VERITAS Report No. 78/039	Subject Group
Title of Report FRIGG FIELD - QUARTERS PLATFORM DESIGN, FABRICATION AND INSTALLATION RESUME (STRUCTURAL PARTS)	
Client/Sponsor of project ELF AQUITAINE NORGE A/S	
Work carried out by Odd Torset et.al.

QUARTERS PLATFORM
FRIGG FIELD
DFI RESUME

**DESIGN-FABRICATION-INSTALLATION**

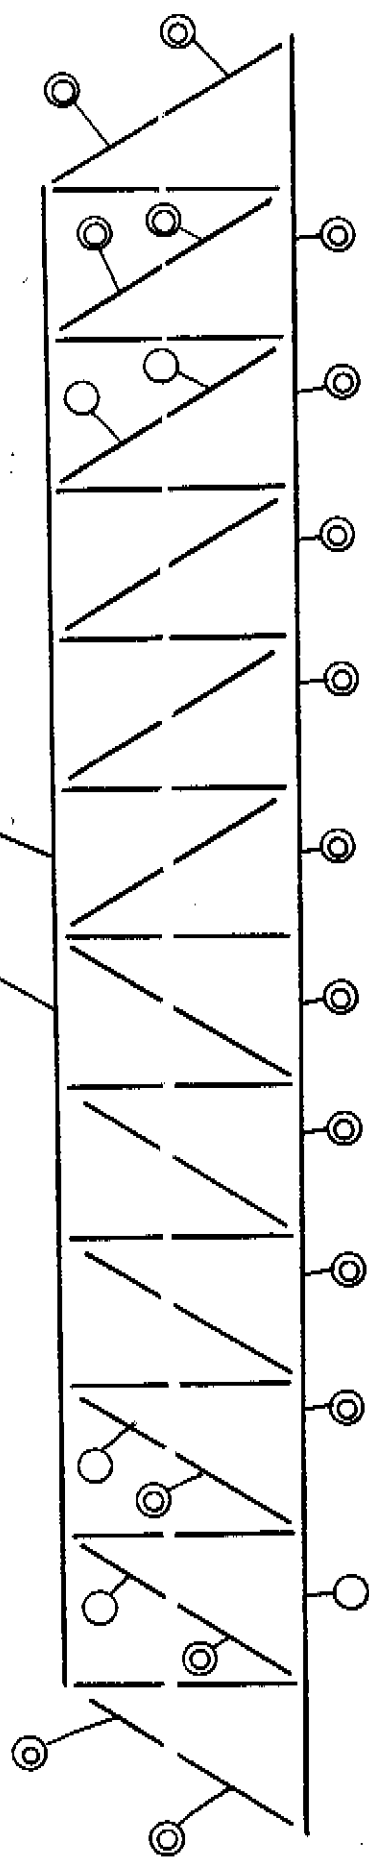
WEST ELEVATION

Members marked with a double circle (@) have a buckling ratio equal to or greater than 0.9 in the extreme environmental condition.

Members marked with a single circle (O) have a buckling ratio between 0.7 and 0.9 in the extreme environmental condition.

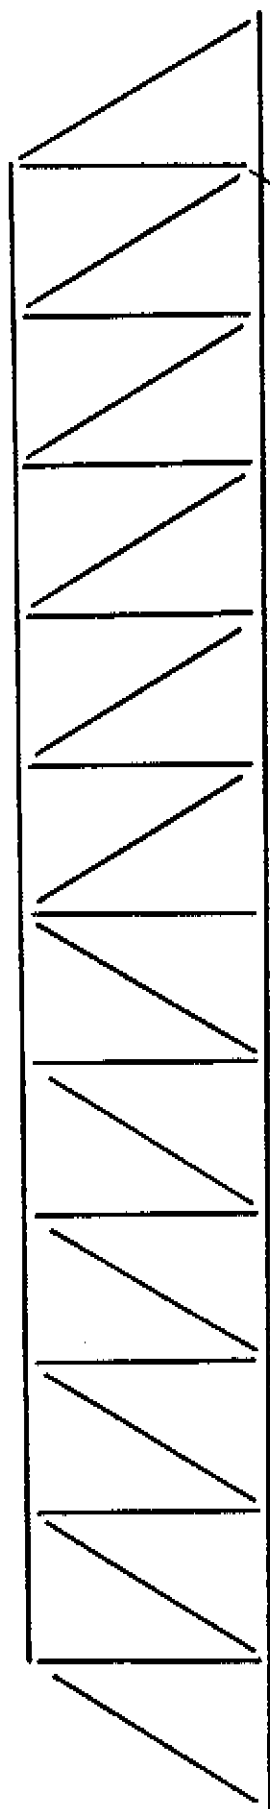
WEST ELEVATION

The following figures describe the most heavily stressed member ends and member sections in the structure. It must be noted this marking refers to nominal static axial-plus bending stress only. Thus no attempt has been made to show hot-spot stresses in the following figures.

) have stresses equal to or above 20 ksi in the extreme condition.

) have stresses between 16 and 20 ksi in the extreme condition.

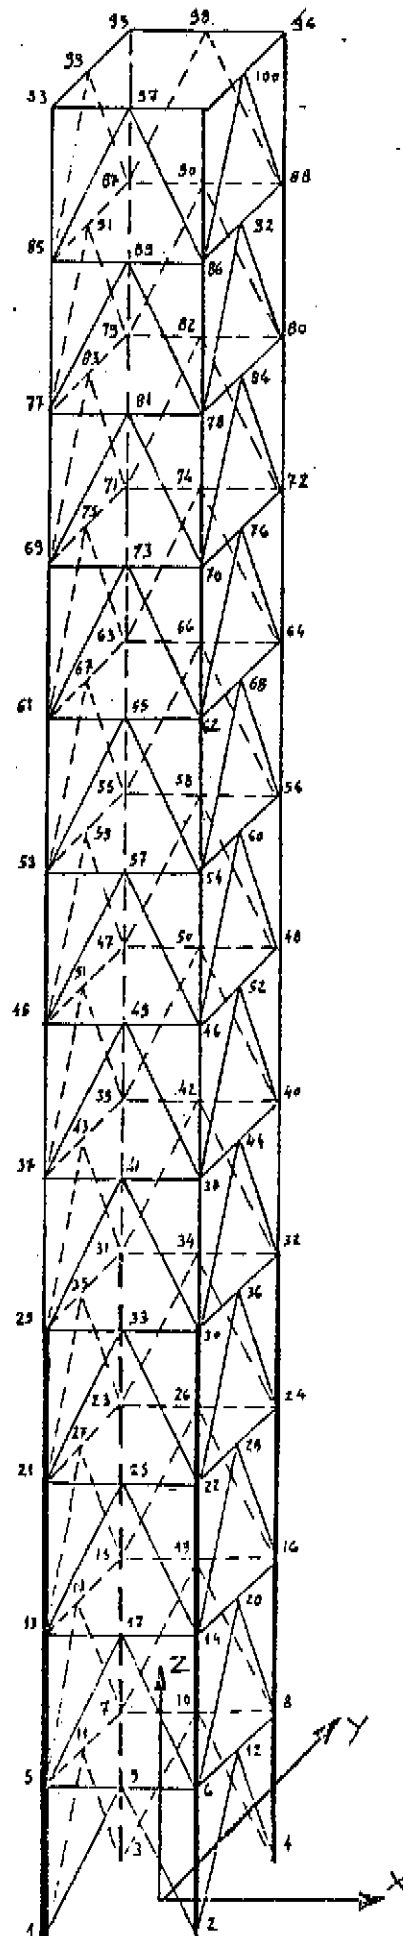
MICROWAVE TOWER MODEL

For the tower itself the stresses is generally found quite acceptable.

The support reactions an however just on the limit for the design of the module trusses. Thus the support members transferring and distributing the reaction forces into the module should be closely inspected.

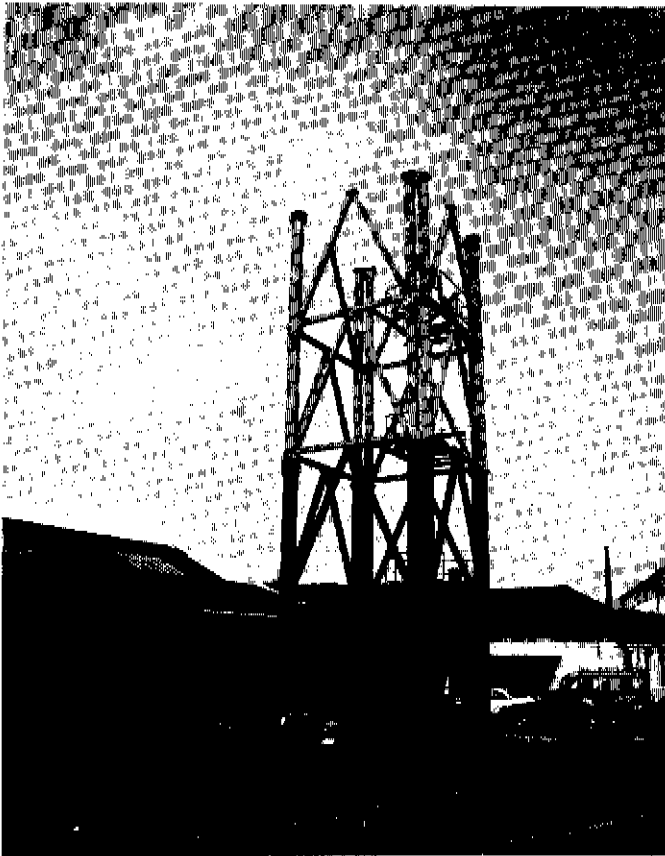
Photo 5
Section of microwave
tower during construction

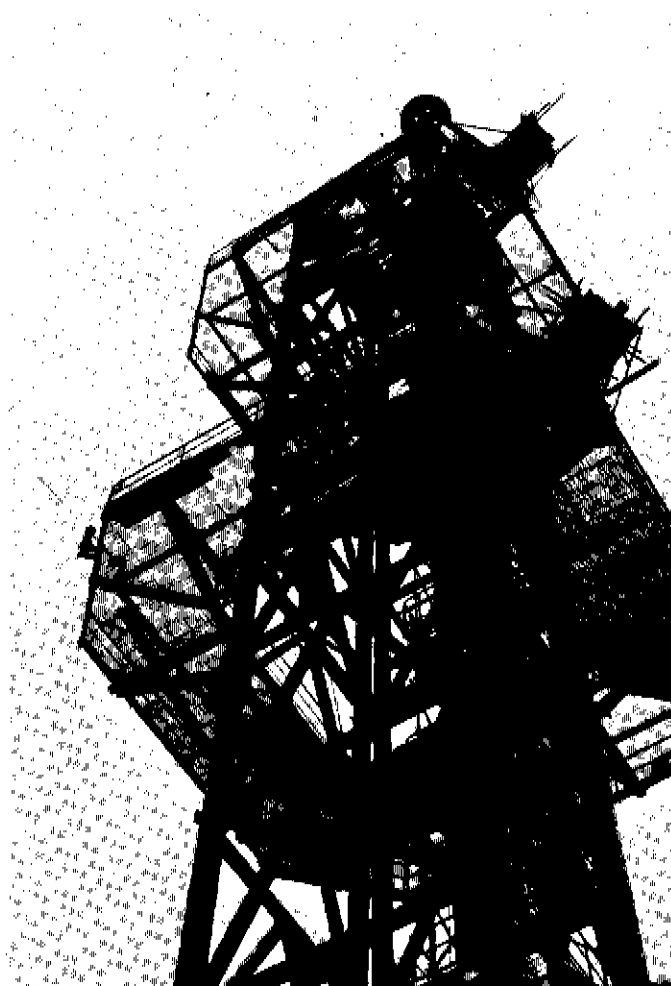
Photo 10: Microwave Tower

- The fabrication of the microwave tower has been carried out according to drawing s CHARPENTE MODERNE n°7436 01 to n° 7436- 19 approved by Mac Dermott.
- The material certificates have been examined and found in order.
- The welding were made according to agreed welding procedures and by approved welders.
- Ultra-sonic test were made satisfactorily.
- The workmanship was good.
- Visual examination and dimensional check have been carried out in presence of ELF and Mac Dermott representative.
