Frigg Field Cessation BASIC ENGINEERING
DP1 Jacket, Main BE Report

Document Title DP1 Jacket – Main BE Report
--

Document Abstract: <p>The document gives a short description of the structure to be removed.</p> <p>Further it gives a detailed description of the work to be performed by the Contractor and the responsibilities the Contractor endorses through the contract.</p> <p>This document is to be read together with the Design Basis for removal.</p>
--

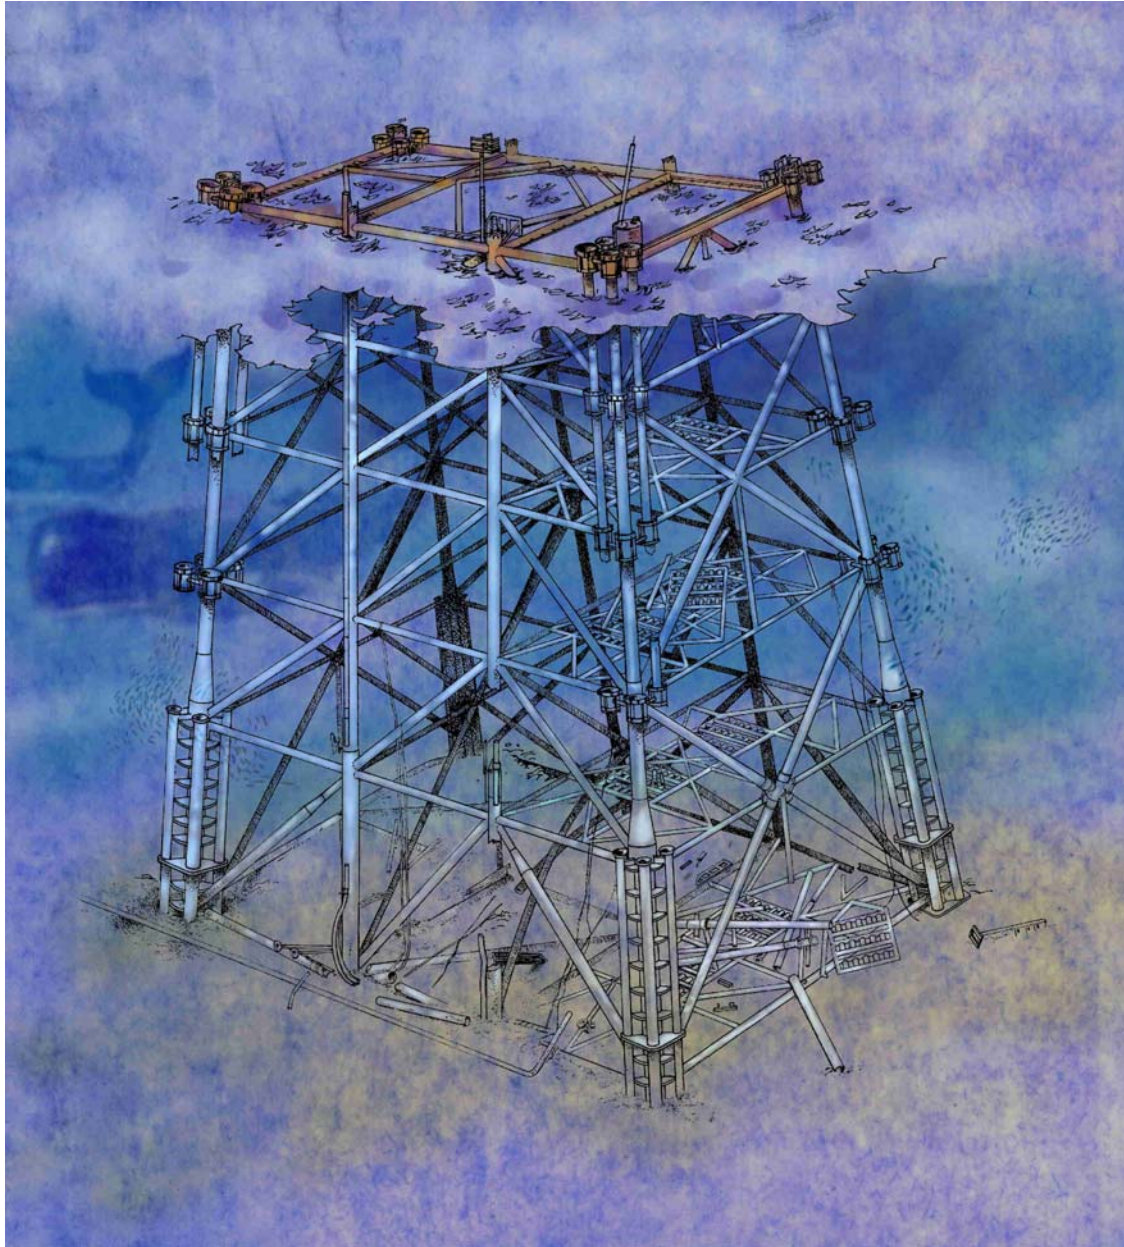
Figure 4-1 General layout drawing of DP1 jacket

The main vertical rows are denoted as 1, 2, 3 and 4 where 2 and 3 are the launch frames; the longitudinal rows are named B and the east row A. The launch runners are located on row A. A general lay out drawing of the DP1 platform is shown in Figure 1. It is noted that the figure 1 is only indicative with regards to information given on drawing

The launch runners are fixed on the two central legs on the east row of the jacket (legs A2 and A3). The present condition of the wooden part of the launch runner is not known.
